Failure Analysis Report

QEM-CCR-2006-00885

Customer:	/	Assy Site:	/
Customer Tracking ID:	/	Fab Site:	/
Customer Part ID:	/	Technology:	/
Customer Contact:	/	Analyst:	/
Device Type:	TLV62568DBVR	TI Contact:	/
		Qty Submitted:	1
Flow Type:	/	Date Submitted:	/
Reviewer:	/	Approval:	/

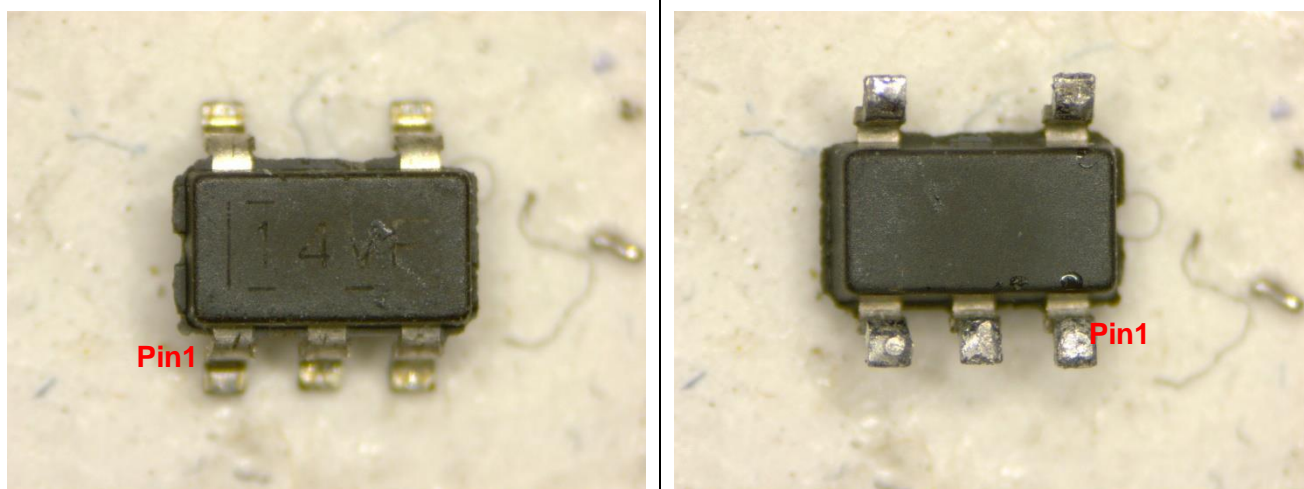
Figure 1. Optical images of unit #1

Solder and flux material was observed. No abnormality was observed on unit #1.

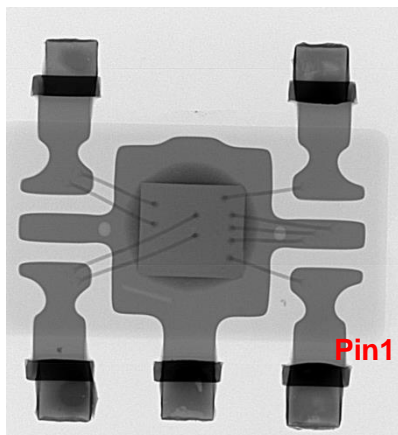
Figure 2. X-ray image of Unit #1

The returned unit was inspected by X-ray. No abnormality was observed on unit #1.

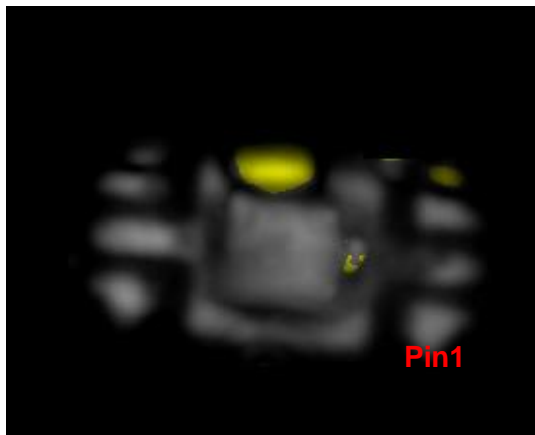
Figure 3. SAM image of Unit #1

Delamination was observed at molding compound/die paddle interface of unit #1.

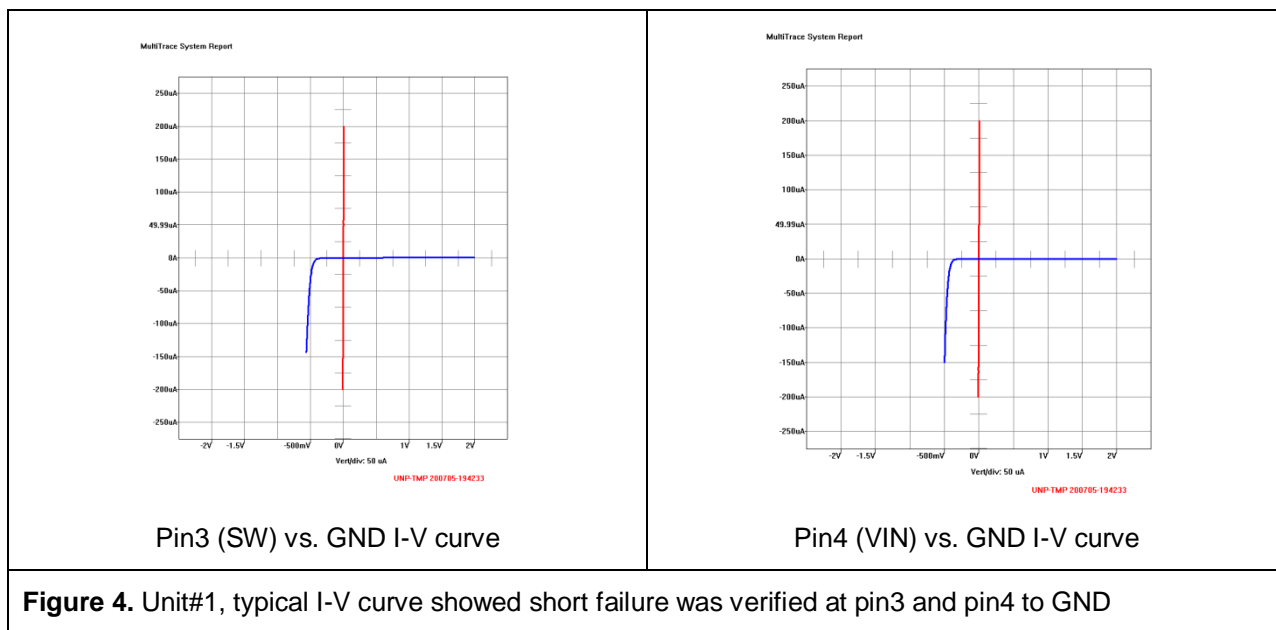
I-V curve trace analysis was performed on unit #1. Short failure was verified at pin3 (SW) and pin4 (VIN) to GND of unit#1.

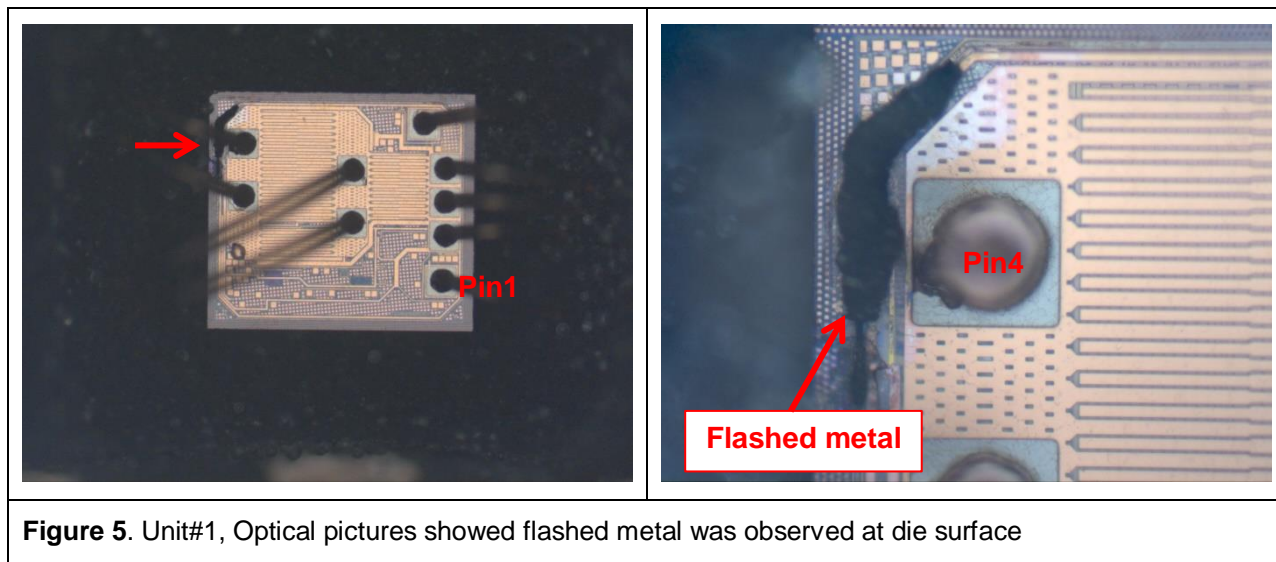
Unit#1 was decapped. EIPD as degraded molding compound was observed at die surface of unit#1.

Short failure was verified on unit #1. After decapsulation, EIPD as degraded molding compound was observed at die surface of unit#1.
