SBC Power Chip Swap Verification ABAVerification condition - EPS power supply 13V, random left and right direction, SBC power chip failure randomly reproduced

Summary: After ABA replacement verification, the original faulty chip fault was reproduced and falsely reported under normal voltage conditions. The fault code was locked to be caused by SBC power chip failure.

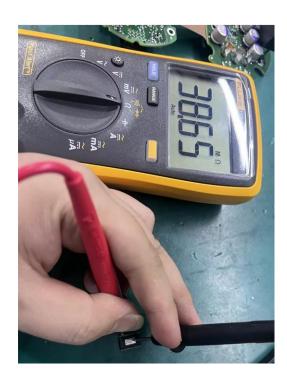
Fault component VSOUT2 impedance

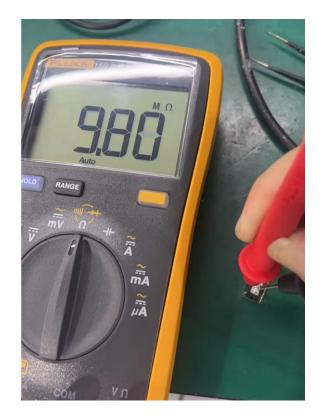
Normal VSOUT2 impedance
