RMW test program w/ logic analyzer traces

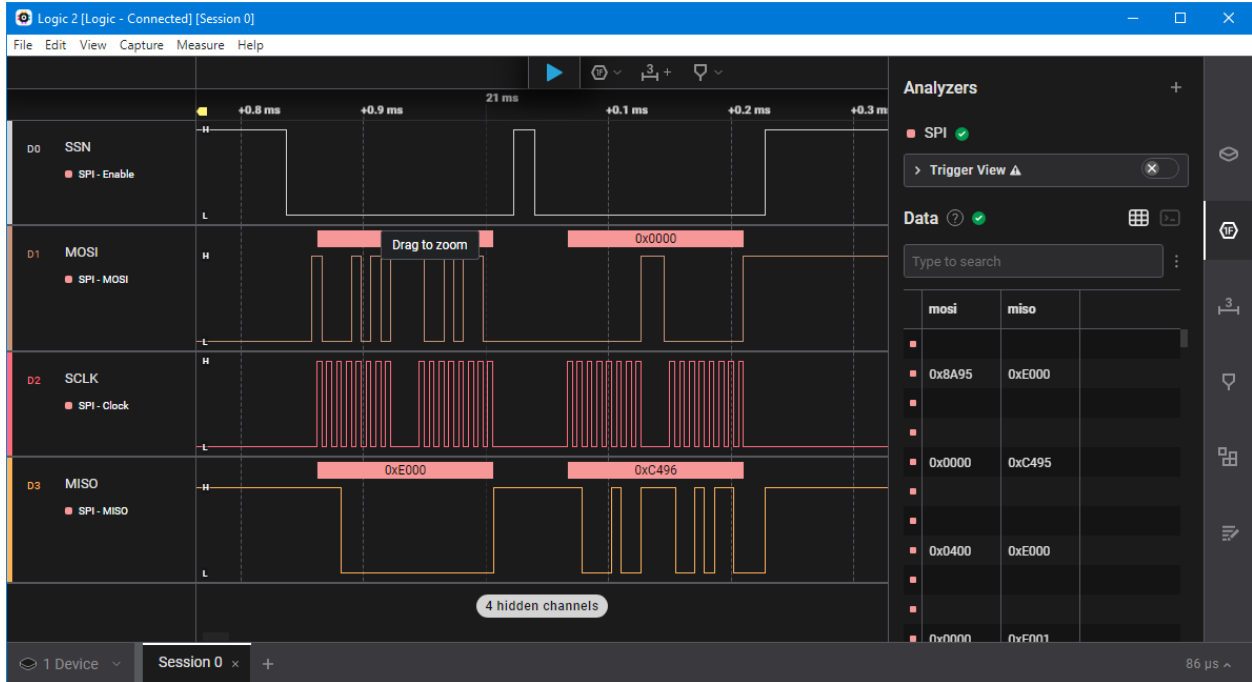
Step 1. Write 0x96 to ThermWarnLimit register (Address = 0x02). Write command is followed by another 16 bit transfer to collect the response frame.

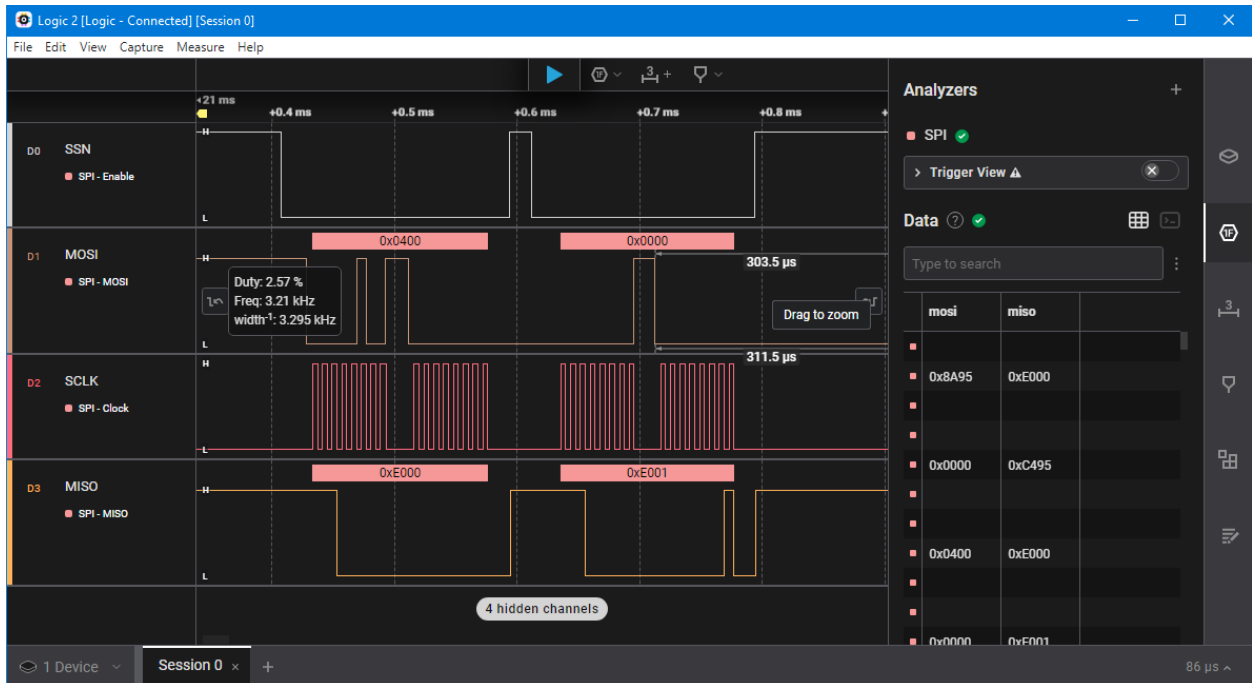
Step 2: Read STATUS register (Address = 0x01). According to datasheet this should clear SPE.

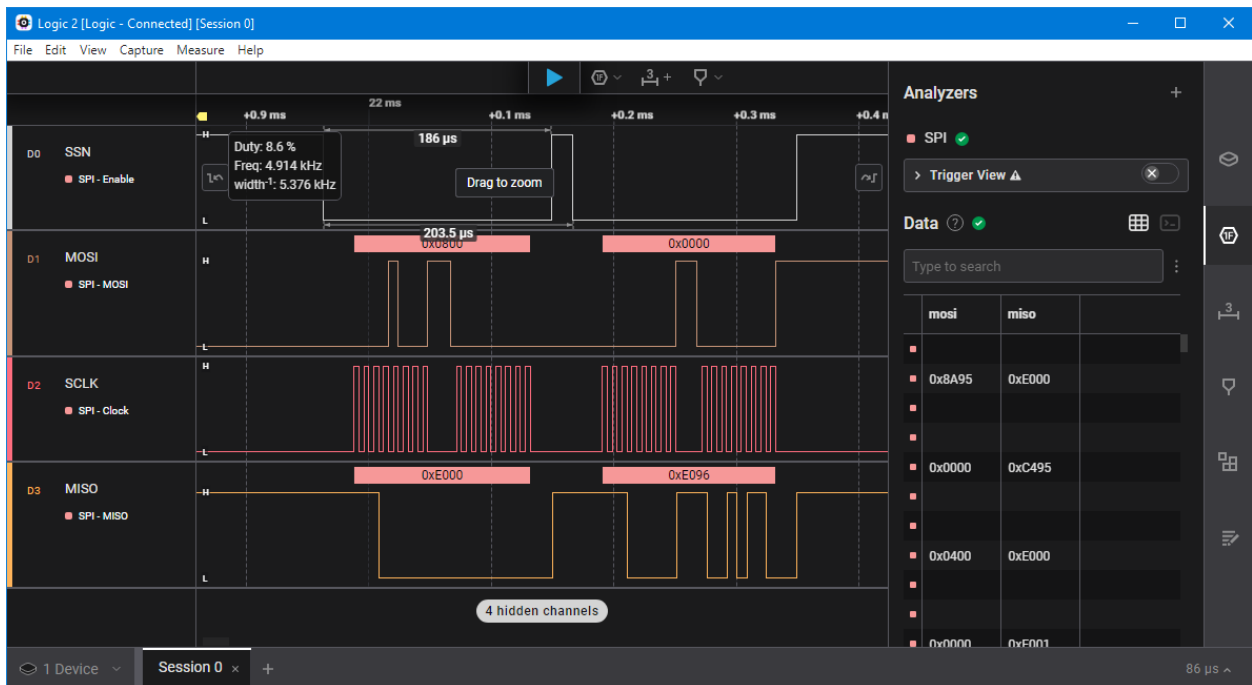
Step 3: Read ThermWarnLimit register (Address = 0x02). If the previous write operation was successful we should get back 0x96 in the datafield of the response frame.

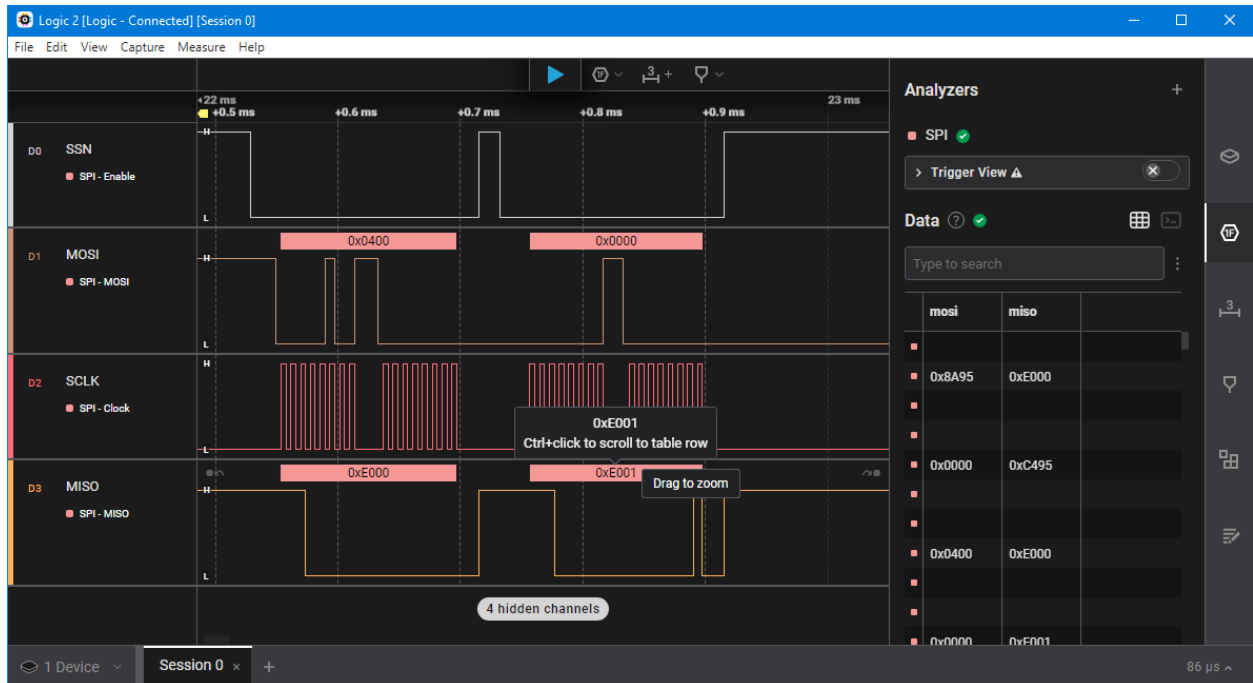
Step 4: Read STATUS register again ...the response frame is 0xE001 so the SPE flag is set in the response frame and the data portion also indicates and active SPI error condition.

- Read STATUS register does not seem to clear the SPE condition?
- TPS92518 should ignore writes w/ SPI errors but they seem to be accepted even though SPE is set in the write response frame. Datasheet says we should receive an Write Error response frame (0x8000).
