## 2. Analysis

### 2) Review operation by BOOST IC MAKER

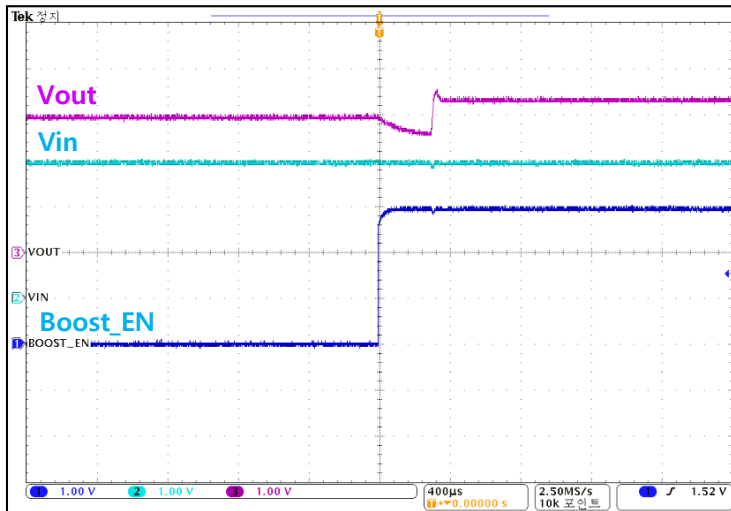
#### ① PBAFA1454A - Revision A

IMS (IM8132S) : Vout 3.3V Normal Output

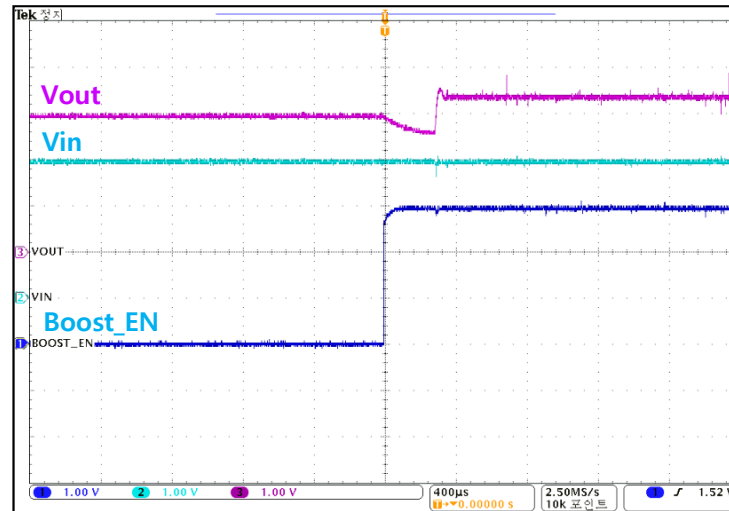
#### ② PBAFA1454B - Revision B

IMS (IM8132S) : Vout 3.3V Normal Output

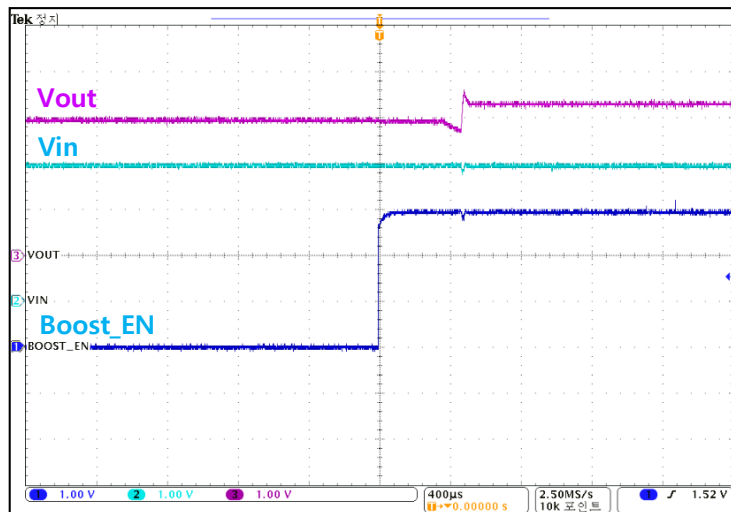
TI (TPS61097A) : Vout 3.3V Normal Output

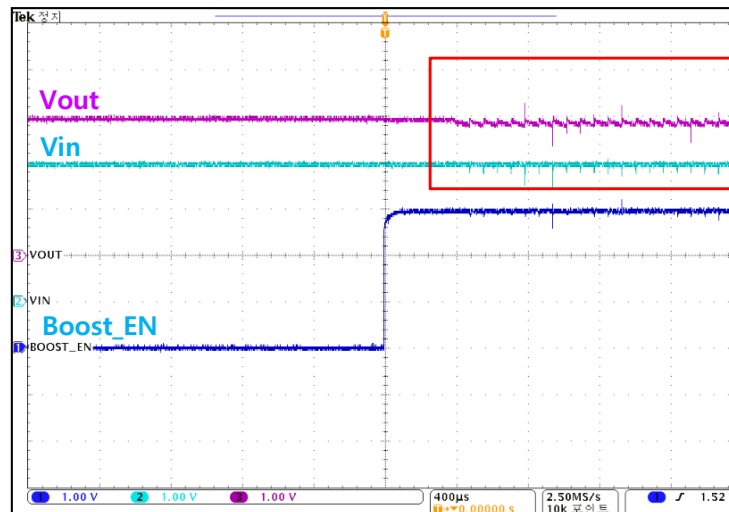
TI (TPS61097A) : Vout 3.3V not output, Vin voltage bypass output.

- Pull-down Resistance (R23) 100K -> Change to 1 Mohm & Remove : No Vout Improvement
- Voltage distribution by adding 100K as Serial to Boost\_EN line: No Vout improvement

#### 2) GND : Connecting GND to (-) terminal Direct : No Vout improvement

- Remove FET (Q1,Q2) and connect with 0 ohm resistance between D-S to connect with GND and (-) terminal Direct - (-) terminal PAD to some copper plates

#### 3) Power engineer (L2) 4.7uH -> 10uH: No Vout improvement

#### 4) Changing the C18, C19 correction number of Boost IC's Vin/Vout: No Vout improvement

- C18,C19 : 10uF -> 1uF : Vout voltage down
- C18,C19 : 10uF -> 22uF : Vout voltage slightly increased (0.02V increase)
