# TPS53219A / Start up issue due to improper ripple injection

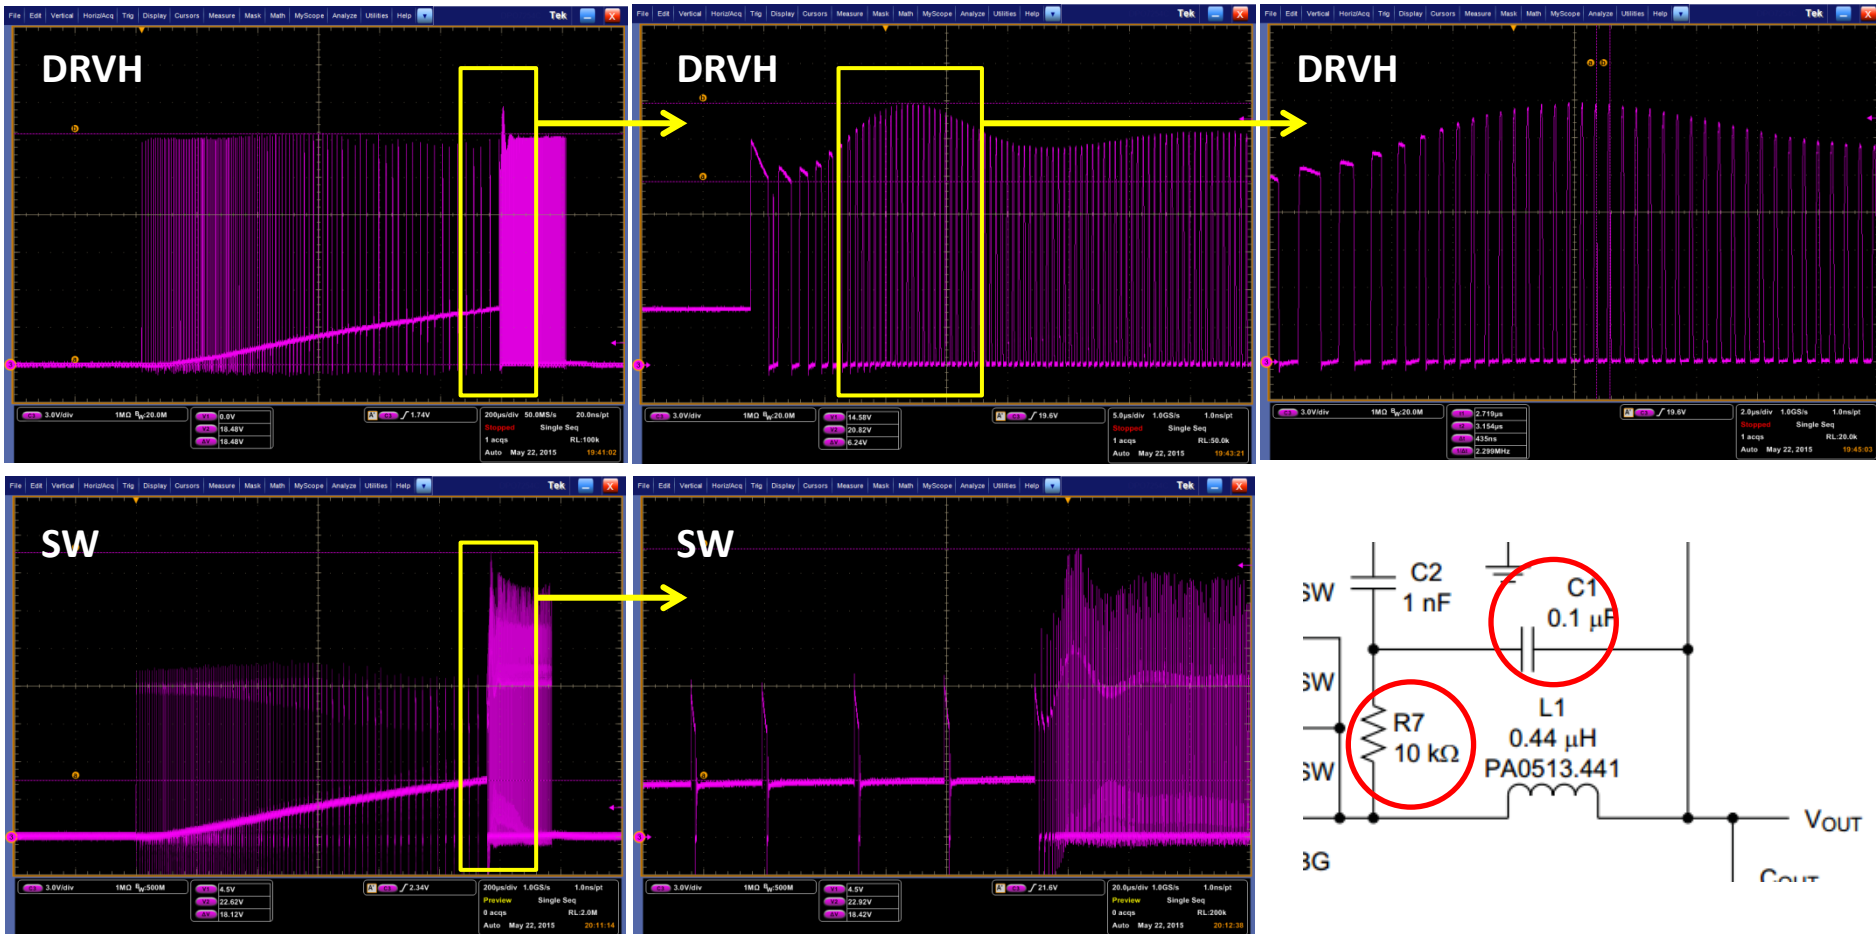
- The switching is stopped during startup.
- The switching frequency is approx. 2MHz before stopping switching.
- This behavior is resolved by resoldering ripple injection component R7 and C1.
