### TPS65130 Vpos ripple issue in Power-save mode:

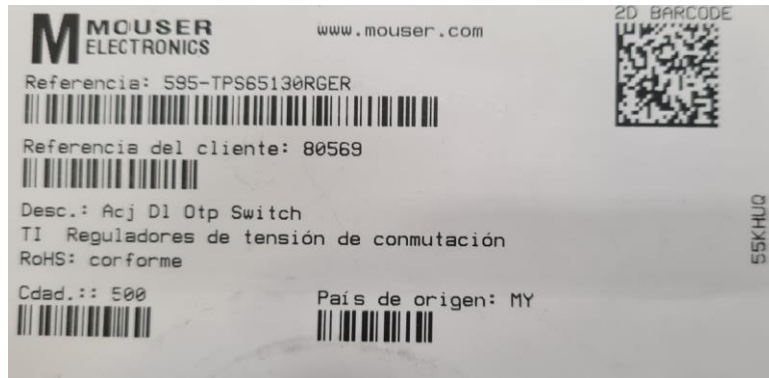
The problem has been detected with the last production lot, and it was never seen before.  
These units have been bought at Mouser:

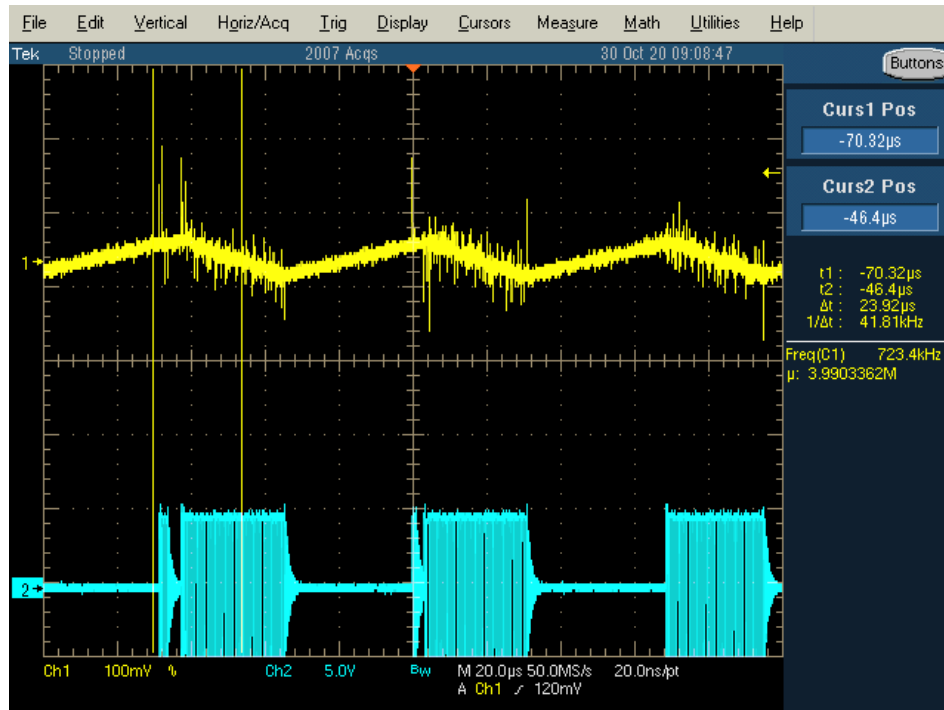
In all circumstances, the waveform in the negative rail is something similar as expected:

... with a AC level of about 50mV, very similar to the one in the figure 47 of the datasheet:

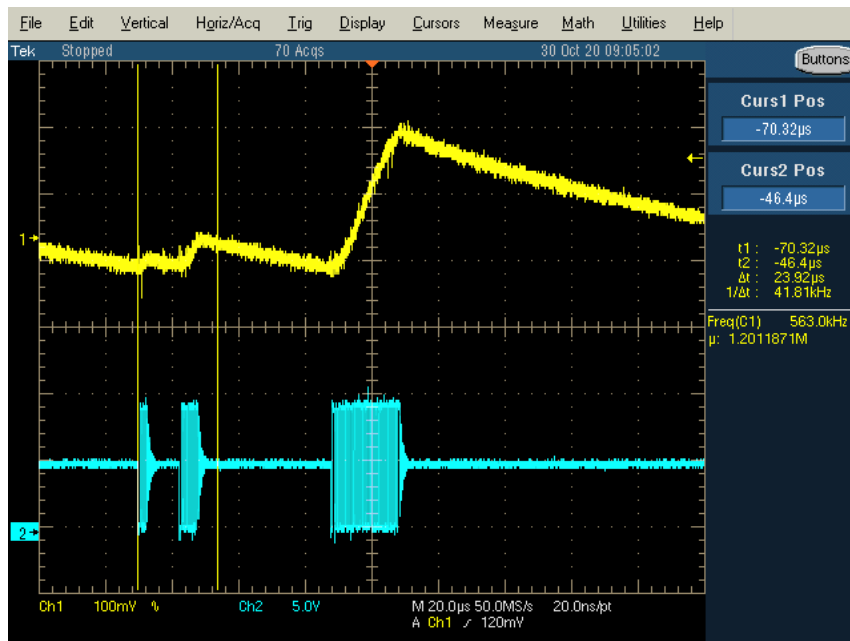
But in nearly the whole of the units for this batch of production, the waveform for the positive rail is not as expected, producing a very high amount of noise:

... with an AC level of about 200mV, far away from the expected in the figure 46 of the datasheet:

If we replace the IC in a unit with the problem, with one from an older production date, the problem is solved. If we replace the IC with one of the same reel, the problem persists.

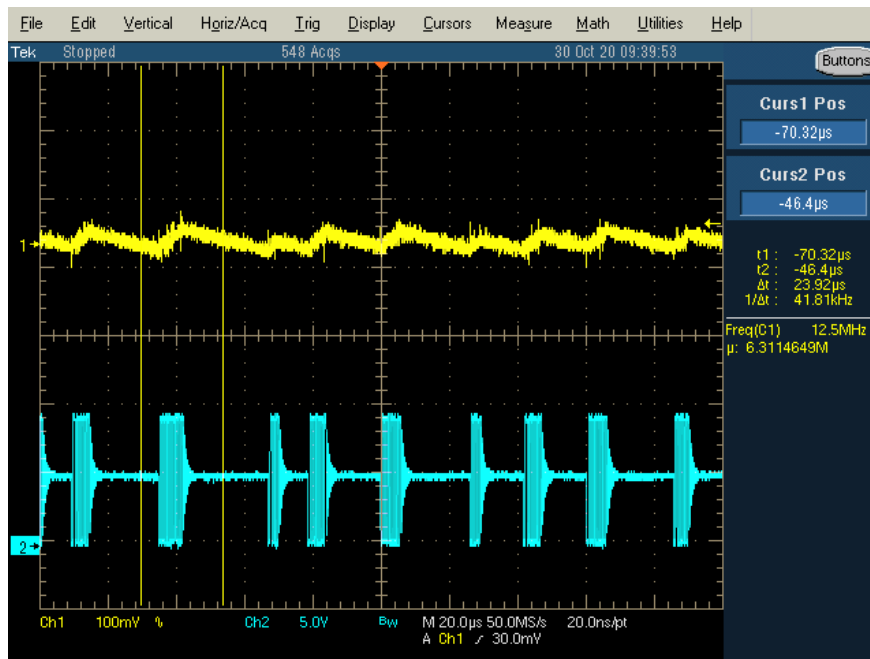
A few units are good, with a waveform very similar to the one of the datasheets:
