Problem with flyback driver PFC at low temperatures

Version	Datum	Was	Autor
V00	19.09.2022	creation	Stefan Baebler

Reason for measurement

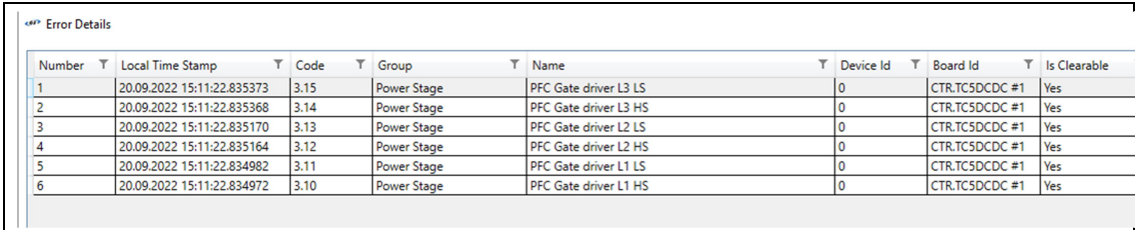
- During temperature tests with the new Infineon modules (FF17MR12W1M1HP_B11) in the complete unit, all desat errors were always triggered at an ambient temperature of 0°C and a time of 15-20min.

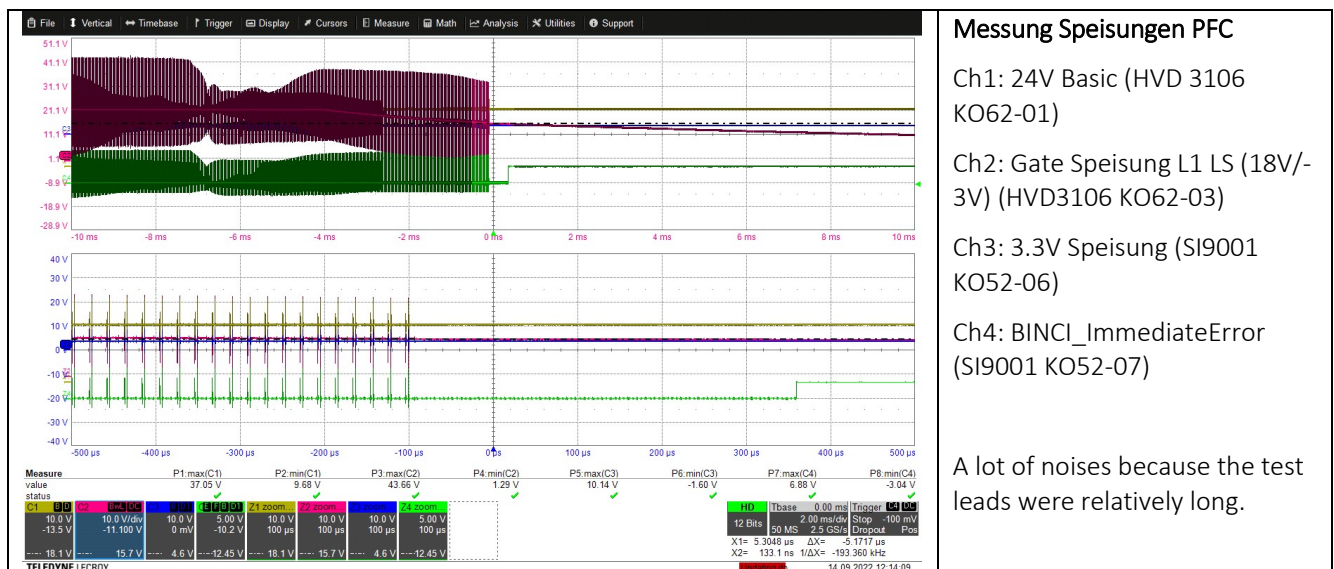
From the measurement it can be seen that the gate supply starts to drop at a certain point. At 12.7V (15.7V -3V) the voltage drops below the UVLO threshold of the driver and the desat triggers. In order to measure the signal BINCI_ImmediateError at the DSP debug I/O of the CTR.DCDC, the firmware version V1.5.0.29 was loaded onto the DUT.

Therefore, the source of the error may still be in the flyback circuit or in the 24V ISR GD path.

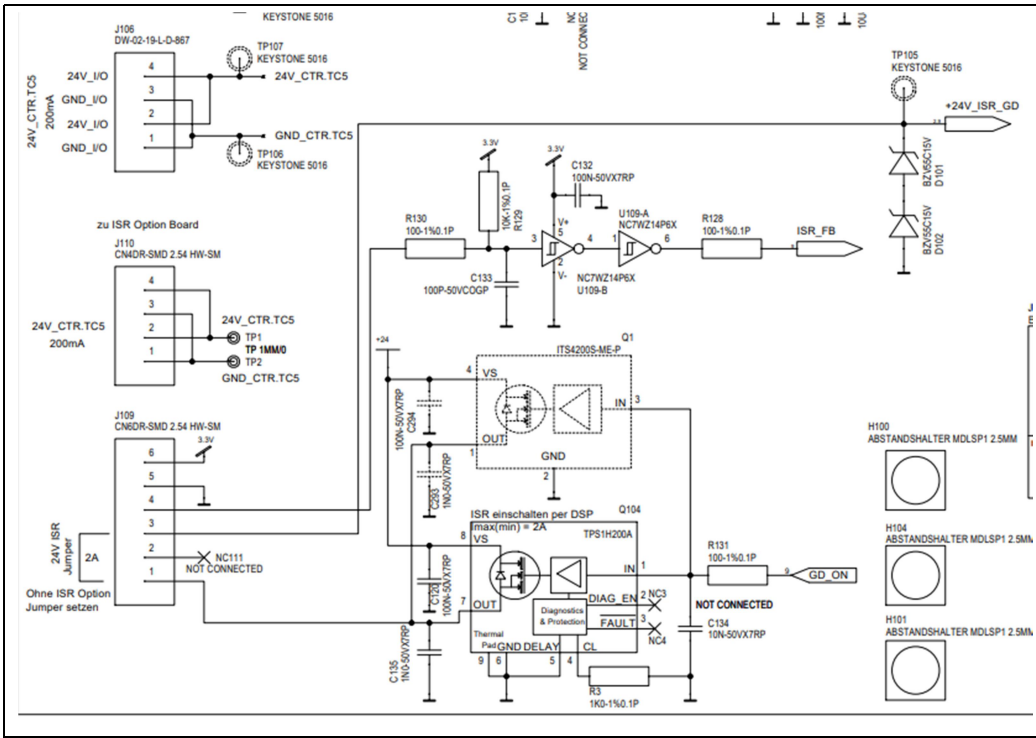
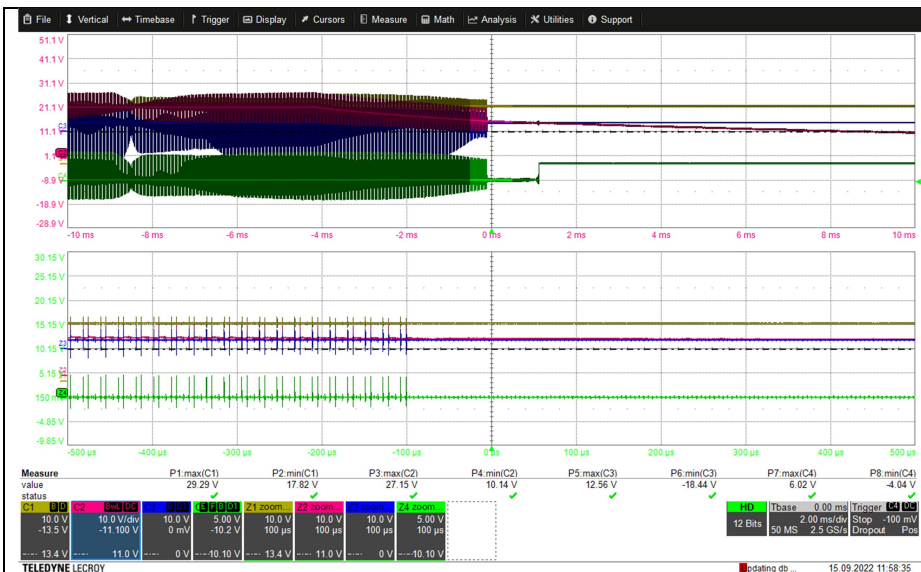
Measurement supplies/signals
PFC
 Ch1: 24V ISR_GD (HVD3106 KO62-01)
 Ch2: Gate supply L1 LS (18V/3V) (HVD3106 KO62-03)
 Ch3: Signal GD_ON (SI9001 KO52-06)
 Ch4: BINCl_ImmediateError (SI9001 KO52-07)

A lot of noises because the test leads were relatively long.

The 24V ISR_GD looks good, so the problem can only be with the flyback circuit.

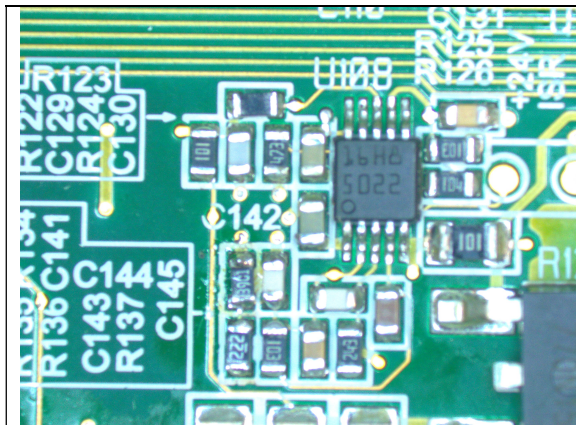
- The flyback driver LM5022MM has internal problems with low temperatures.

Installed driver LM5022MM (Faulty driver)
Datecode:16H8

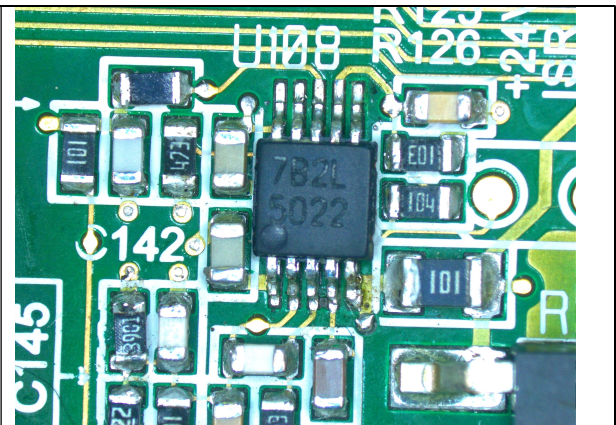
New driver LM5022MM
Datecode:7B2L

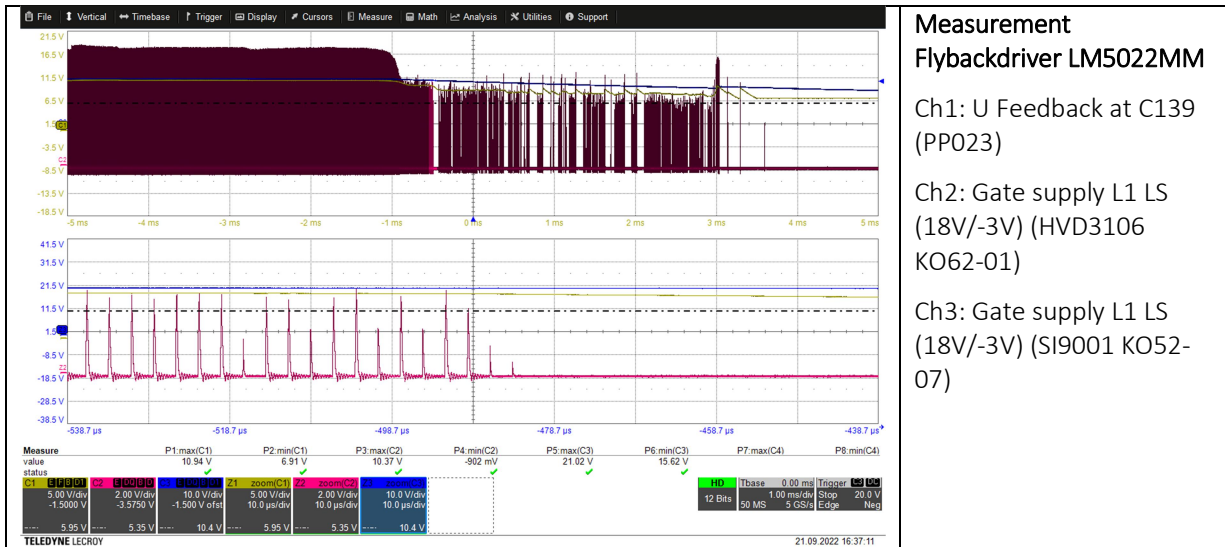
Measurement Flybackdriver LM5022MM

The measurement shows that the driver starts to shorten the duty cycle at a certain temperature. As a result, the voltage at the output starts to drop until the UVLO threshold of the gate drivers is undershot and they switch off. It is not possible to say what internally in the driver cannot cope with the low temperatures.

The faulty driver was also desoldered and tested on another print and the same errors occurred.
