**Fig 1) Typical Recovery from UVLO state of upper driver in UCC21520.**

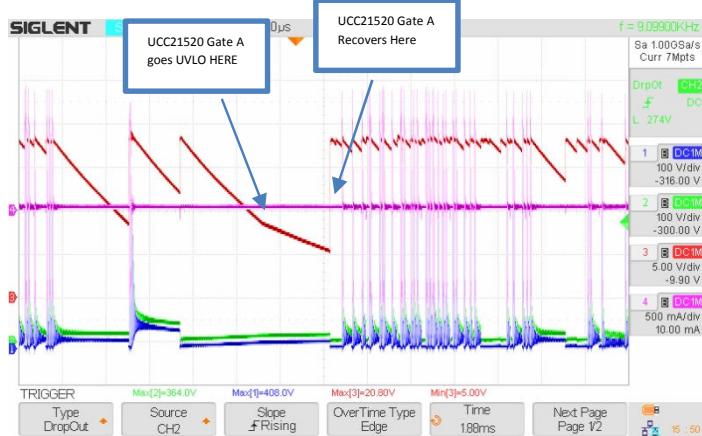
- CH1)** Source C (One Leg of Full Bridge)
  - CH2)** Source A (The Full Bridge Leg Corresponding to this Driver)
  - CH3)** Boot Strap Cap (Measured W/ Isolated Probe)
- At random, a gap impules long enough to cause UVLO is encountered. This happens at no-load, and also after load-dump events. It is unavoidable with this bootstrap topology.**

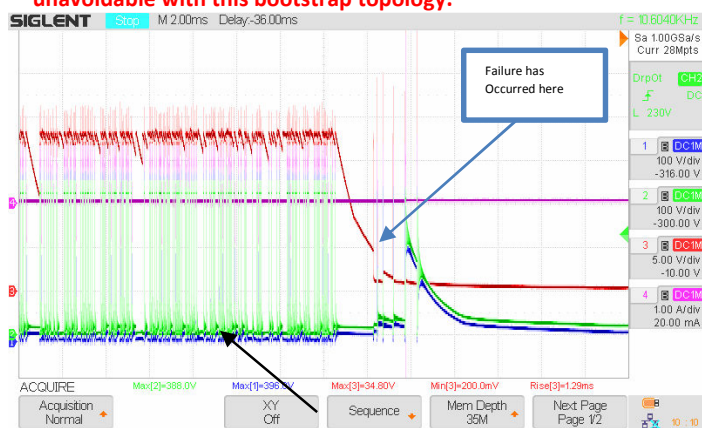
**Fig 2) UCC21520 - Failure Observation, Full Scale**

- CH1)** Source C (One Leg of Full Bridge)
  - CH2)** Source A (The Full Bridge Leg Corresponding to this Transition)
  - CH3)**  $V_{GS}^{Q7}$ , GATE A Turn on (Measured W/ Isolated Probe)
  - CH4)** Shim Inductor Current in Full Bridge
- Failure is observed upon first bootstrap after a UVLO event.

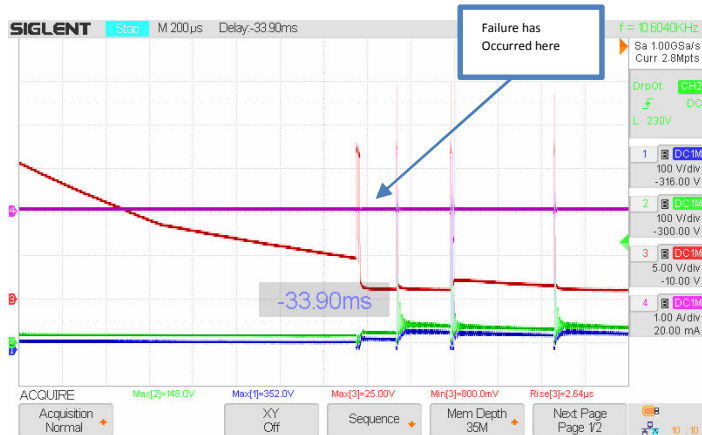
**Fig 3) UCC21520 - Failure Observation, Zoom**

When the bootstrap cap recharges, the driver appears as those the output (OUT A) is either shorted to VSSA, or becomes shorted to VSSA when a high Gate state is requested, as the Bootstrap voltage discharges rapidly.

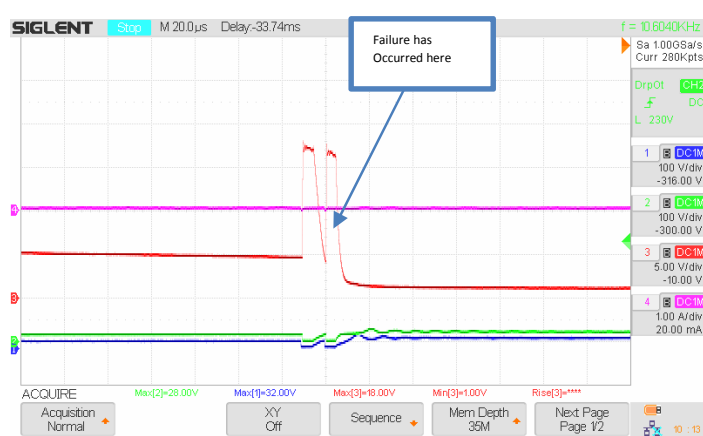
**Fig 4) UCC21520 - Failure Observation, Zoom**

- CH1)** Source C (One Leg of Full Bridge)
  - CH2)** Source A (The Full Bridge Leg Corresponding to this Transition)
  - CH3)**  $V_{GS}^{Q7}$ , GATE A Turn on (Measured W/ Isolated Probe)
  - CH4)** Shim Inductor Current in Full Bridge
- Note the quick discharge of the bootstrap voltage after the lower mosfet in the totem pole has turned off.

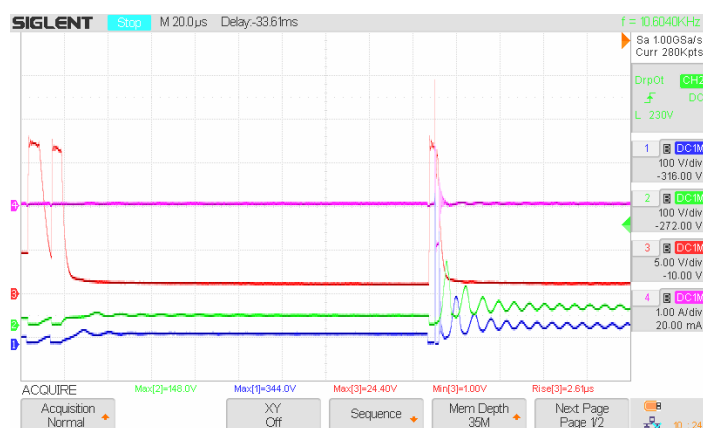
**Fig 5) UCC21520 - Failure Observation, Zoom**

Converter continues to attempt to run, though power can't be transferred

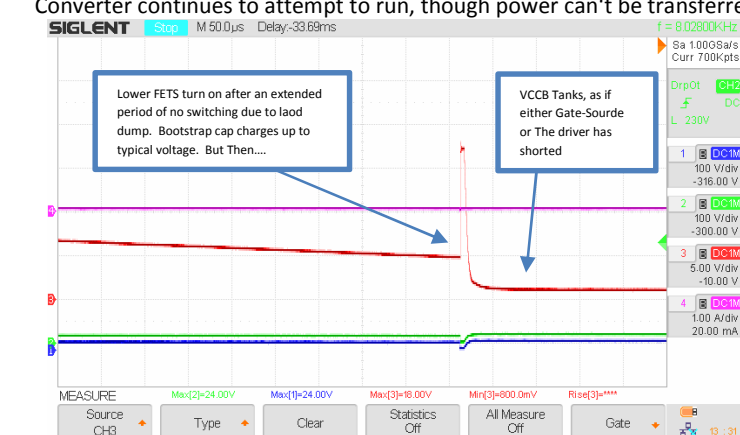
**Fig 6) UCC21520 -FAILURE OF A UNIQUE SECOND UNIT**

A SECOND UNIT WAS TESTED TO FAILURE, AND EXTREMELY SIMILAR WAVEFORMS ARE OBSERVED.

In both cases, No MOSFETS have failed (G-S, D-S, D-G or otherwise). Yet UCC21520 shows shorted from OUTA to VSSA when removed from ckt.
