UCC256302 frequency stability issue

Problem description

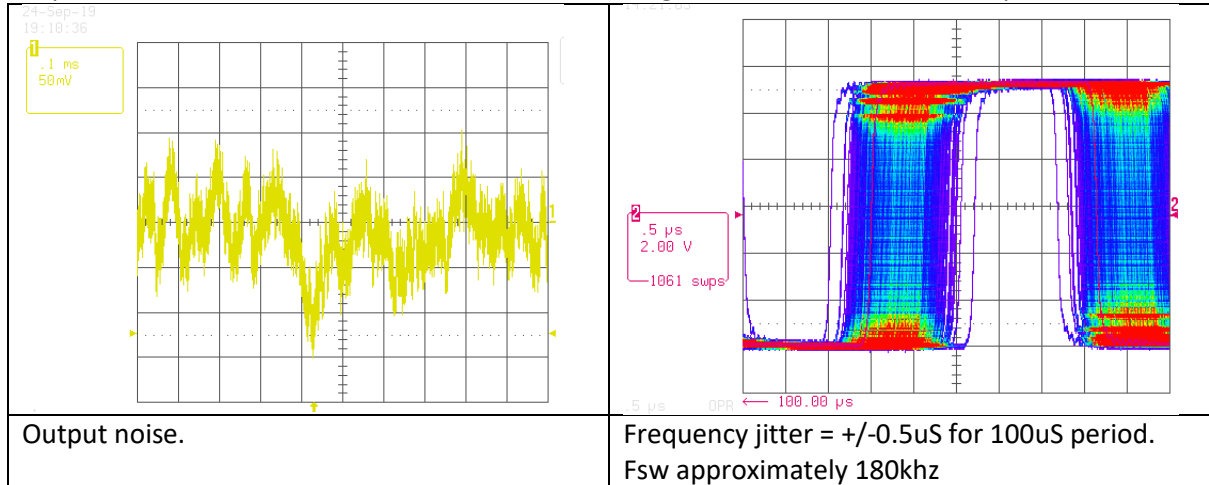
Output noise from LLC converter is unstable when using UCC256302 IC as shown in plot below.

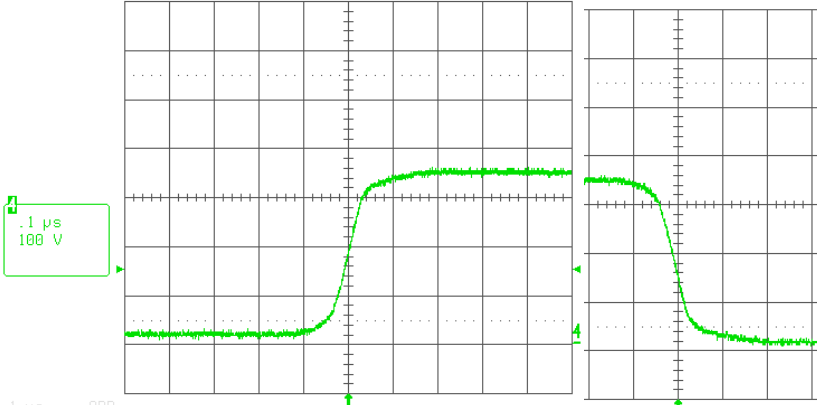
<p>0.1 μs 100 V</p> <p>100.0 μs</p>	<p>Switching edges</p>

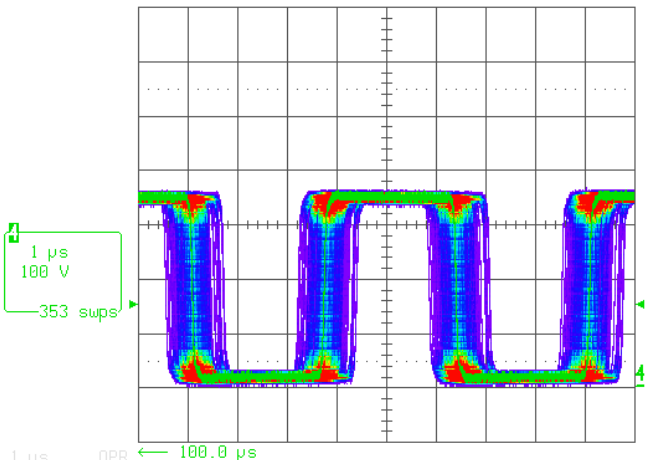
Even with these modifications, significant frequency jitter can still be observed.

<p>1 μs 100 V</p> <p>353 supps</p> <p>100.0 μs</p>	<p>Switching jitter at 100μs delay from trigger.</p>
<p>25-Sep-19 15:30:59</p>

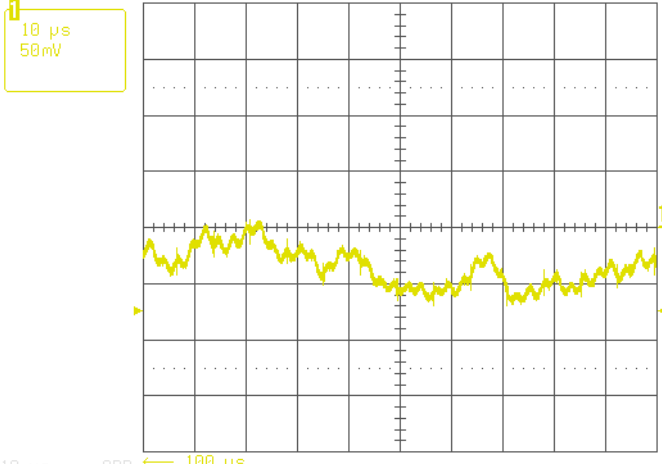
<p>10 μs 50 mV</p> <p>100 μs</p>	<p>CH1 = Output ripple</p>
