一、异常现象，出现一颗 TPS62135 异常 SW 无输出，电压跌落，PG 拉低后级通过 PG 控制的电源使能拉低导致后级掉电。时间约 240us。

此处电路设计为：12V - 5V - 3.3V

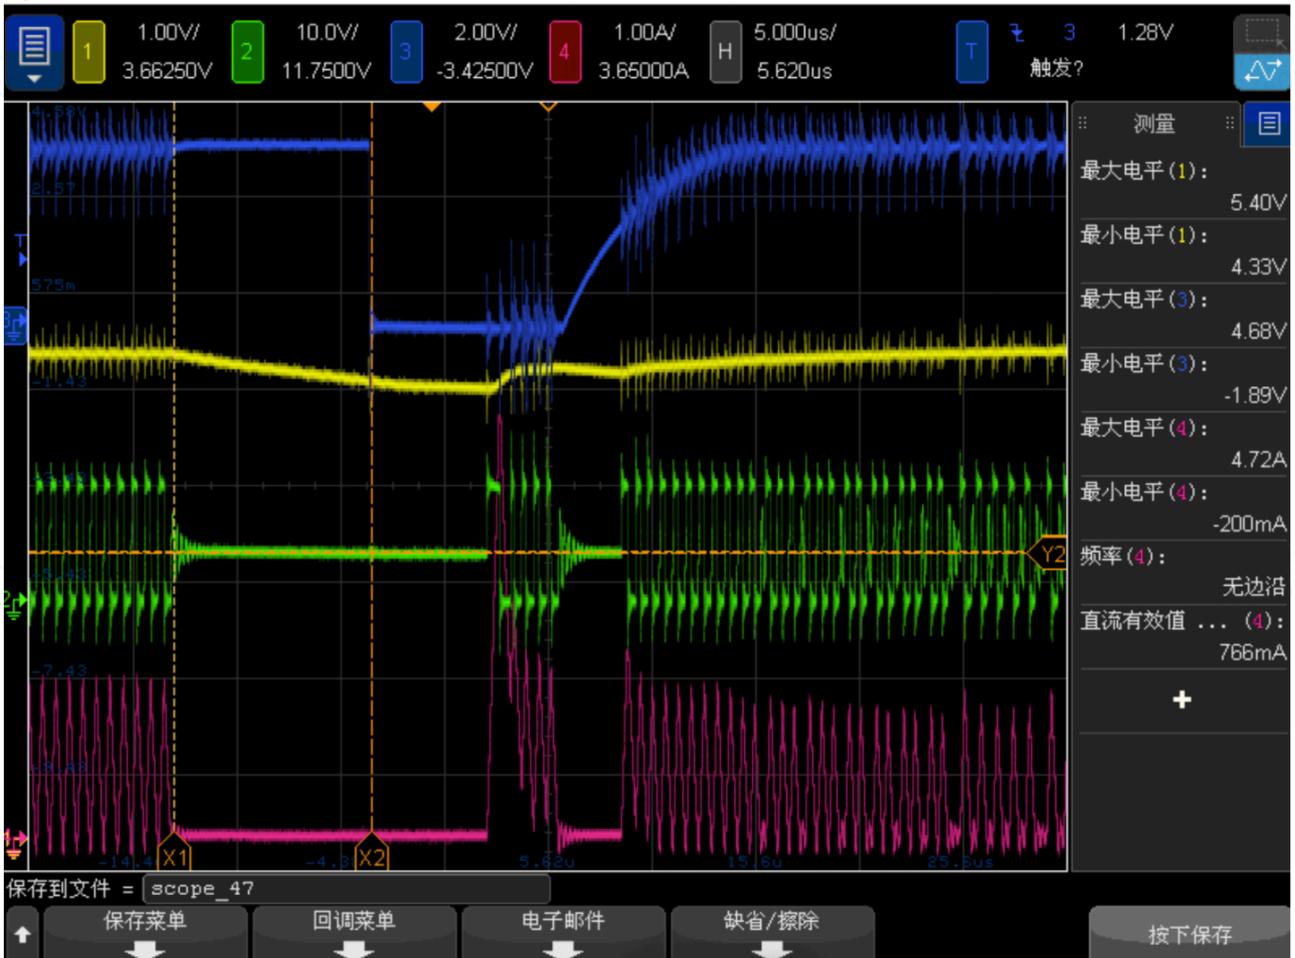
蓝线: 5V PGood

黄线: 5V

绿线: 5V SW

粉线: 5V Inductor Current

可以明显发现, 在 5V 电压开始跌落的时候, SW 不再有 PWM 输出, 同时电感的纹波电流归零。当跌落出 $5V \times 96\% = 4.8V$ 时, 5V Power Good 主动拉低。

在拉低后的 8us 左右时, 会有一个冲击电流, 峰值电流超过 4.7A (状态有点类似开关 In-rush)。对应的一个 PWM 占空比较大。

但是在出现电压跌落 SW 位置的电压并没有置零, 像是上管处于了 MOS 管的放大区, 电压幅值约为 4.5V。

适用 3109 的 workaround: 5V 分压控制 3.3V EN, 取代 5V PG 控制 3.3V EN;

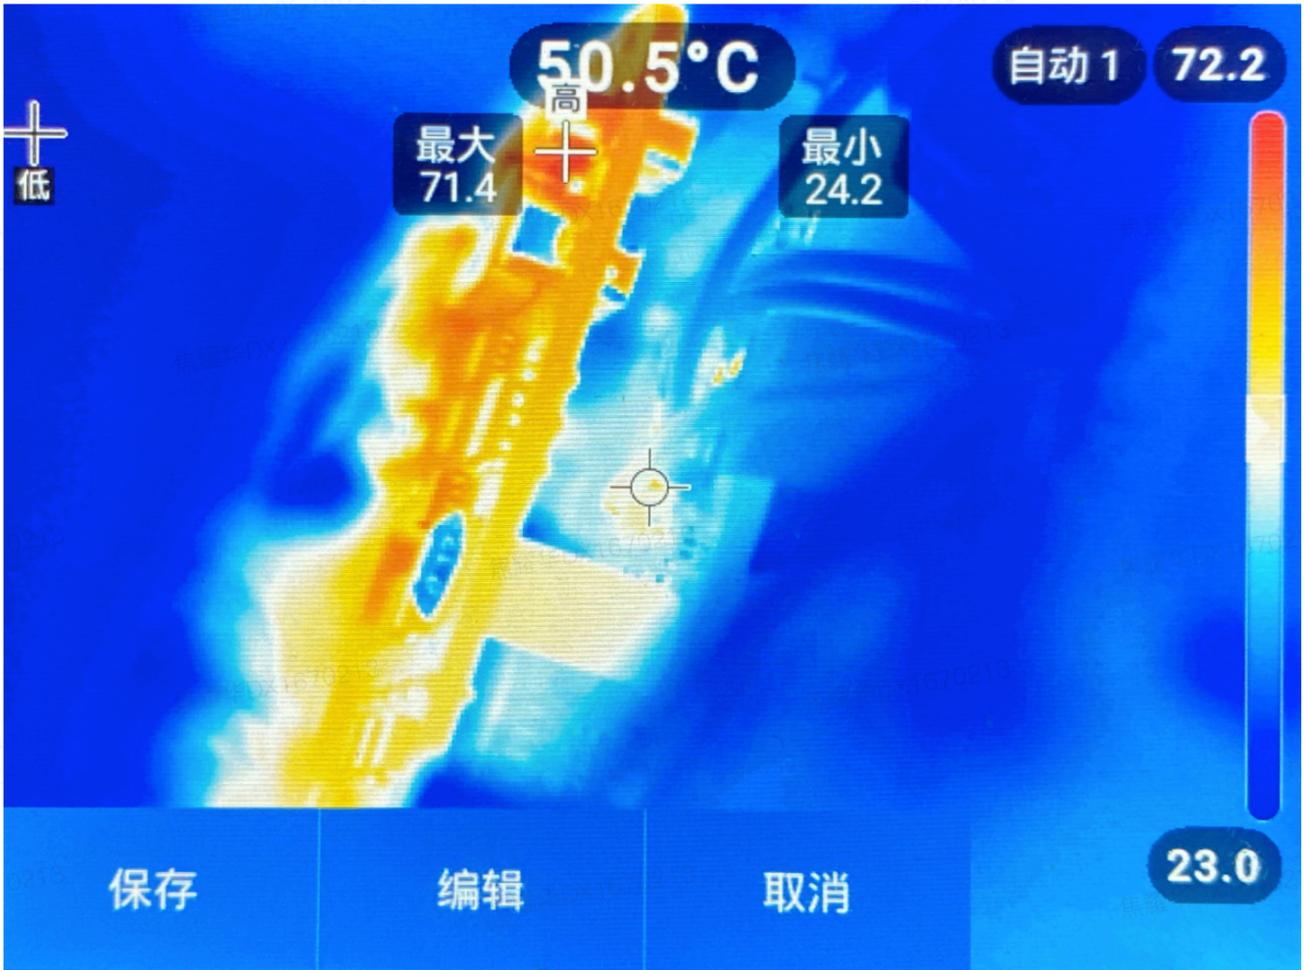
TPS62135 温度测试 (按照功率折算, JT 小于 70 摄氏度, 远小于 160 摄氏度):

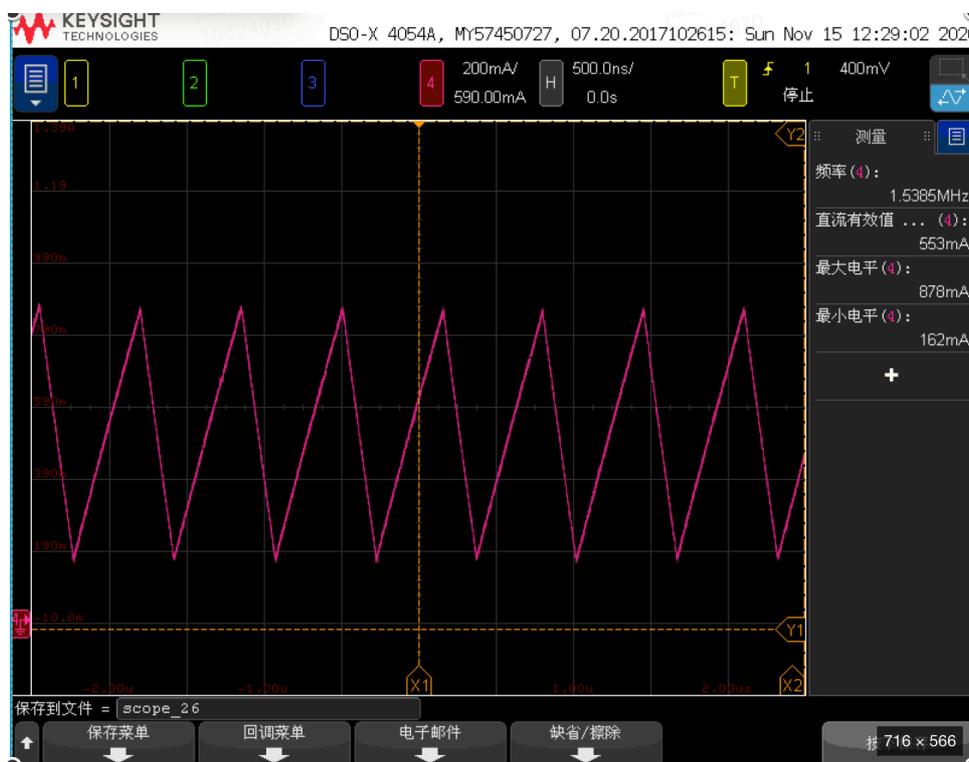
1、5V 输出电流波形（均值 878mA，无过流现象）

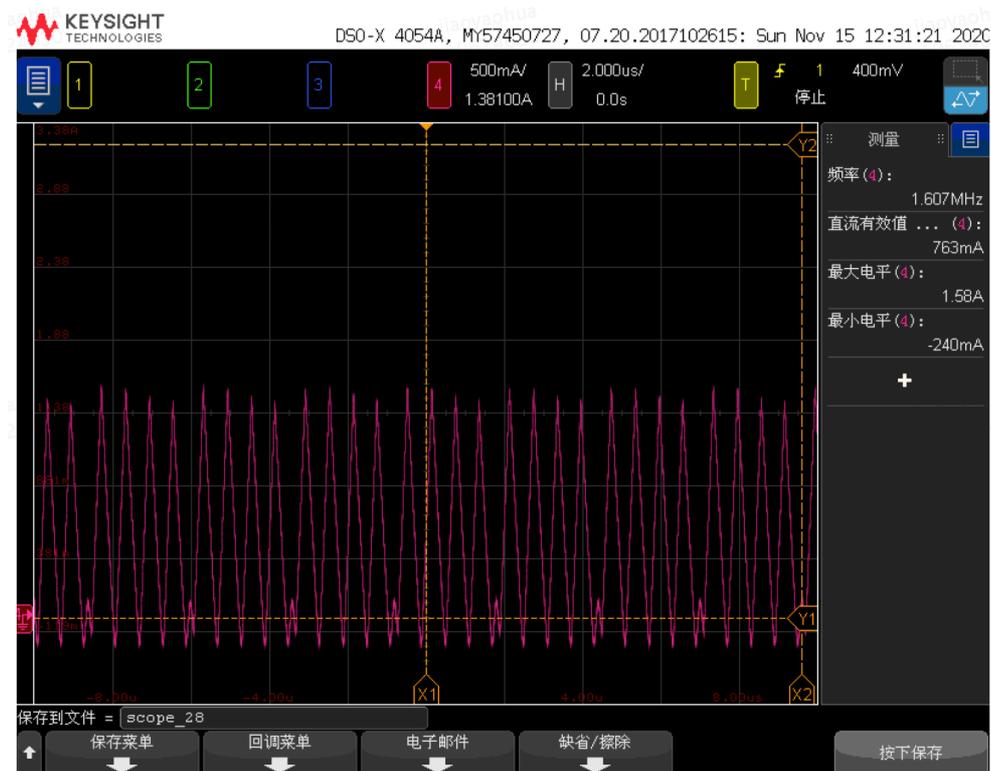
2、3.3V 输出电流波形（763mA，无过流现象）

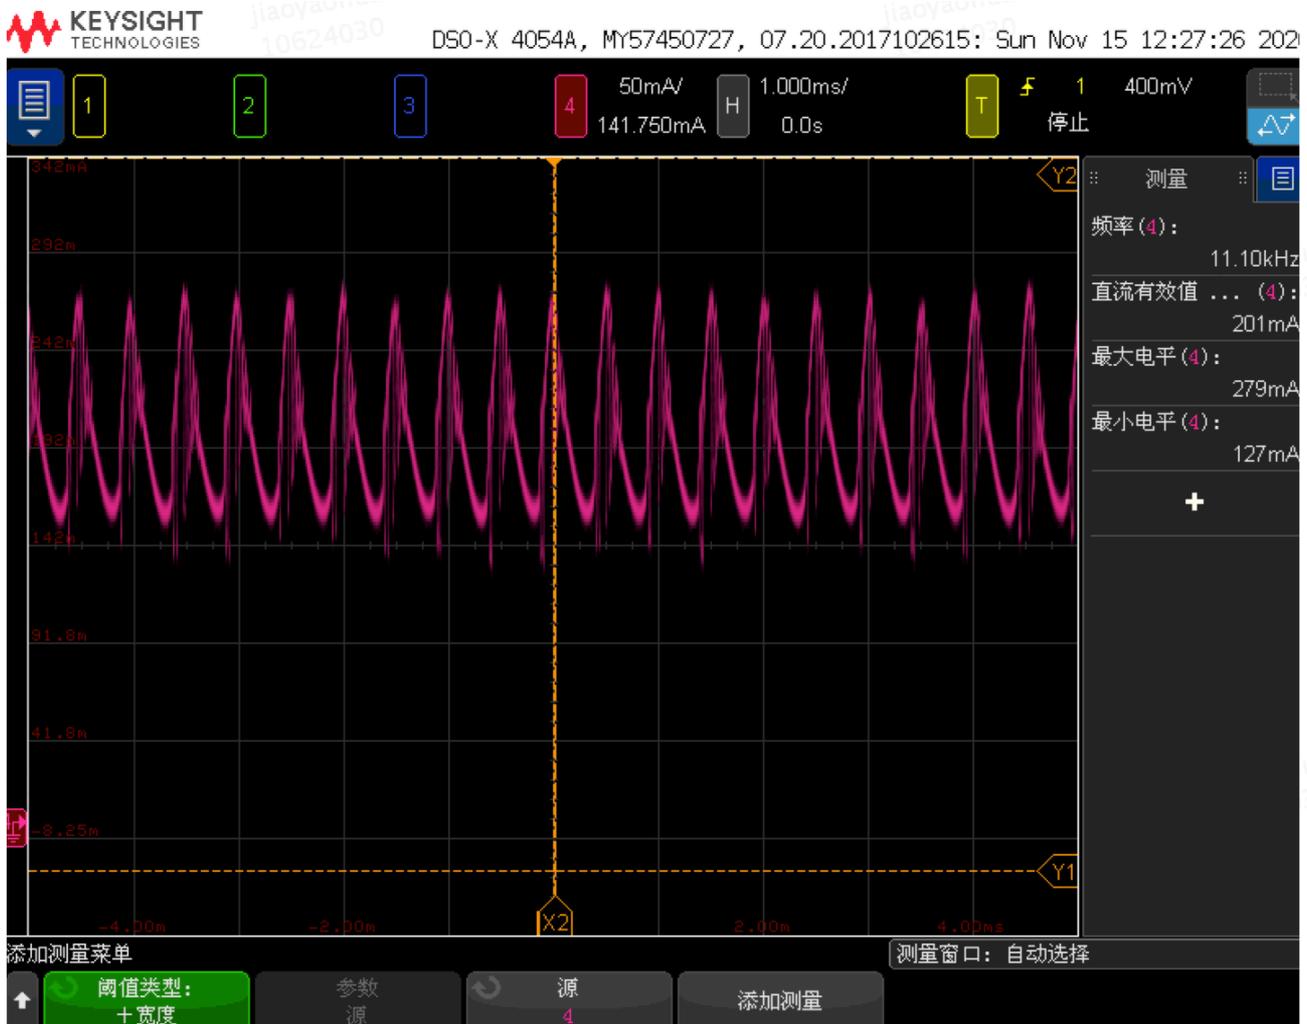
3、风扇（5V 其他负载）电流波形（279mA）

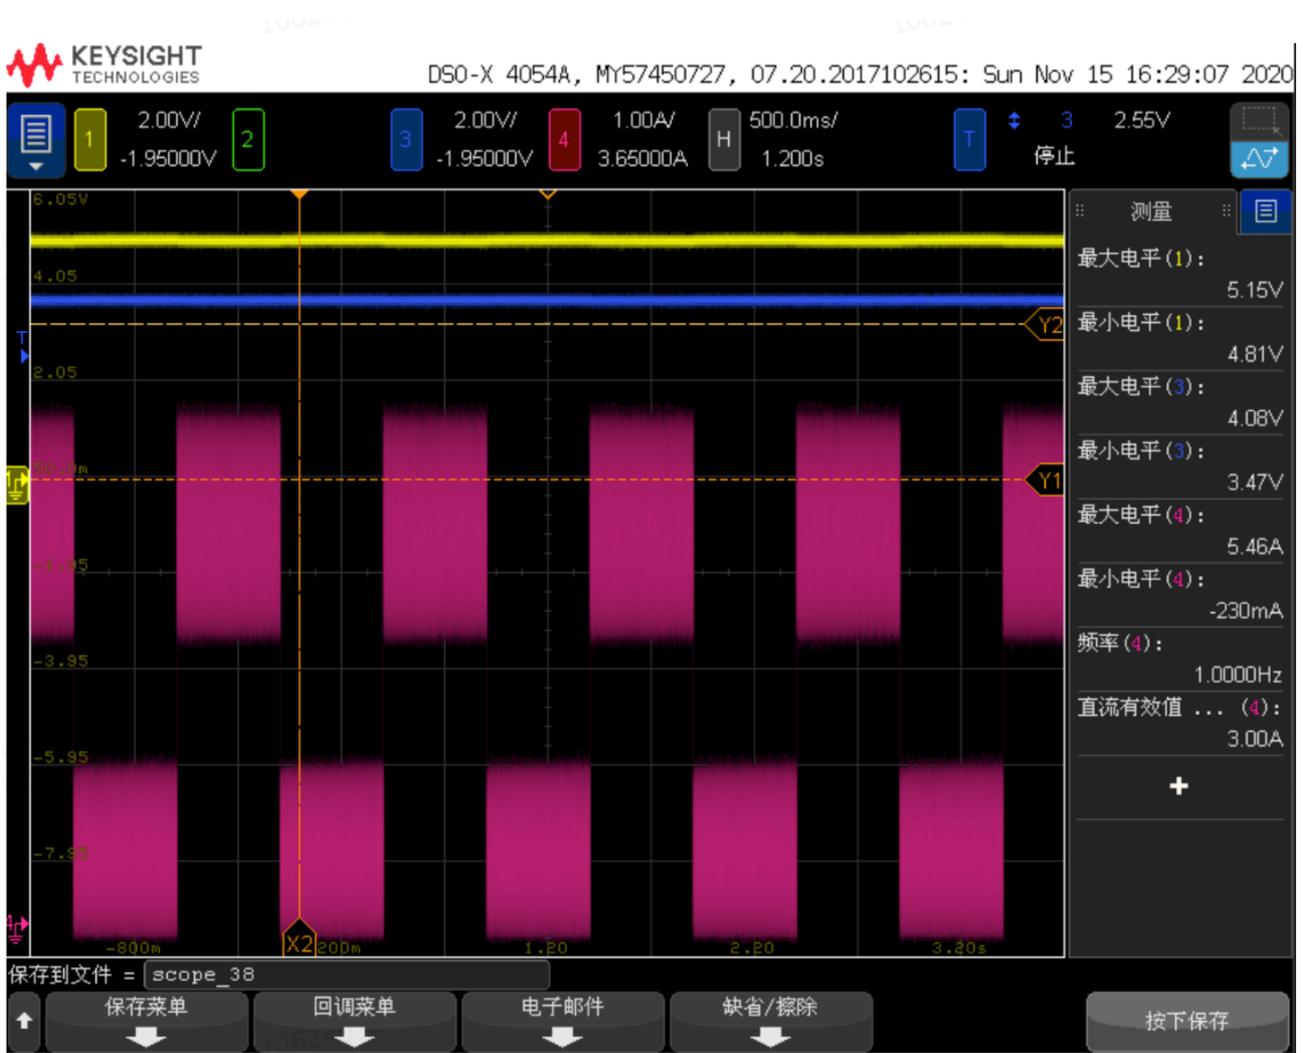
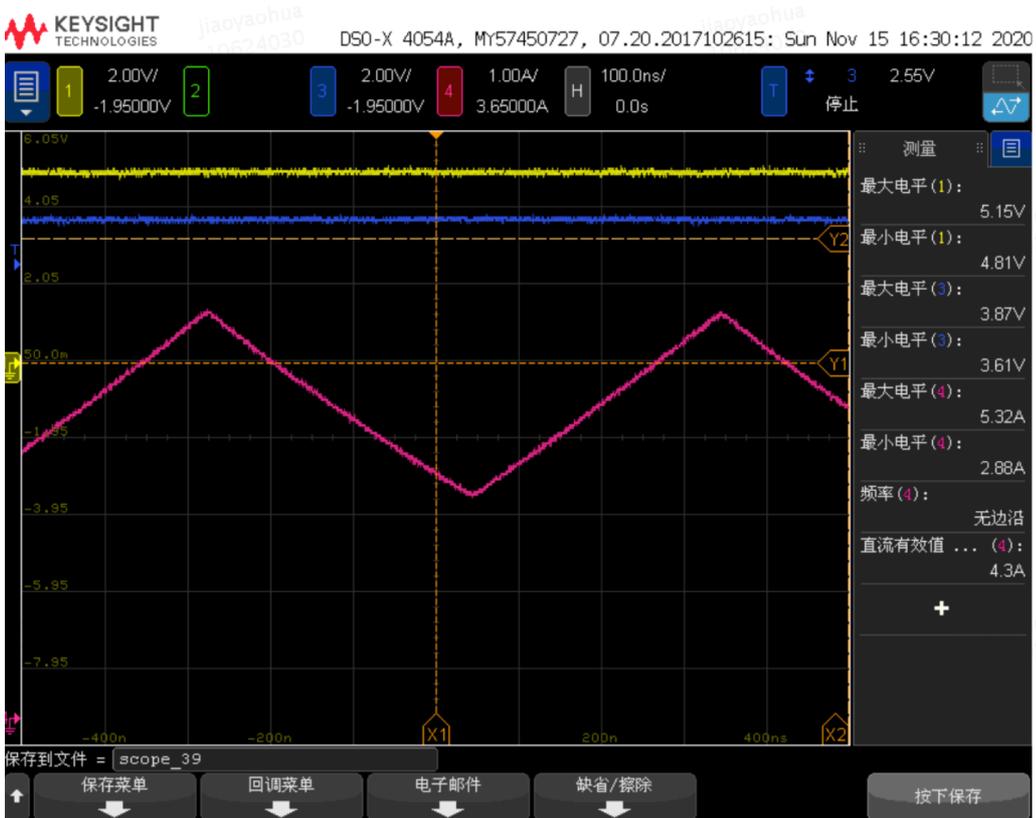
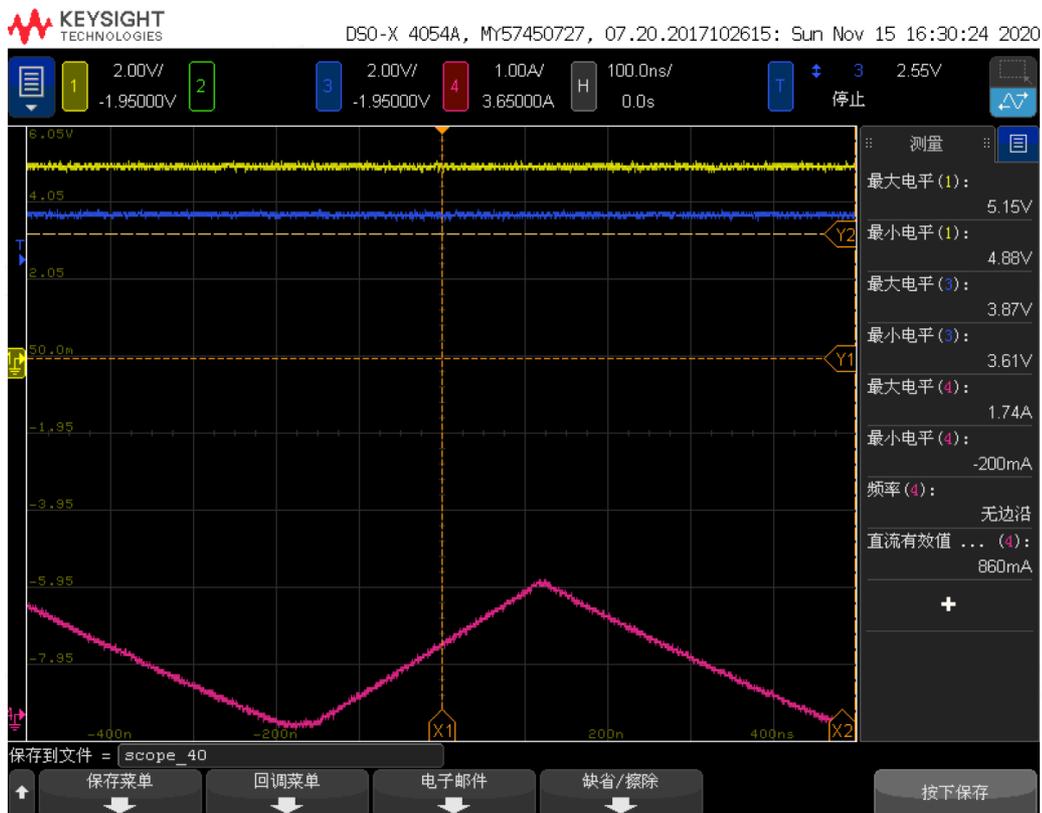
测试结果: 输出电压略微跌落 (60mV 左右), PGood 信号无跳变。

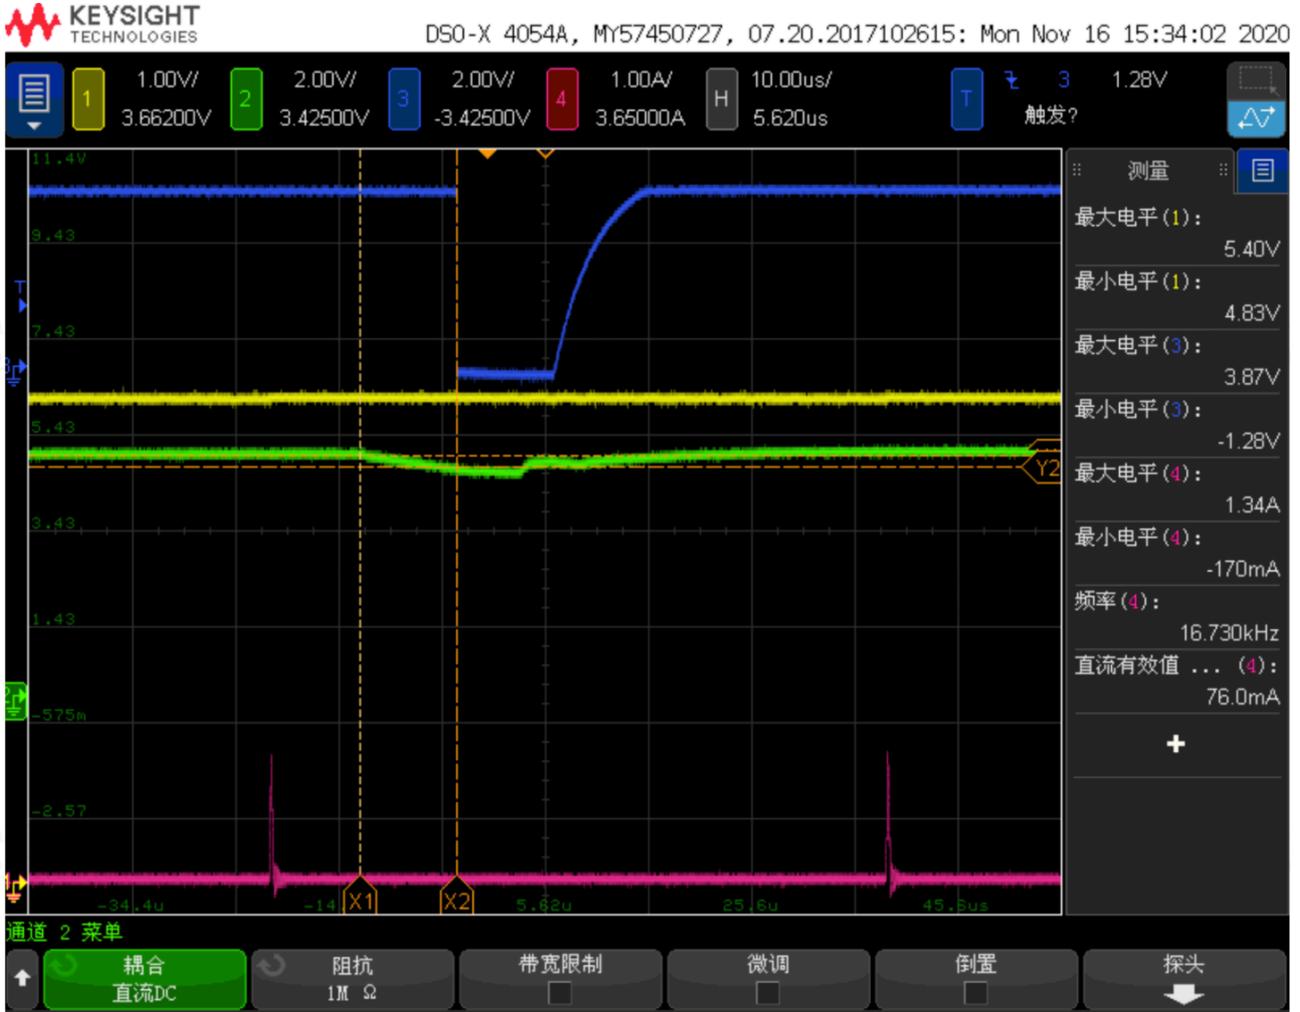
既然双目外设可能影响 SYS_5V，抓取在 SYS_5V 复现电压跌落时的 TX2_VDD5_CAM 的电压电流波形，并未发现有电压冲击或者电流冲击的异常。

并且因为双目的 5V 电流异常小，对应的 TPS62135 进入了轻载调频模式。

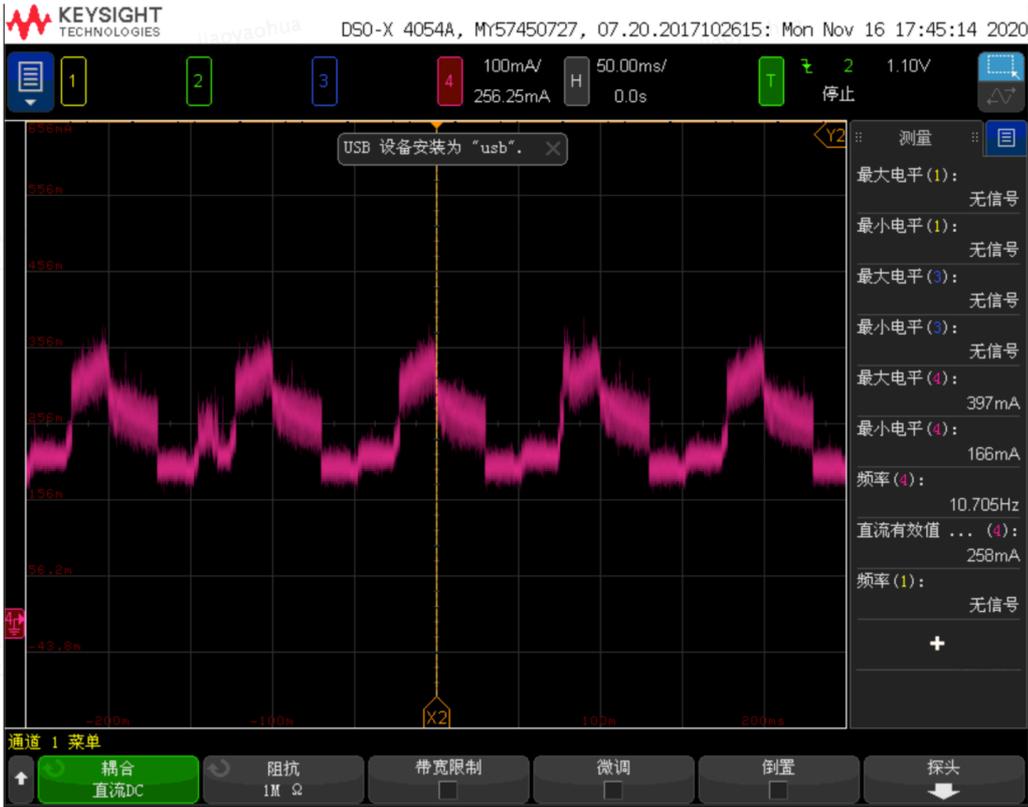
二、由于怀疑双目会影响系统，结论是双目在电源上看起来不是导致 5V 原因，5V 电压跌落会导致 12V 电压爬升。

测量双目 12V 电源的电流变化特性如下图：

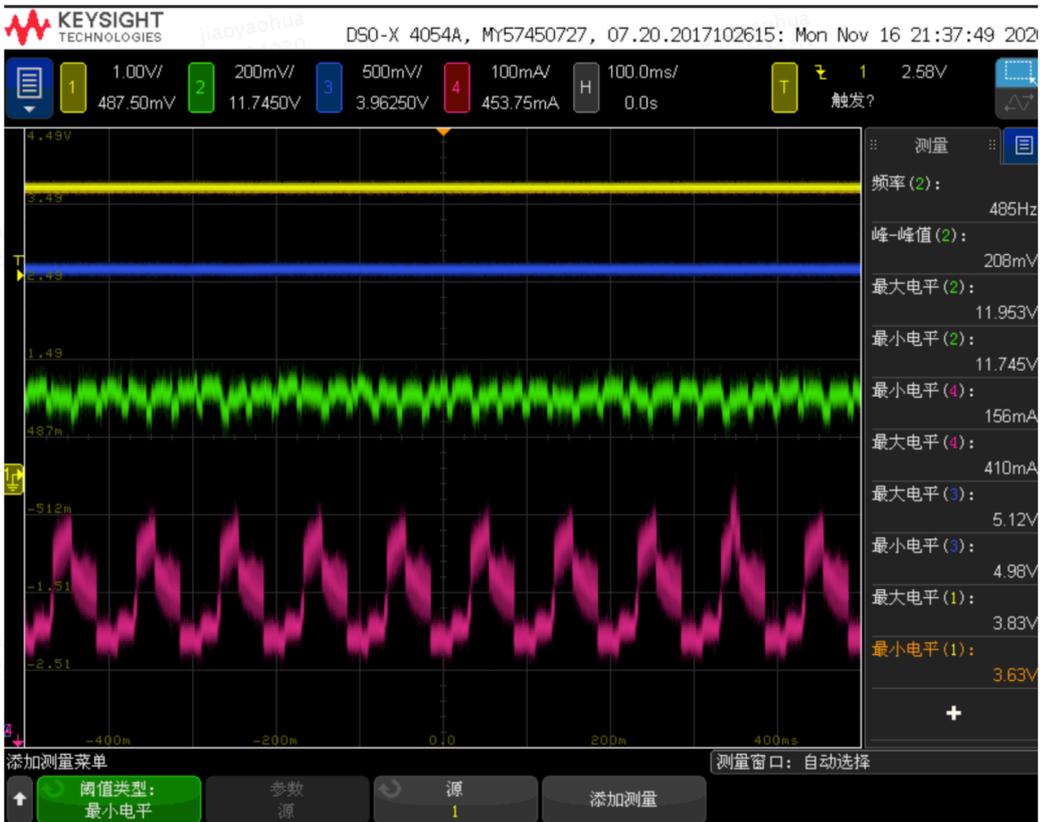
多路抓取双目的 12V 电流波形（粉色）、5V 输出（蓝色）、5V Power Good（黄色）和 12V（绿色）电压波形如下（在不同 Time Scale 中）：

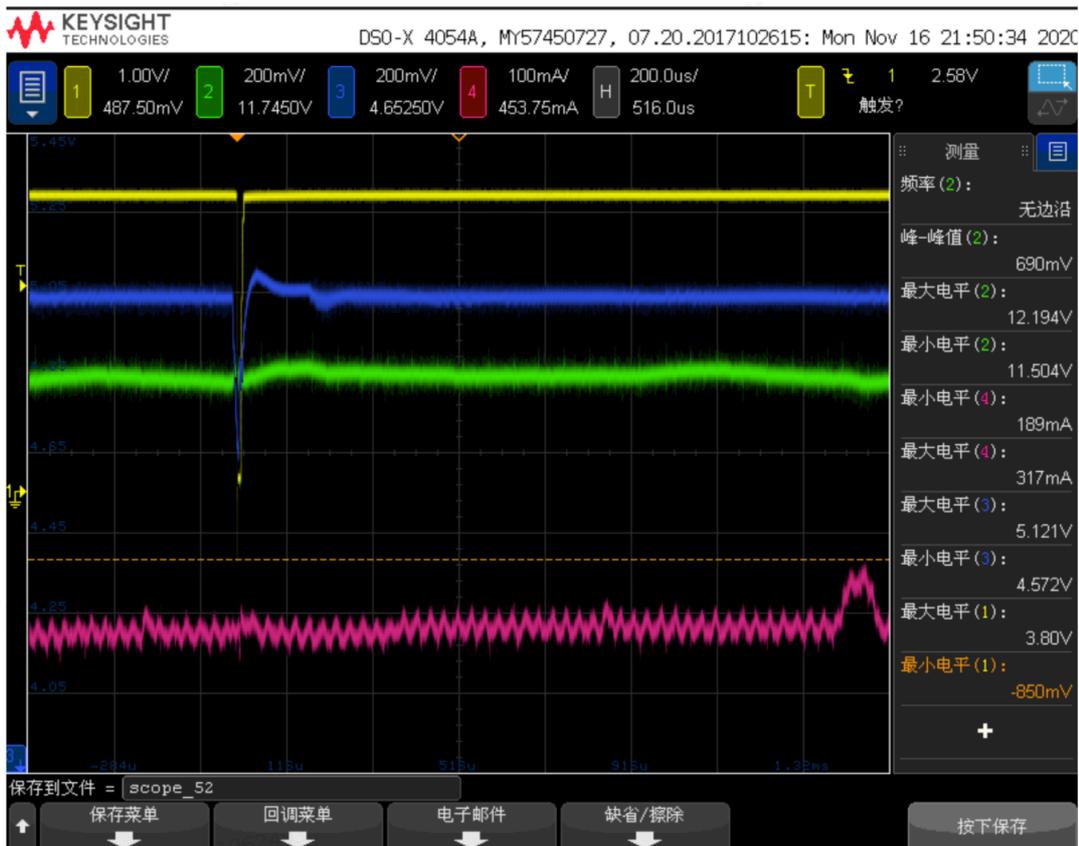
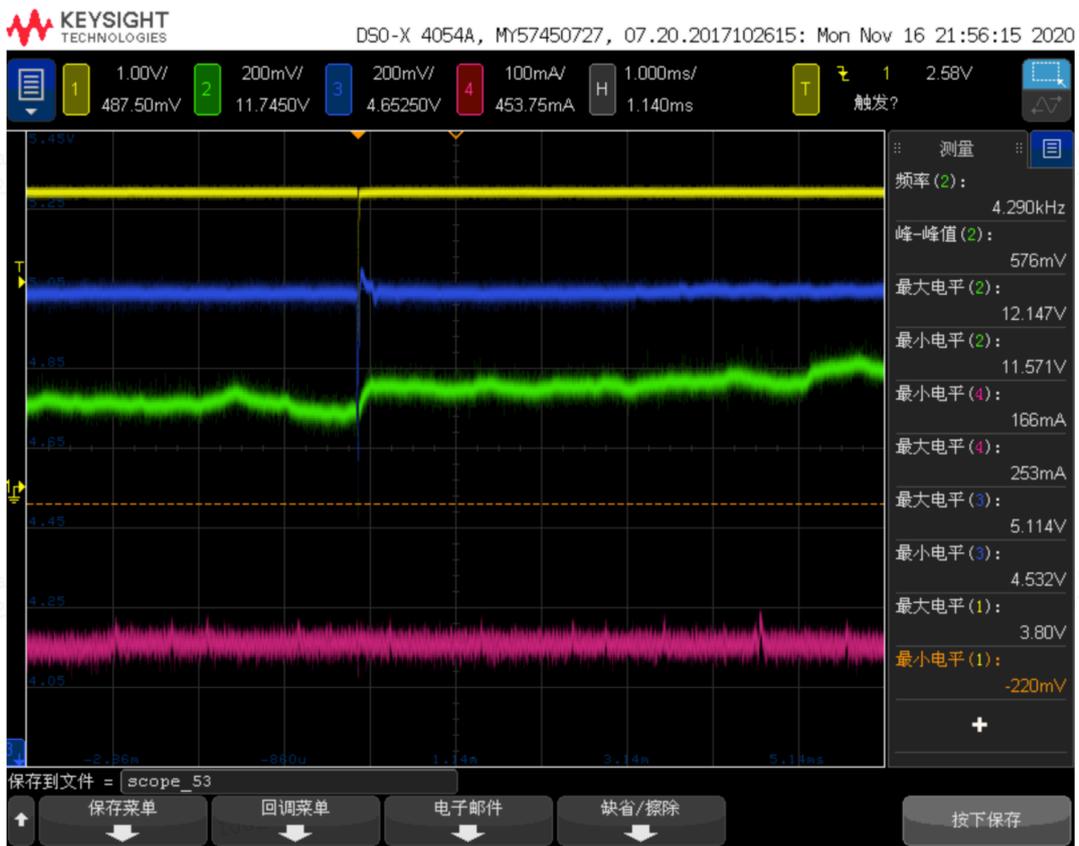
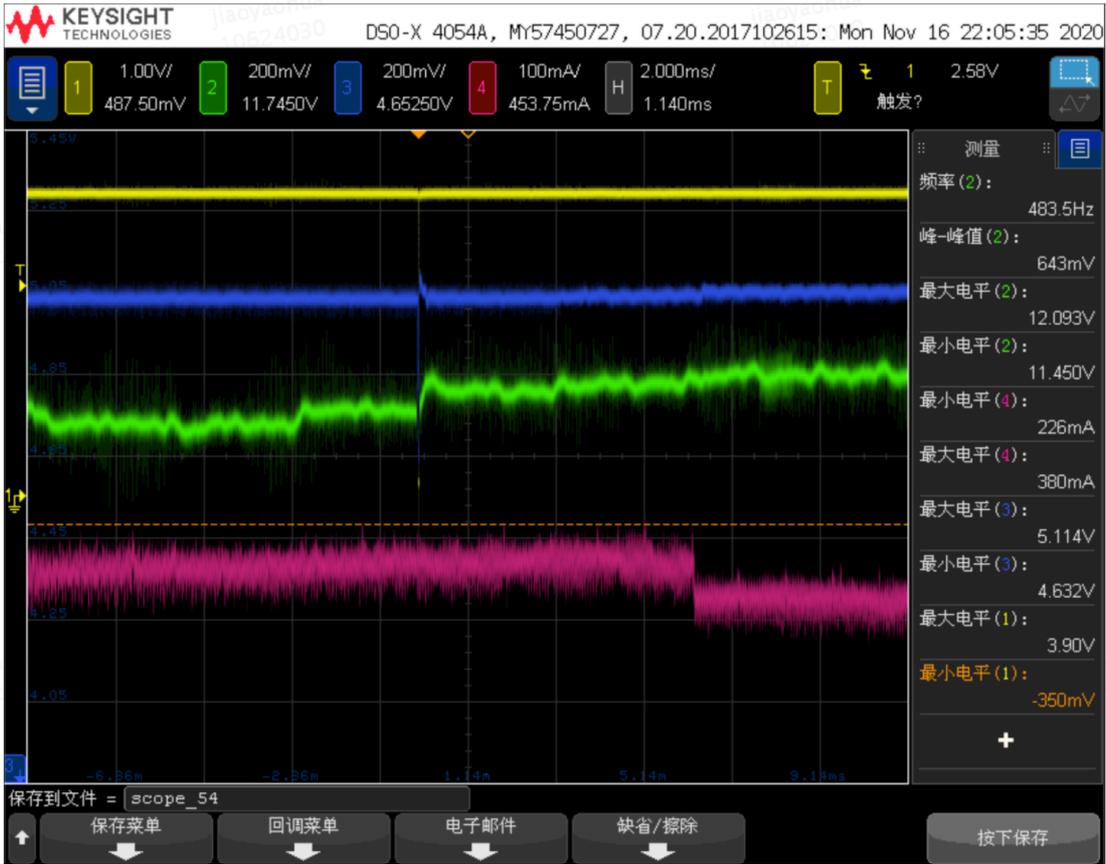
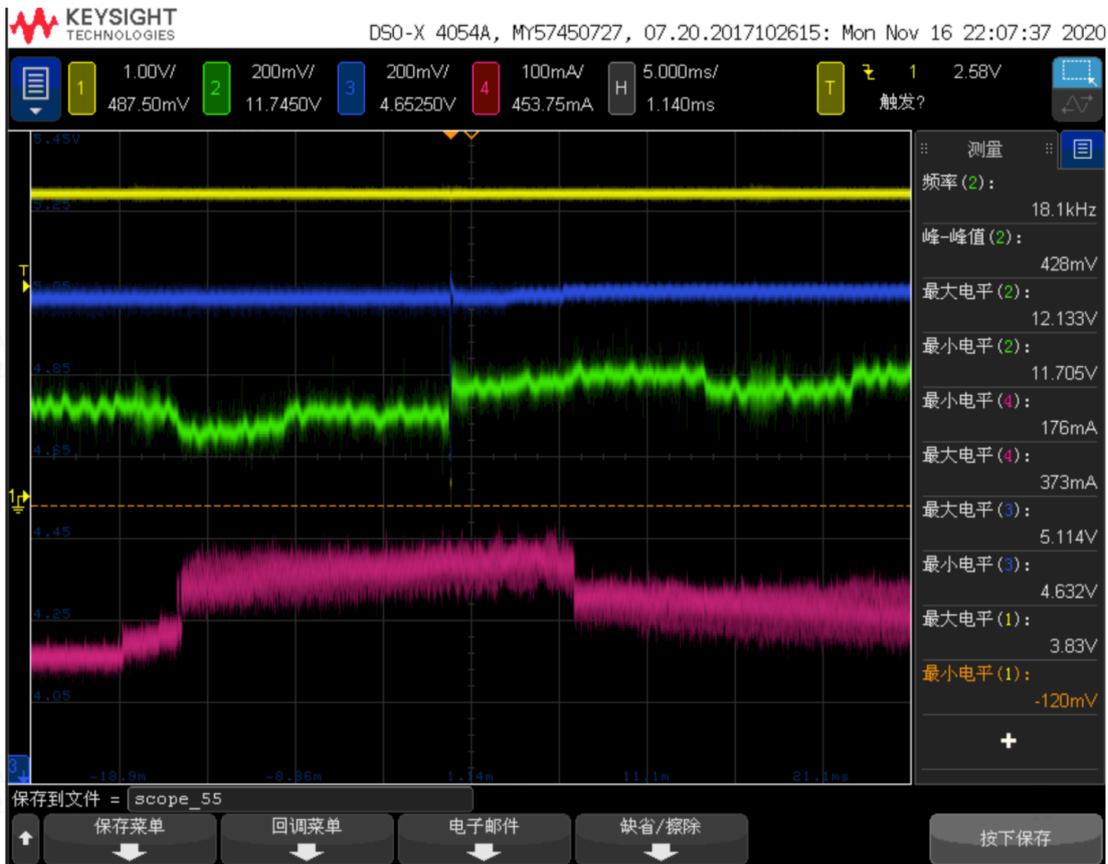
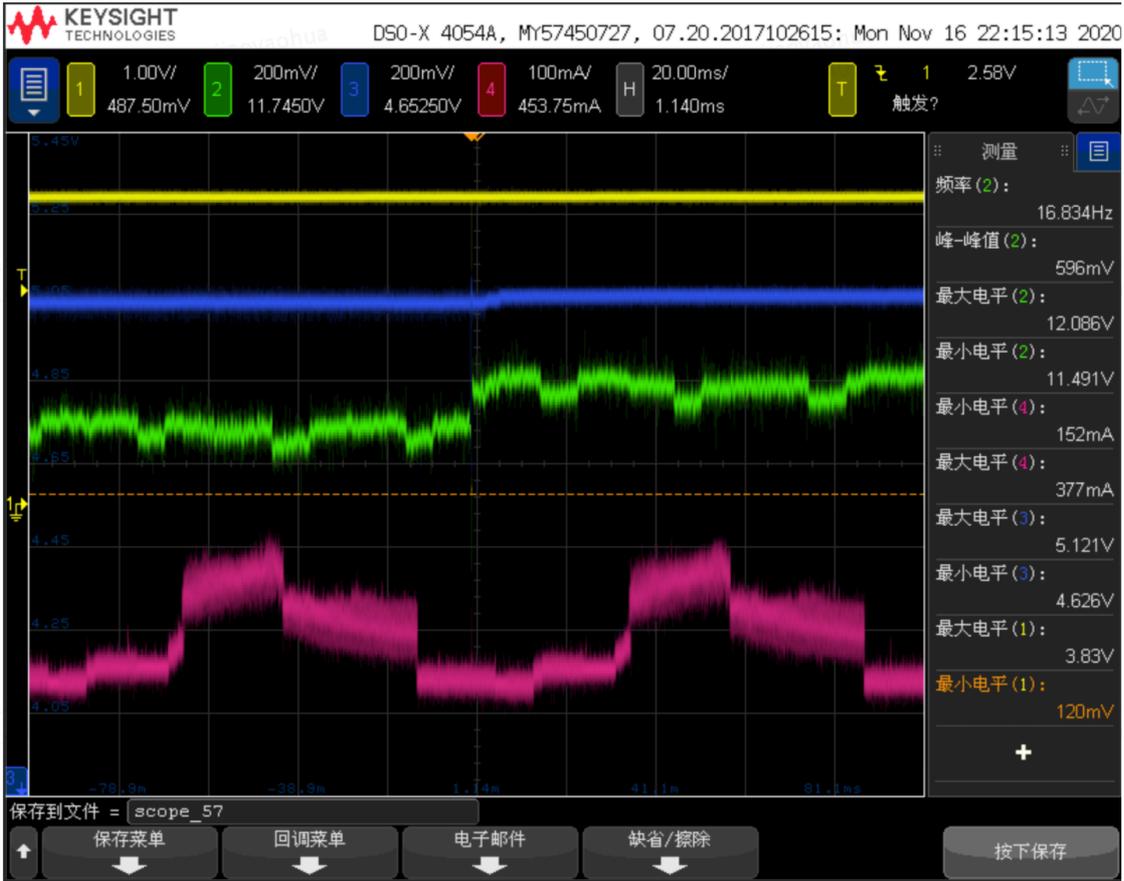
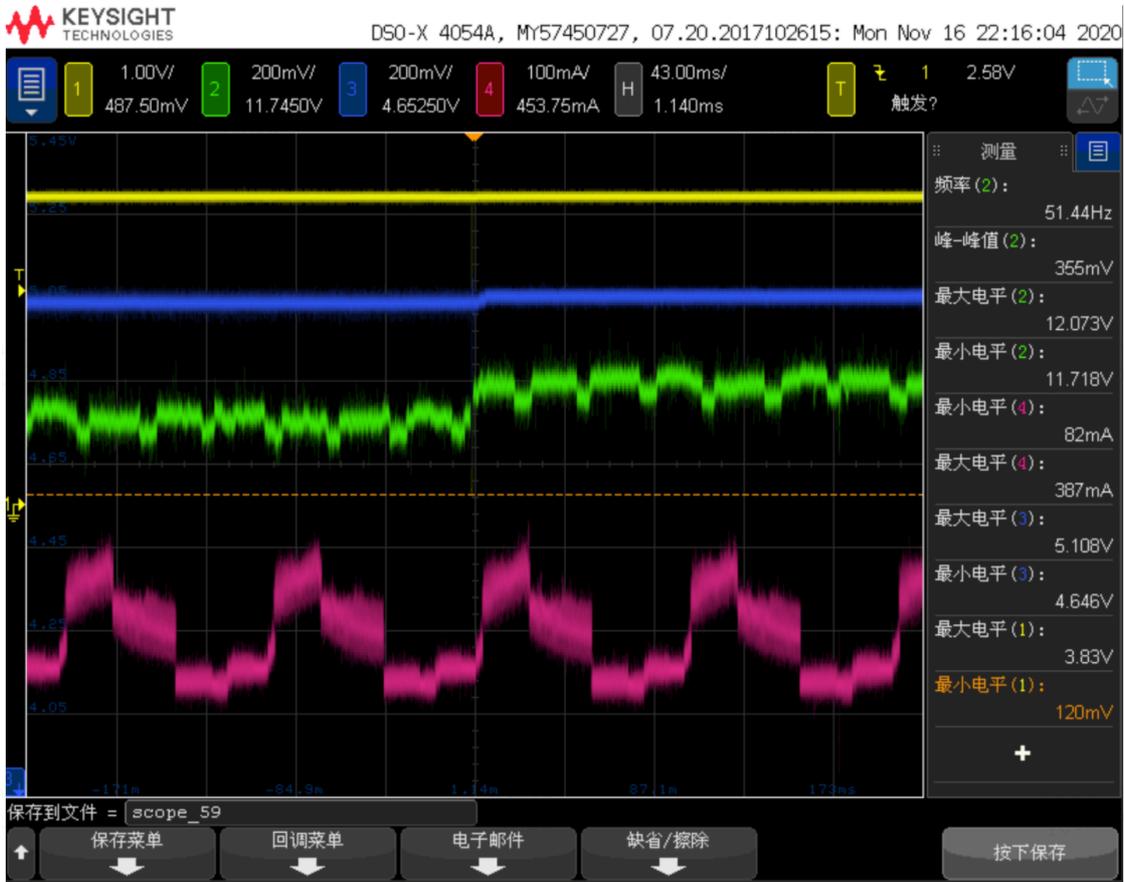
触发 Reboot 的波形如下：
