Report No:	SZ07282021001
Date:	2021/07/28
Page:	1/10

Project Inspection Report

Company : Beijing Yuanda Innovation Technologies Ltd.
Address : Room 506, Building 1, No.10 Caihefang Road, Haidian District, Beijing
Sample Name : LMZ14203
Manufacture : TI
Date Code : N/A
Package Type : SMT-TO
Sample Number : 4 PCS
Check Number : 4 PCS
Date of Received : 07/19/2021
Date of Tested : 07/19/2021 ~ 07/27/2021

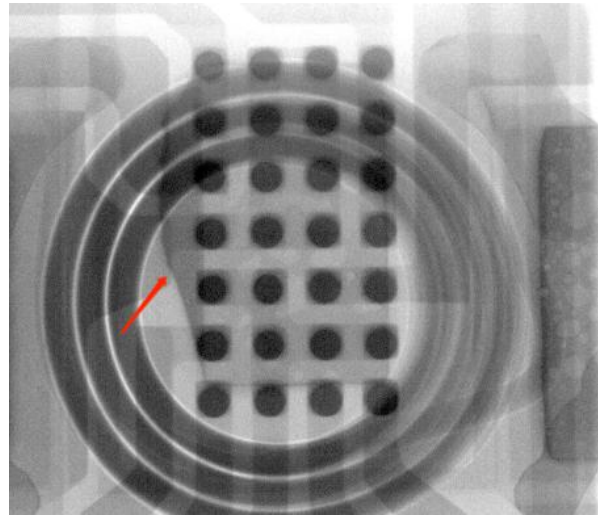
G1-Top View-Zoom-2(The area indicated by the arrow may have a silver glue anomaly)

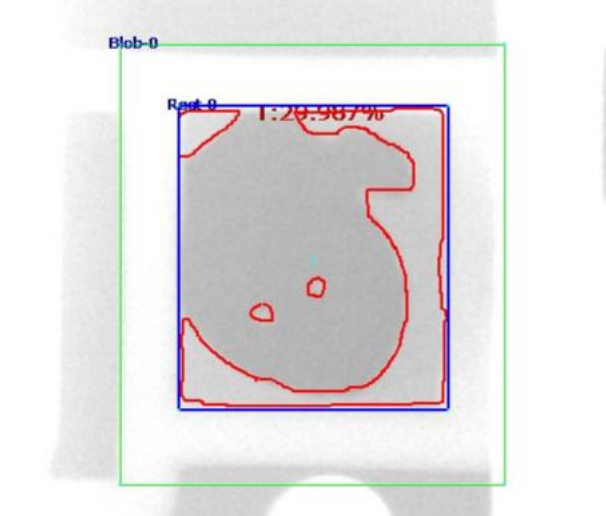
X-ray inspection on 4PCS (G1,G2,F1,F2)samples, showed that there might be abnormal silver glue in the area around G1, G2, F1, F2 Die. The internal welding cavity rate of G1,G2,F1,F2 is abnormal, and the welding cavity rate is G1-29.987,G2-39.215,F1-34.242,F2-39.197.

G1-Top View-Zoom-3(The selection in red box is welding cavity) voidage-29.987%

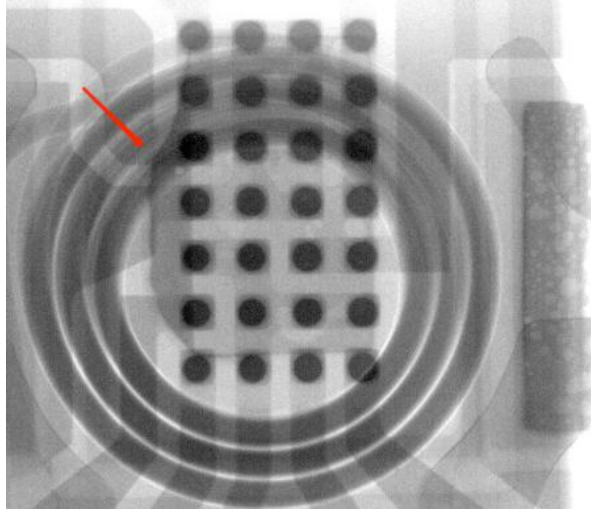
G2-Top View-Zoom-2(The area indicated by the arrow may have a silver glue anomaly)

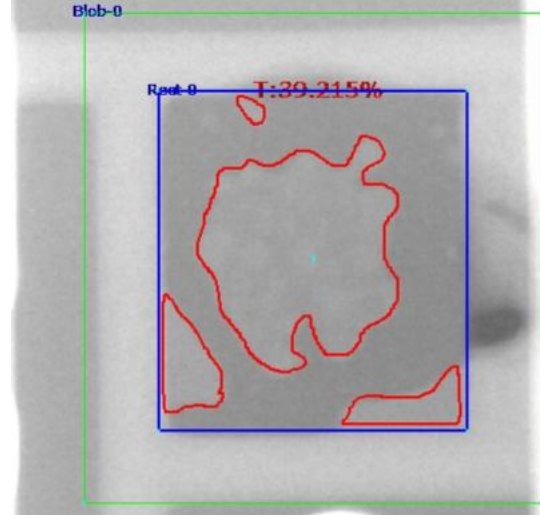
G2-Top View-Zoom-3(The selection in red box is welding cavity) voidage-39.215%

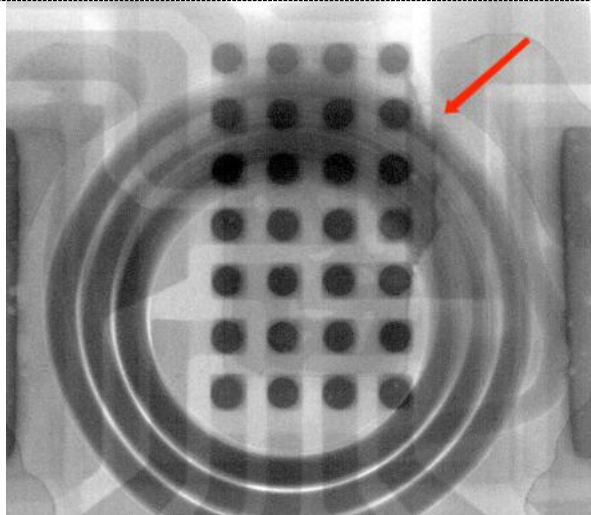
F1-Top View-Zoom-2(The area indicated by the arrow may have a silver glue anomaly)

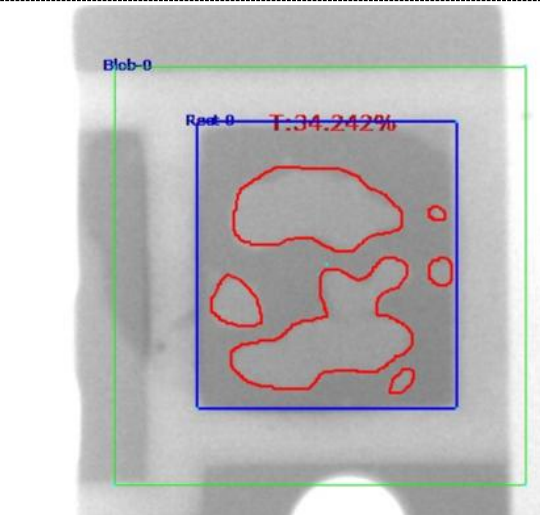
F1-Top View-Zoom-3(The selection in red box is welding cavity) voidage-34.242%

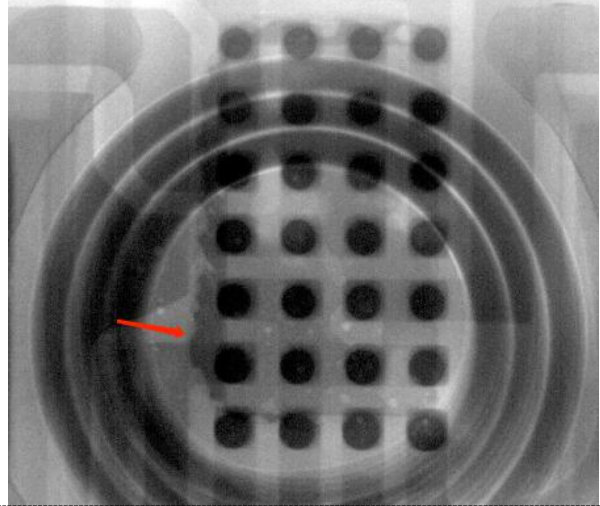
F2-Top View-Zoom-1(The area indicated by the arrow may have a silver glue anomaly)

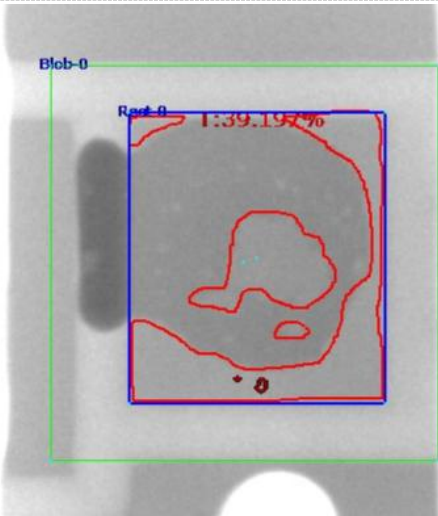
F2-Top View-Zoom-2(The selection in red box is welding cavity) voidage-39.197%

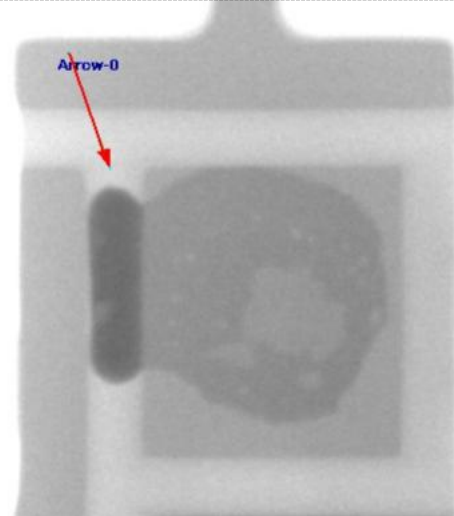
F2 found suspected abnormal adhesion.

F2-Top View-Zoom-3(The red arrow indicates suspected adhesion)
