## Motor startup problem on Avenger Servo drives.

### 1. Background.

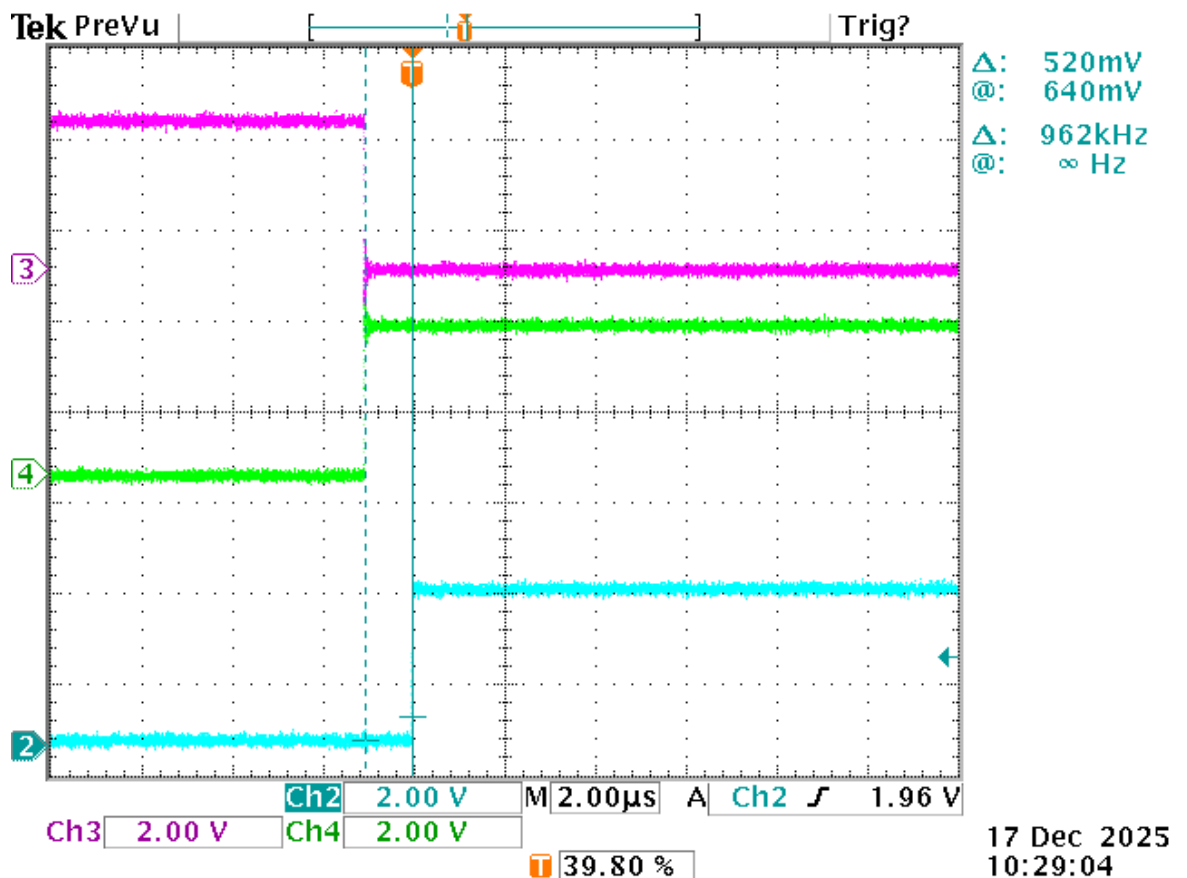
Fig1. Ch2: GATE\_EN, Ch4: INL\_C, Ch3: INH\_C. Plot shows that the PWM signals are activated approx. 1μs before gate enable is issued. This plot was taken on an instance where the motor did not activate for a number of seconds. It's identical for the instance where the motor starts immediately.

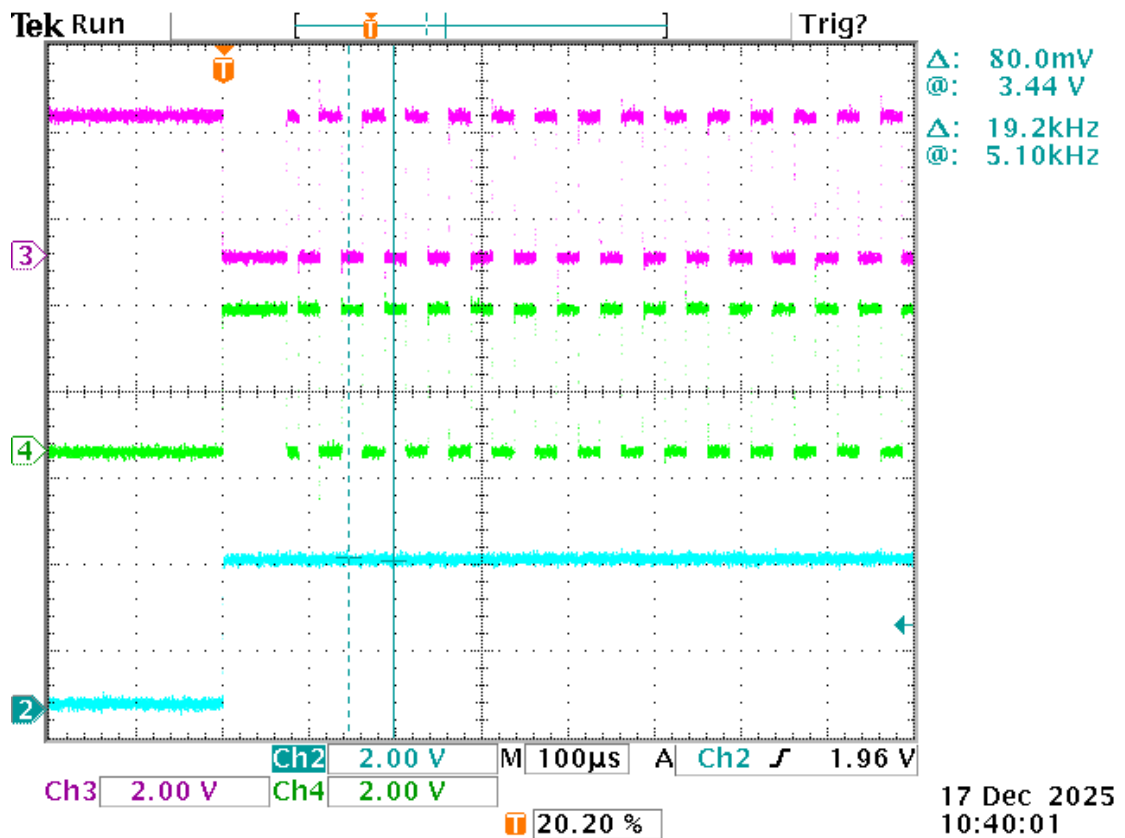
Fig2. Ch2: GATE\_EN, Ch4: INL\_C, Ch3: INH\_C. Plot shows the PWM sequence for a longer period (longer timebase) after GATE\_EN signal goes hi. This plot was taken on an instance where the motor did not activate for a number of seconds. It's identical for the instance where the motor starts immediately.

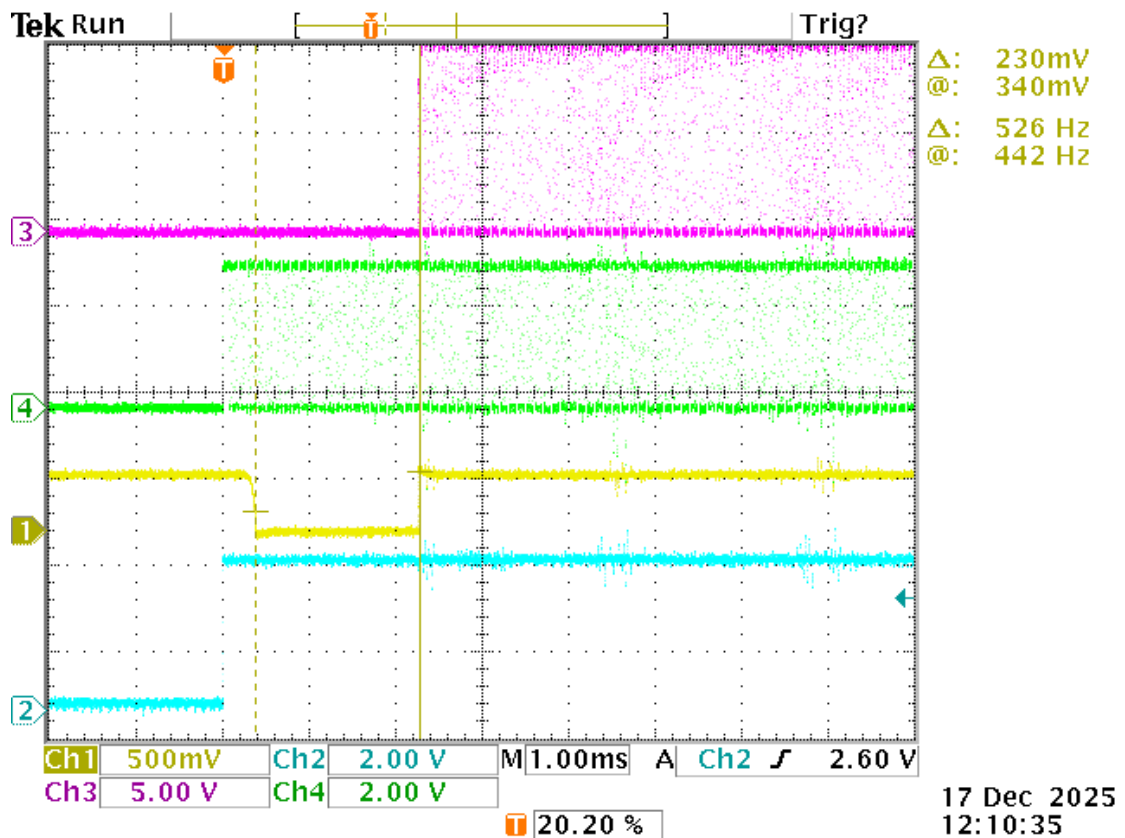
Fig3. Ch2: GATE\_EN, Ch4: INL\_C, Ch3: GL\_C. Ch1 (5v/div): FAULT

Plot shows Gate\_en going hi and INL\_C signals starting at the same time. A little time after this we see FAULT going hi indicating that there is a fault in the chip. After 2ms approx. the fault is cleared automatically by the device and the GL\_C gate drive signals are issued to the power FETs and the motor starts. We can see later in the plots below the reason for the short fault condition (Time for GVDD to reach good limits)

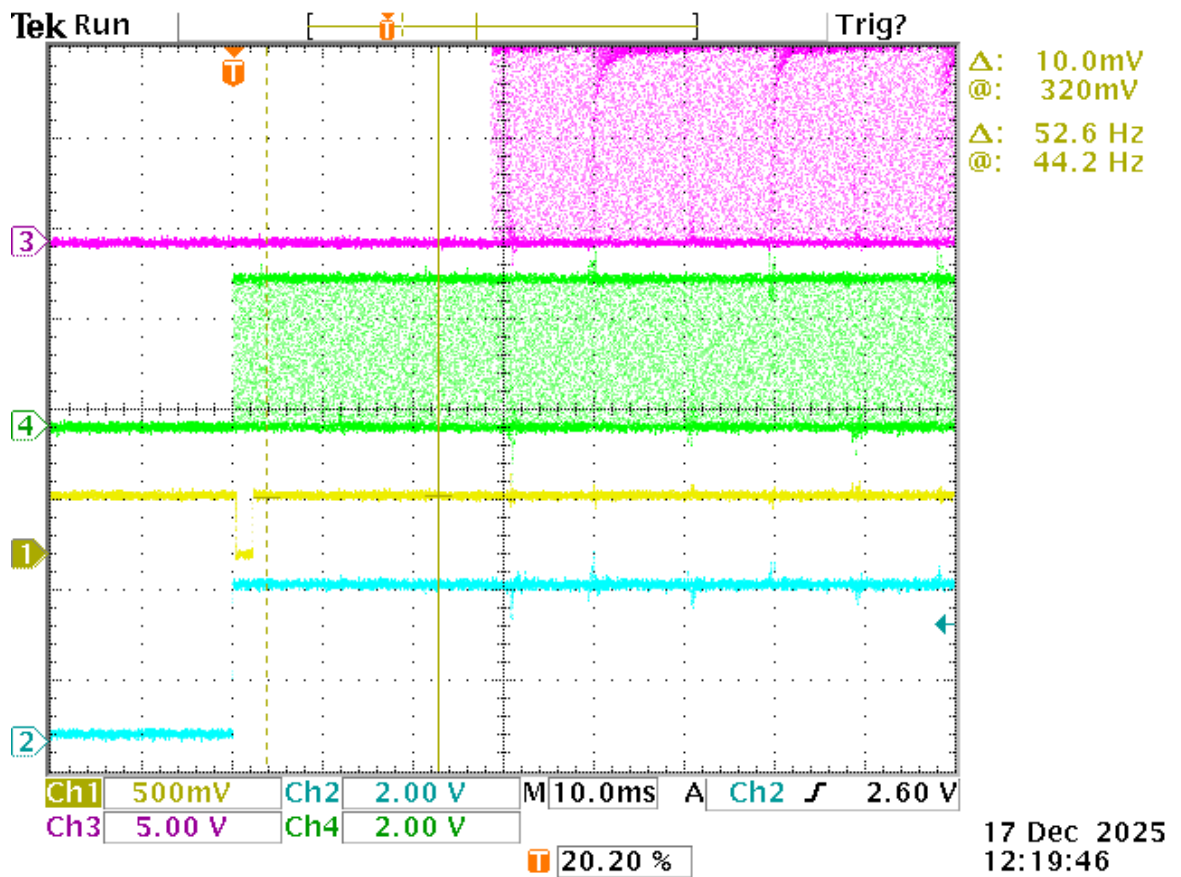
Fig4. Ch2: GATE\_EN, Ch4: INL\_C, Ch3: GL\_C. Ch1 (5v/div): FAULT

Plot shows Gate\_en going hi (Longer time base as opposed to Fig 3 above). A little time after this we see FAULT going hi indicating that there is a fault in the chip. After 2ms approx. the fault is cleared automatically by the device. However in this case there is a further unexplained delay of approx. 30mS before the GL\_C gate drive signals are issued to the power FETs. Motor still starts in this scenario. The 30 mS delay is not noticeable.

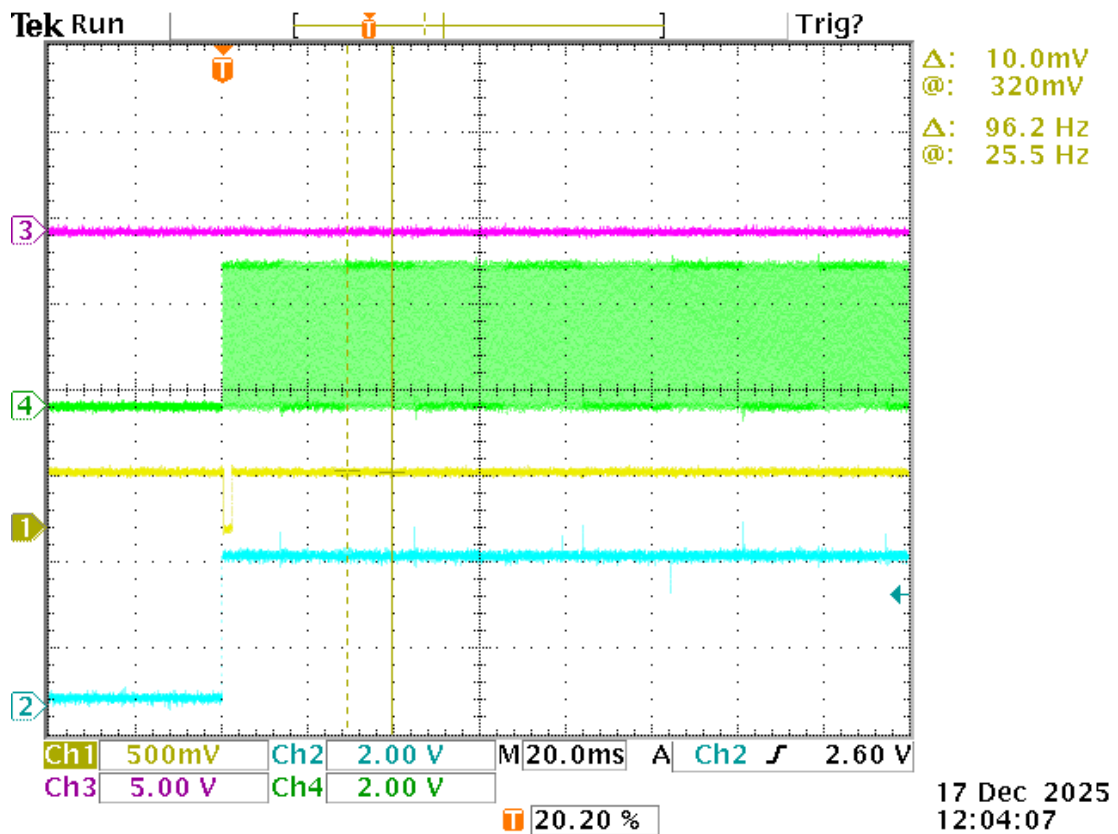
Fig5. Ch2: GATE\_EN, Ch4: INL\_C, Ch3: GL\_C. Ch1 (5v/div): FAULT

Plot shows Gate\_en going hi. A little time after this we see FAULT going hi indicating that there is a fault in the chip. After 2ms approx. the fault is cleared automatically by the device. However in this case the GL\_C gate drive signals are not issued to the power mosfets for approx. 3-4 seconds. During this 3-4 second period the motor does not start.

Eventually after the 3-4 second period the motor control S/W saturates the phase that was not activated (BLDC two phase control scheme) now gets activated, As soon as the new set of PWM signals is activated by the uP the DRV8303 seems to 'wake up' and send gate drive signals to the power mosfets and the motor turns.

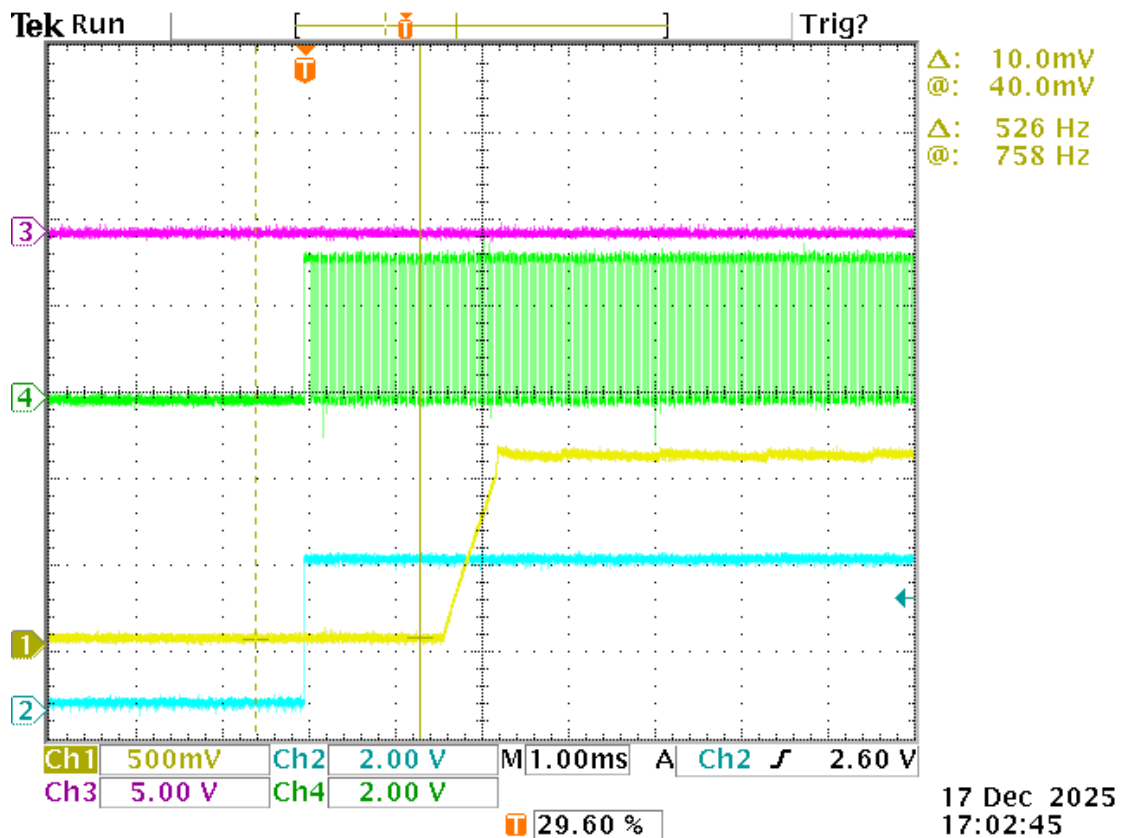
Fig6. Ch2: GATE\_EN, Ch4: INL\_C, Ch3: GL\_C. Ch1 (5v/div): GVDD

Plot shows GATE\_EN going hi. GVDD starts to charge 1.5mS later and is within limits after approx. 2mS. (this is the reason for the short FAULT condition in previous plots.)

In this instance the gate drive signals are not transmitted by the DRV8303 i.e. no signals on Ch3 above. (as yet unexplained) but are delayed for the 3-4 seconds (as described in Fig 5 above). The motor does not move until then.

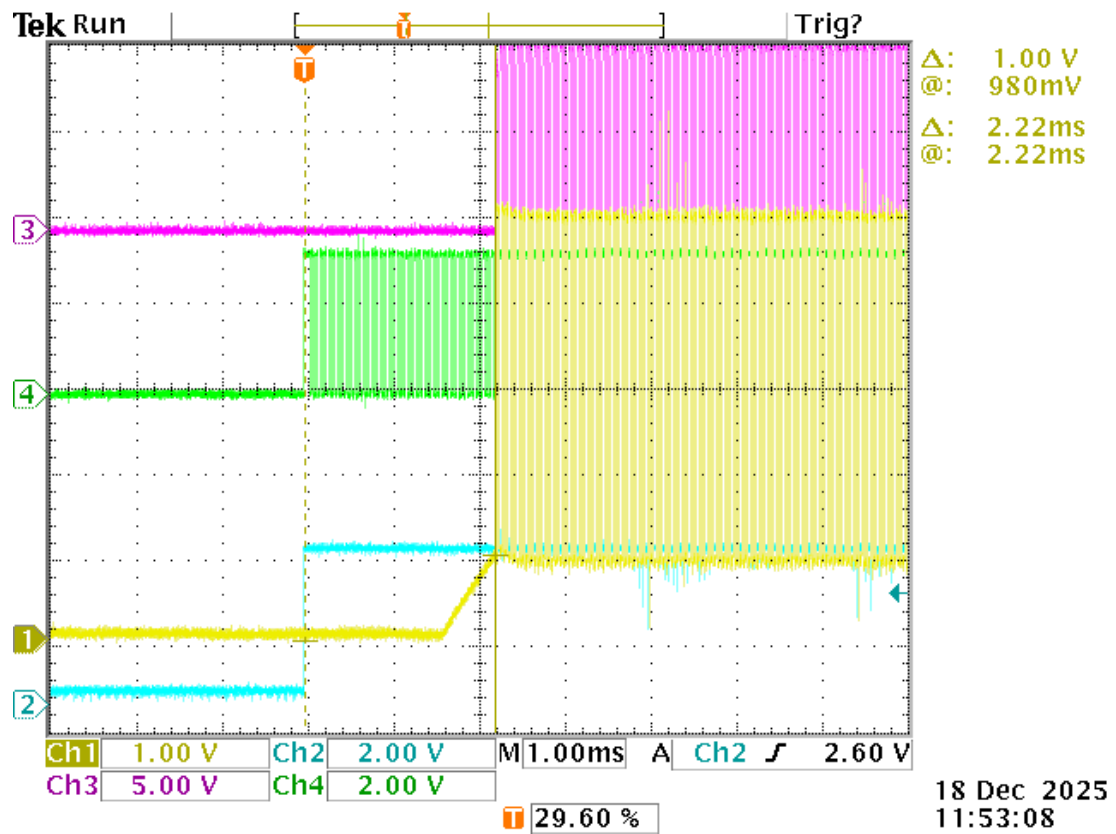
Fig7. Ch2: GATE\_EN, Ch4: INL\_C, Ch3: GL\_C. Ch1 (10v/div): BST\_C

Plot shows GATE\_EN going hi. BST\_C starts to charge 1.5mS later and is within limits after approx. 2.2mS. At this point the DRV8303 transmits the gate drive signals and the bridge starts to switch. BST\_C then switches between GVDD level (when lower mosfet is on) and Vbus + GVDD (when upper mosfet is on).

In this instance the motor activated normally.

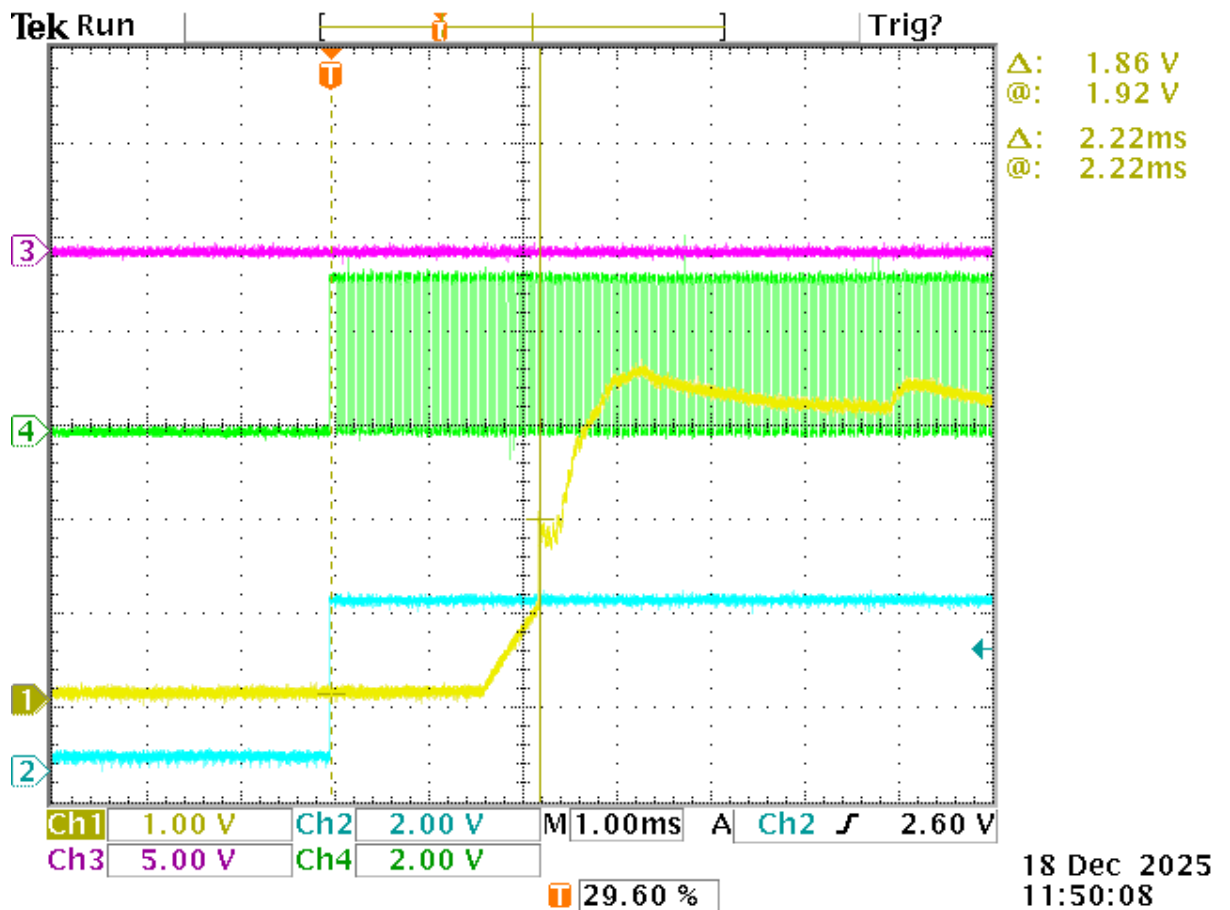
Fig8. Ch2: GATE\_EN, Ch4: INL\_C, Ch3: GL\_C. Ch1 (10v/div): BST\_C

Plot shows GATE\_EN going hi. BST\_C starts to charge 1.5mS later and is within limits after approx. 2.2mS. At this point in this case the DRV8303 does not transmit the gate drive signals as it should to the power mosfets. (Gate drive signals are not seen on Ch3 which is the gate drive signals to the lower C mosfet. ) The BST\_C voltage is not determined and this also shows that the bridge is not switching during this period.

In this instance the motor did not activate for a number of seconds i.e the fault condition that is as yet unexplained.

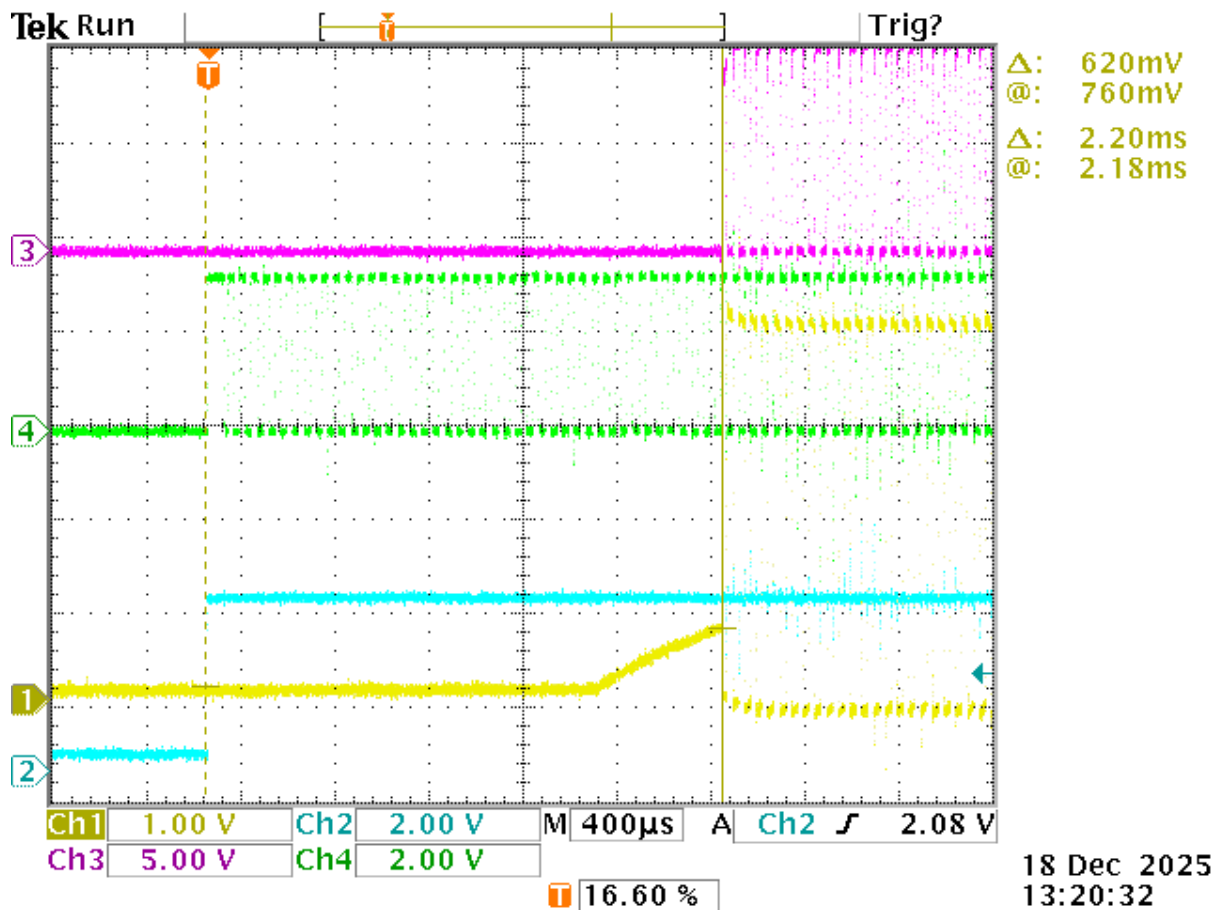
Fig9. Ch2: GATE\_EN, Ch4: INL\_C, Ch3: GL\_C. Ch1 (10v/div): SH\_C  
Plot shows GATE\_EN going hi. 2.2 mS later the DRV8303 transmits gate drive signals.

*The DRV8301 gate drivers may not correctly power up if a voltage greater than 8.5 V is present on any SH\_X pin when EN\_GATE is brought logic high (device enabled) after PVDD power is applied ( $PVDD1 > PVDD_{UV}$ ). This sequence should be avoided by ensuring the voltage levels on the SH\_X pins are less than 8.5 V when the DRV8301 is enabled through EN\_GATE.*

This plot shows that the voltage on the SH\_C pin is less than 8.5V on device. SH\_B and SH\_A were also monitored during gate enable going hi. Characteristic was the same as that shown for SH\_C in fig 9 above.
