Failure Analysis Report

FA QEM-CCR-1906-00715

Customer:	WINTECH (DSTR)	Assy Site:	TAI
Customer Tracking ID:		Fab Site:	CU3
Customer Part ID:		Technology:	LBC5
Customer Contact:	Yi Dary	Analyst:	Rang Cheng
Device Type:	DRV8840PWPR	TI Contact:	Jerry Xiao
		Qty Submitted:	1
Flow Type:	Customer Return	Date Submitted:	2019-06-26
Reviewer:	Chaplin Tu	Approval:	Rang Cheng

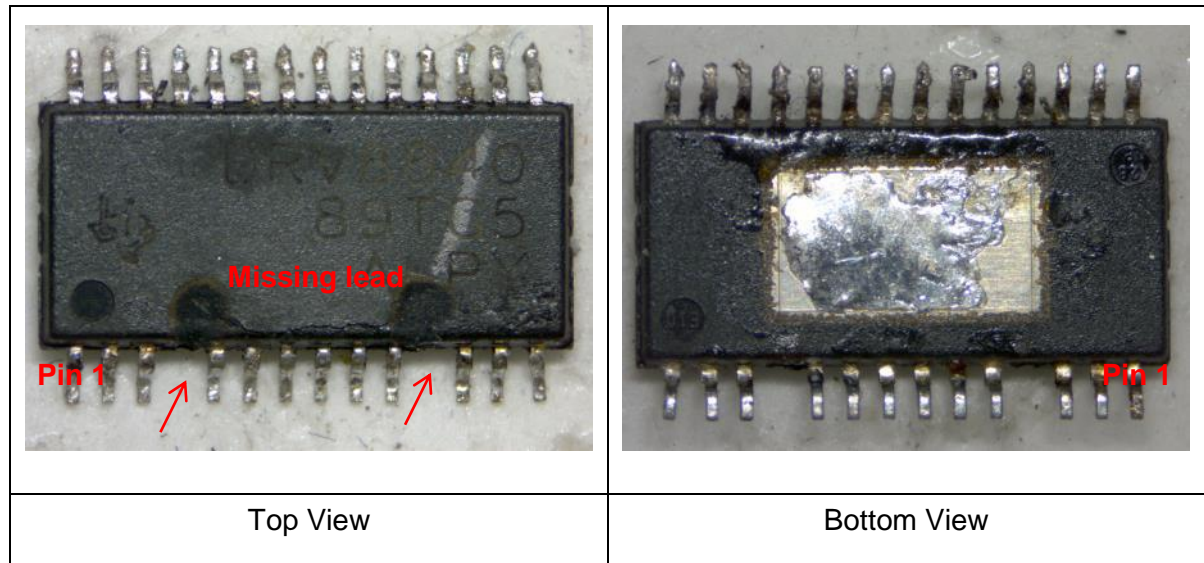
The returned unit was inspected under microscope. Missing leads were observed from external package.

Fig.1: Optical view of the returned unit.

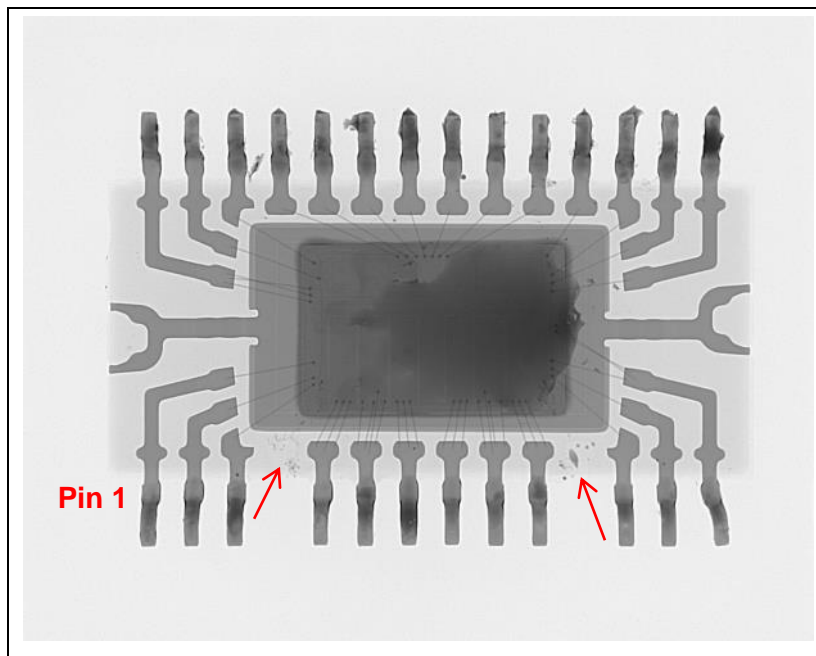
The returned unit was inspected by X-ray. Broken leads and bonding wires were observed from internal package.

Fig.2: X-ray view of the returned unit.

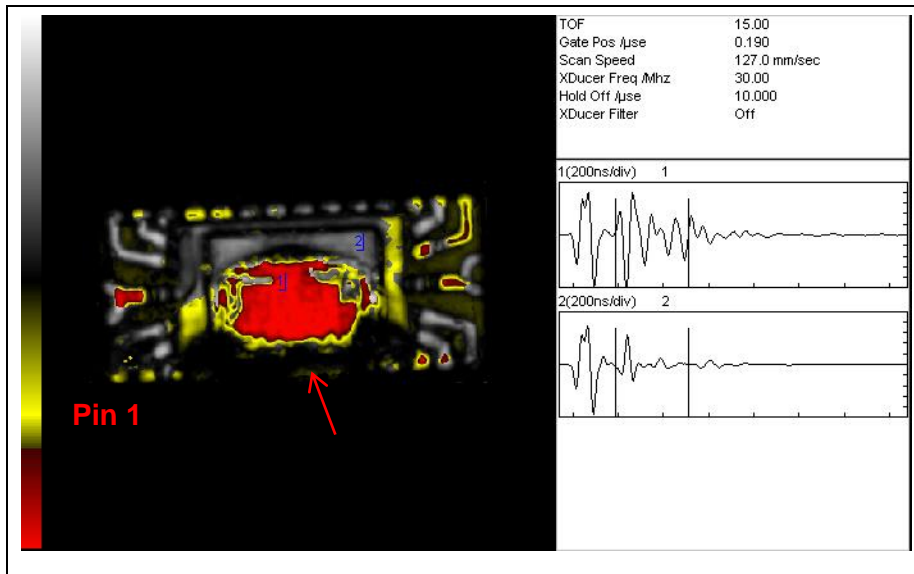
CSAM was performed on returned unit. Delamination was observed over die surface of returned unit.

Fig.3: CSAM image of returned unit.

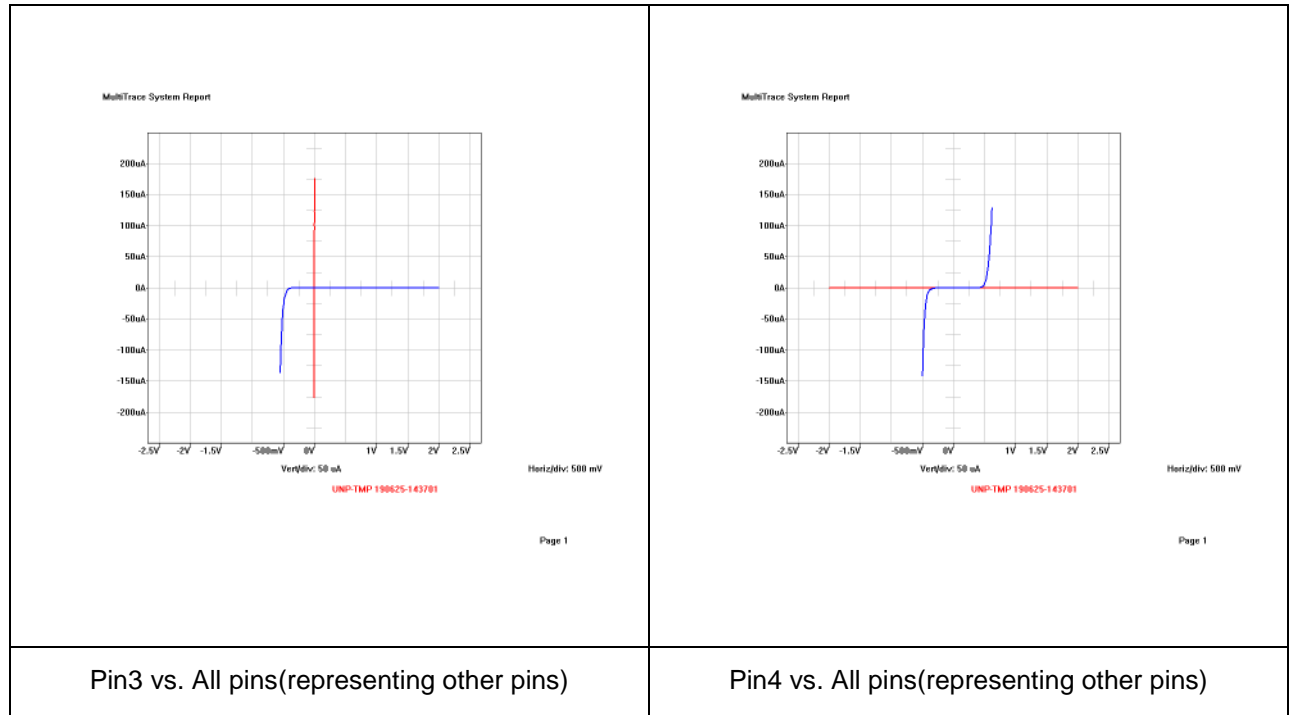
Curve trace analysis was performed on the returned unit. Short failure was verified at pin3, 5, 6, 10 and 12-14. Open failure was verified at pin4(VM), pin7-9 and pin11(VM).

Fig.4: I/V curve image of returned unit. **Correlation unit (blue) & returned units (red).**

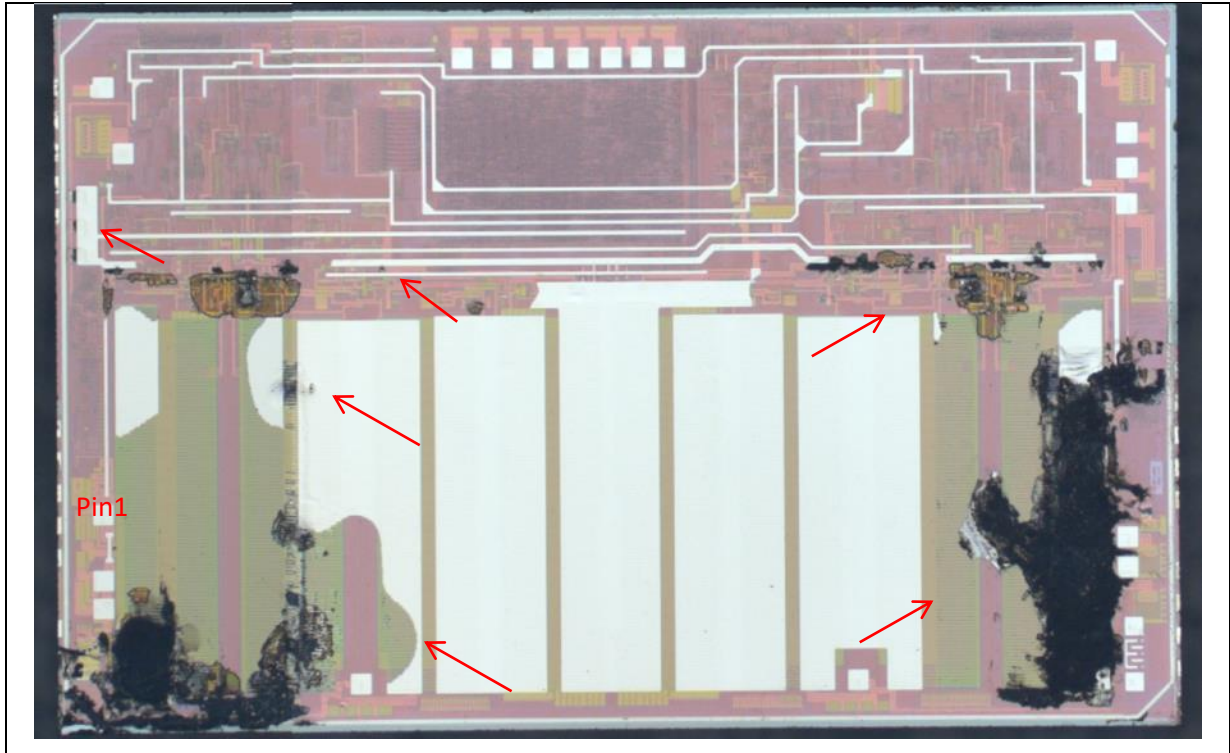
The returned unit was chemically de-capsulated with fuming nitride acid. EIPD (Electrically induced physical defect) was observed on die surface.

Fig.5: Optical image of the returned unit after de-capsulation.

EIPD (Electrically induced physical defect) was observed.

Short and open failure was caused by EIPD.
