# Failure Analysis Report

FA QEM-CCR-2002-00903

Customer:	NEOPHOTONICS	Assy Site:	MLA
Customer Tracking ID:	5370020909,	Fab Site:	TID
Customer Part ID:		Technology:	ASL3C
Customer Contact:	Xiaoxi Zhang	Analyst:	June Zhu
Device Type:	TS3A5018PWR	TI Contact:	Sophia Fei
		Qty Submitted:	1
Flow Type:	Customer Return	Date Submitted:	2020-03-06
Reviewer:	Shengzhuan Huang	Approval:	Shengzhuan Huang

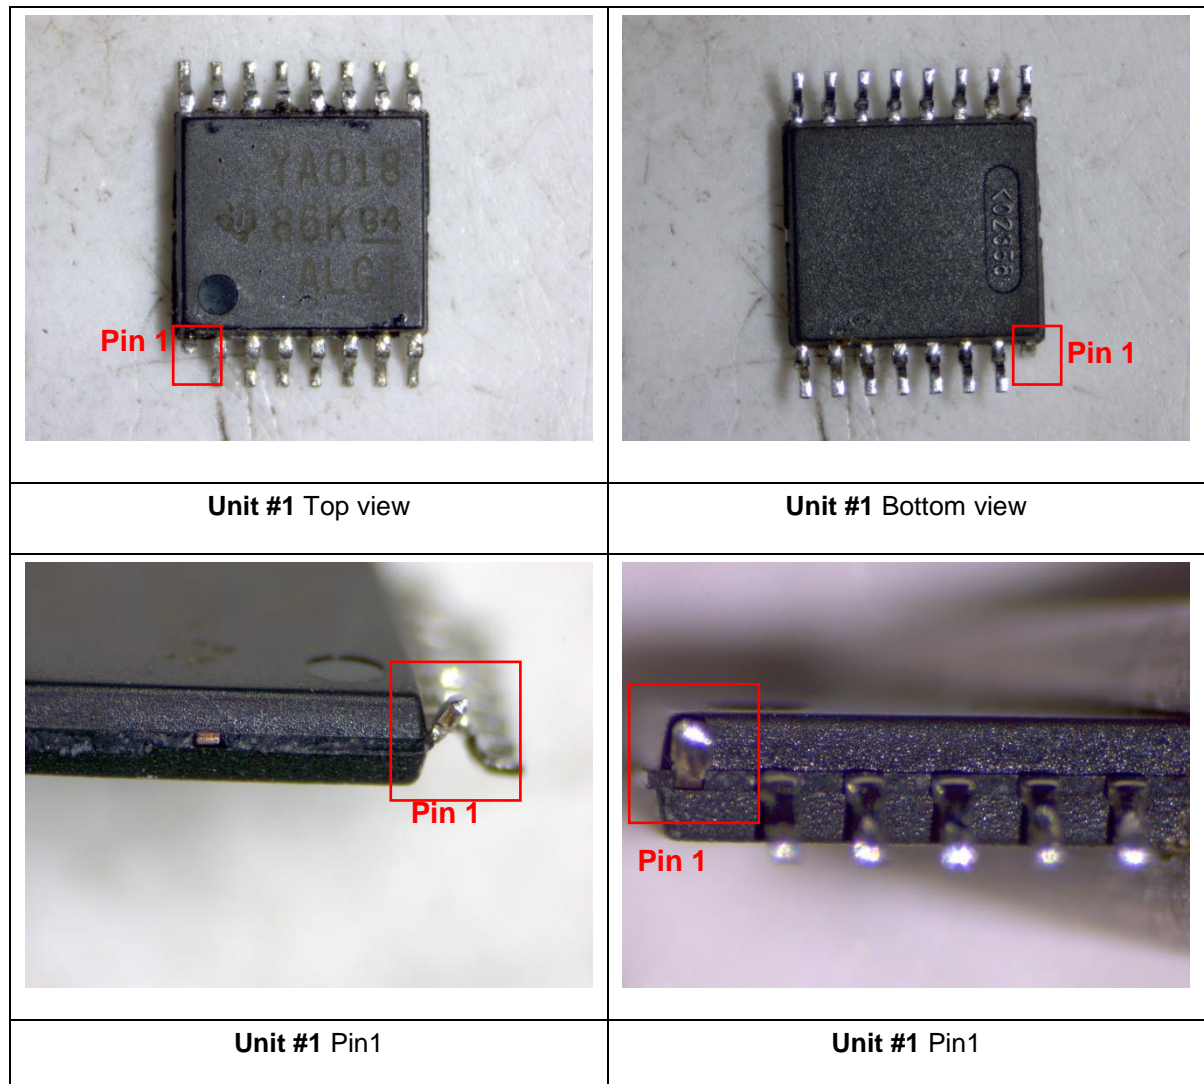
Optical inspection was performed on returned units. Bent lead was observed at pin1.

**Fig.1:** Optical view of the returned unit.

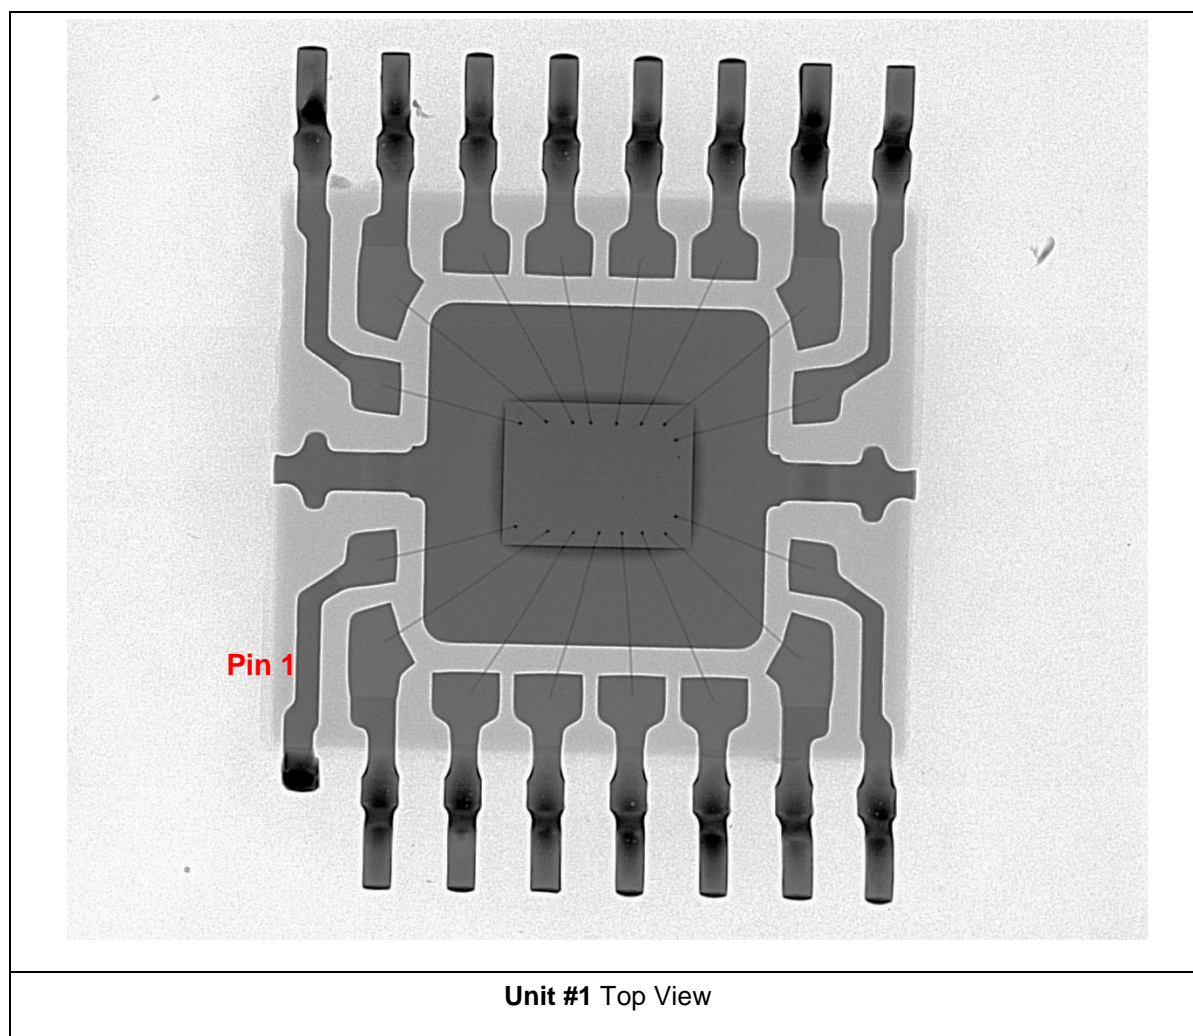
The returned unit#1 was inspected by X-ray. No anomaly was observed.

**Fig.2:** X-ray view of the returned unit.

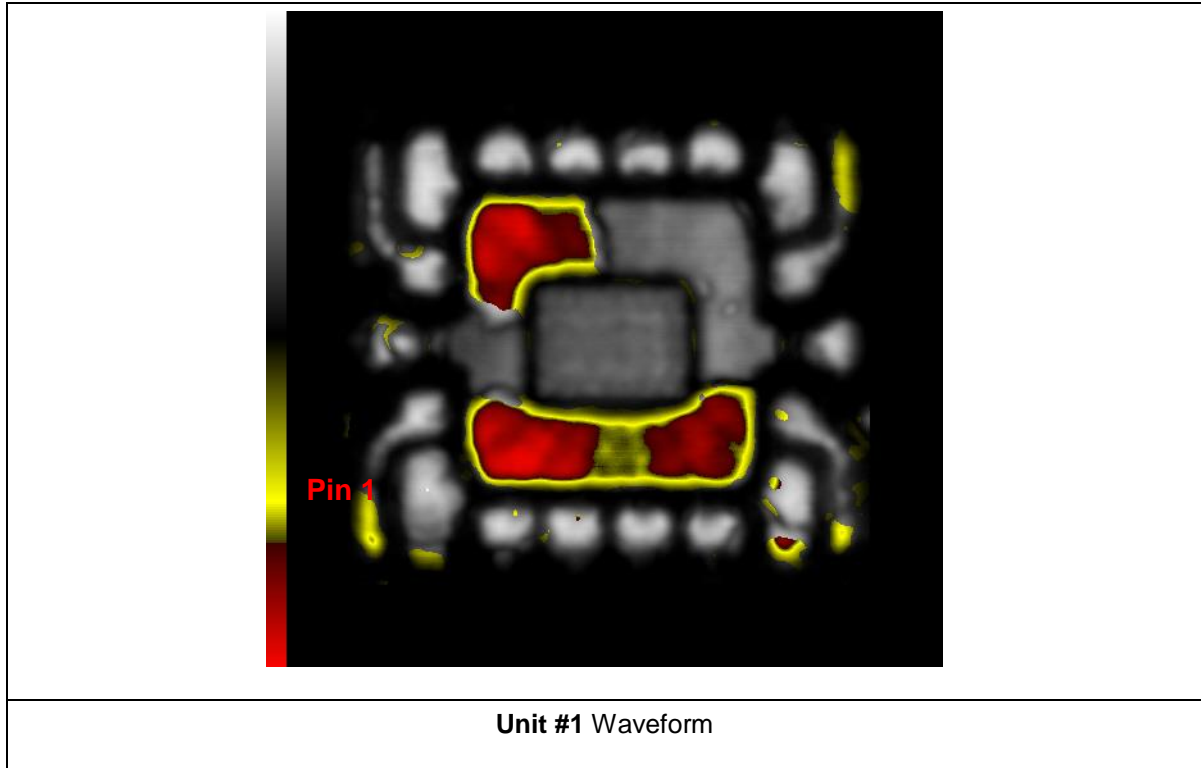
Scanning acoustic microscopy inspection was performed on the returned units. No delamination was observed on die surface.

**Fig.3:** CSAM view of the returned unit.

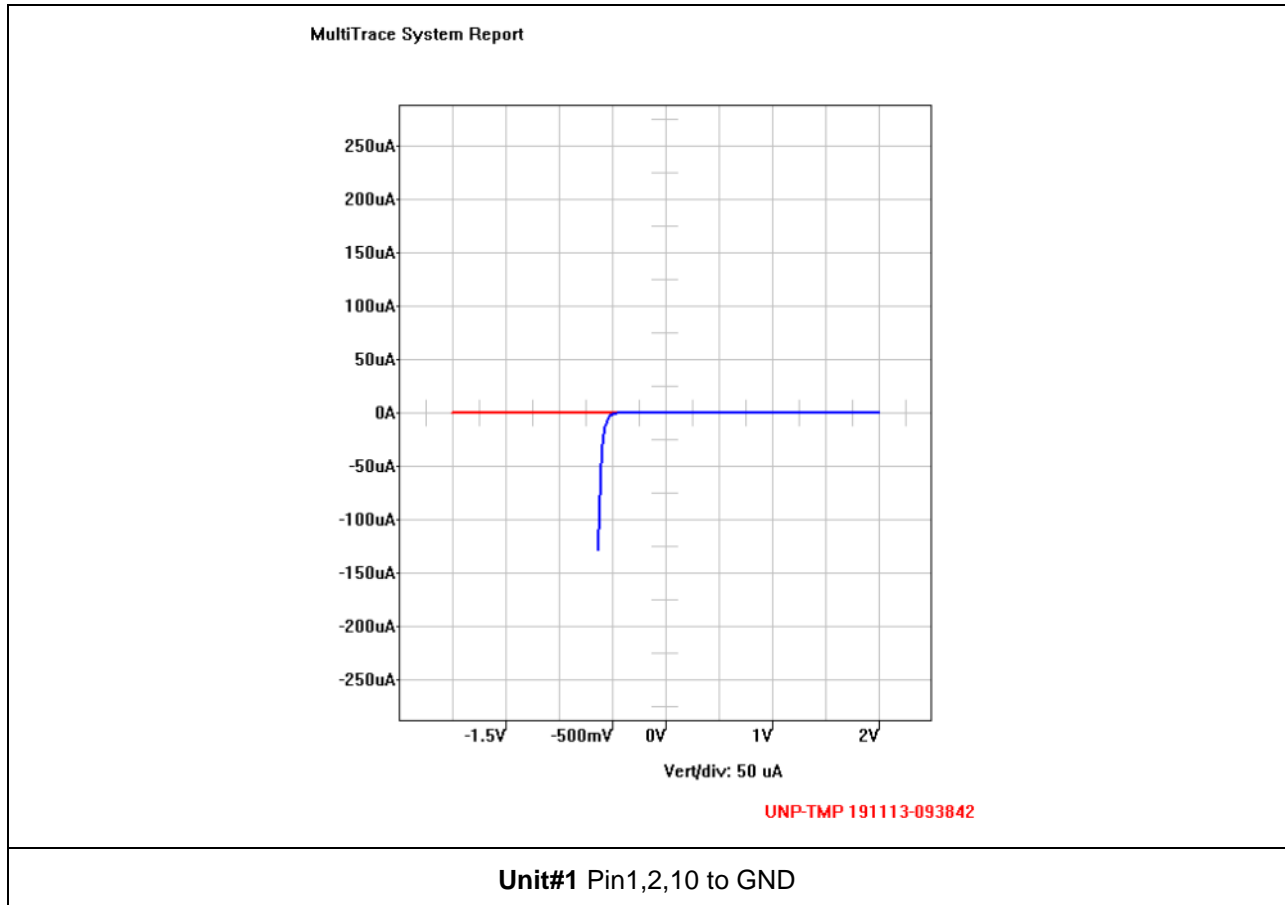
Curve trace analysis was performed on the returned units. Open failure was observed at pin1,2,10. **Blue curve** represents correlation unit. **Red curve** represents returned units.

**Fig.4:** CT of the returned unit.

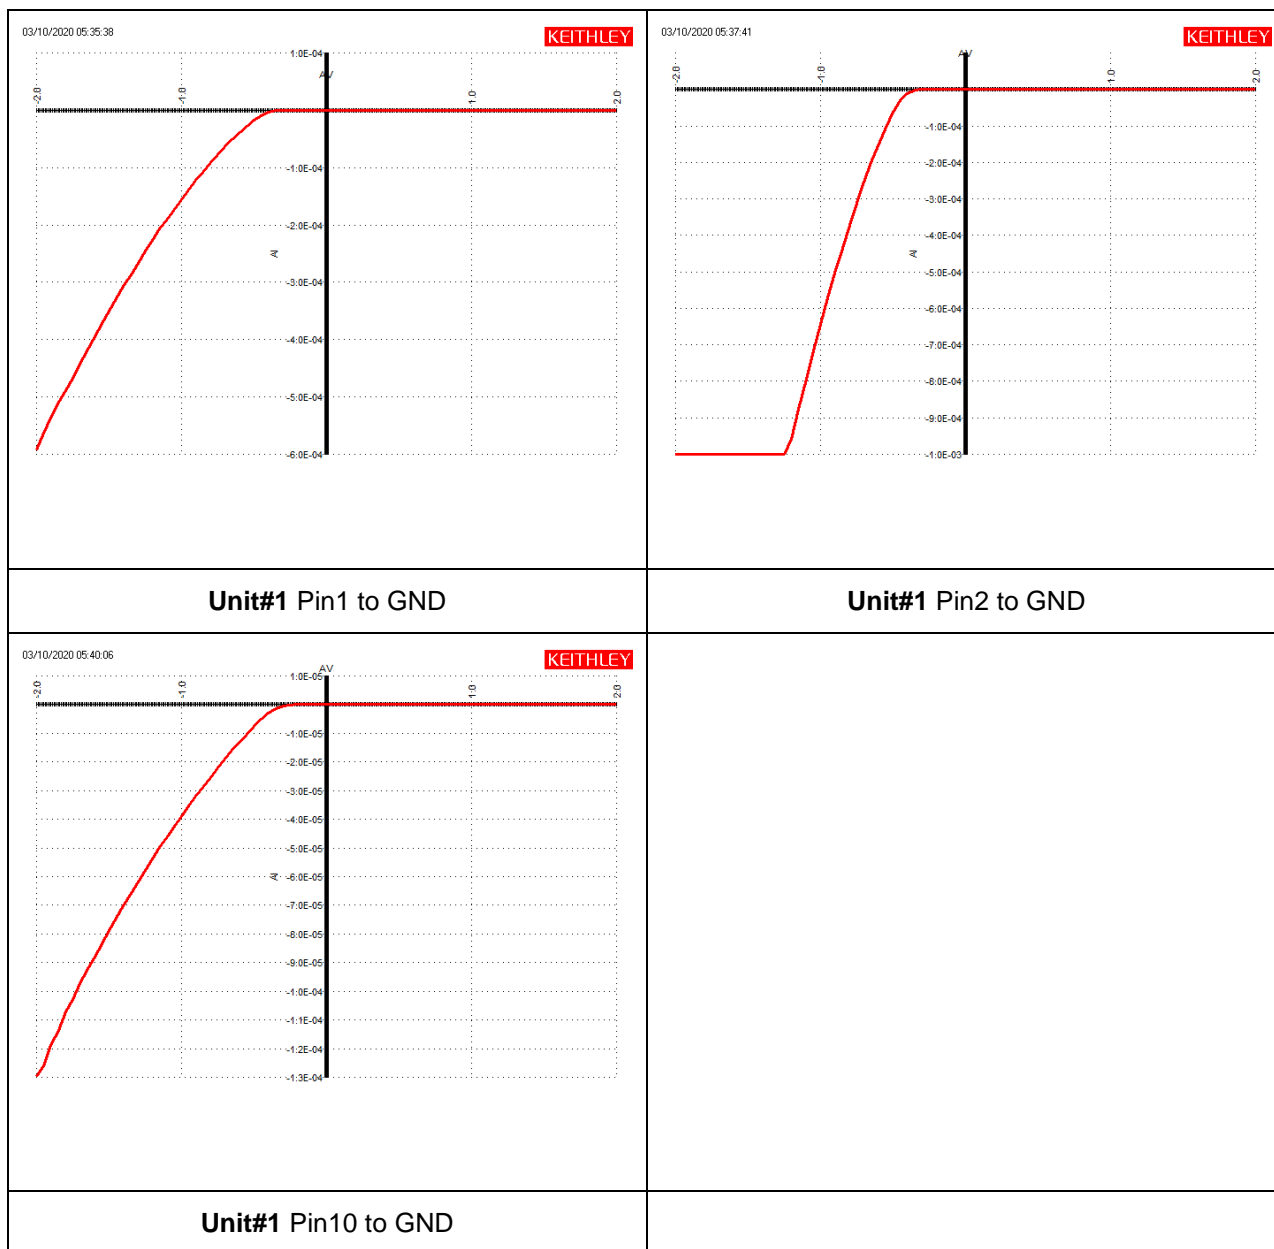
Curve trace analysis was performed on Cu wire. No open failure was observed. Damage suspect to be at wedge of pin1,2,10.

**Fig.5:** CT recheck on exposed wire.

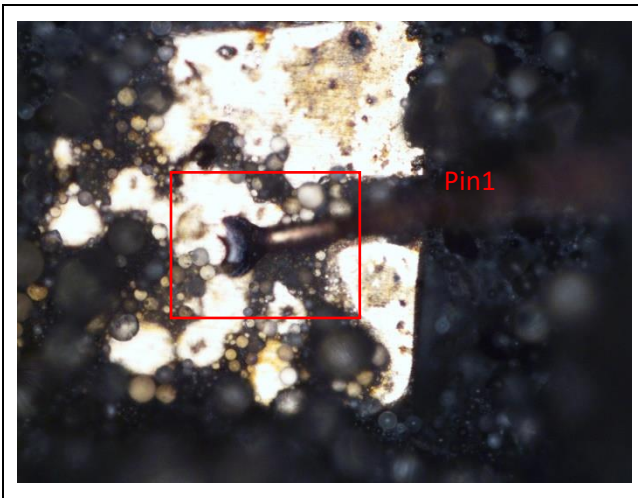
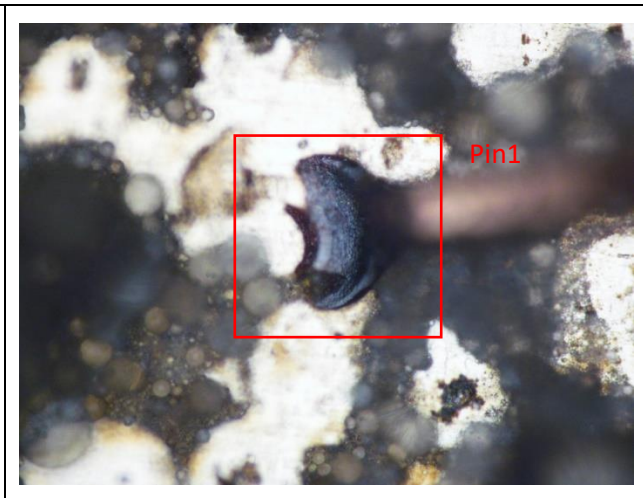
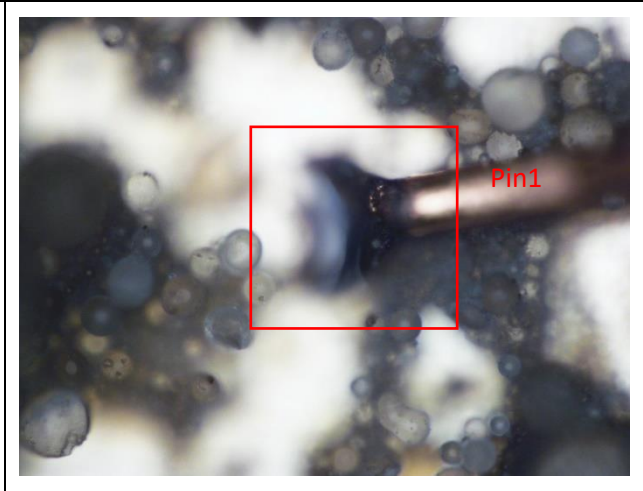
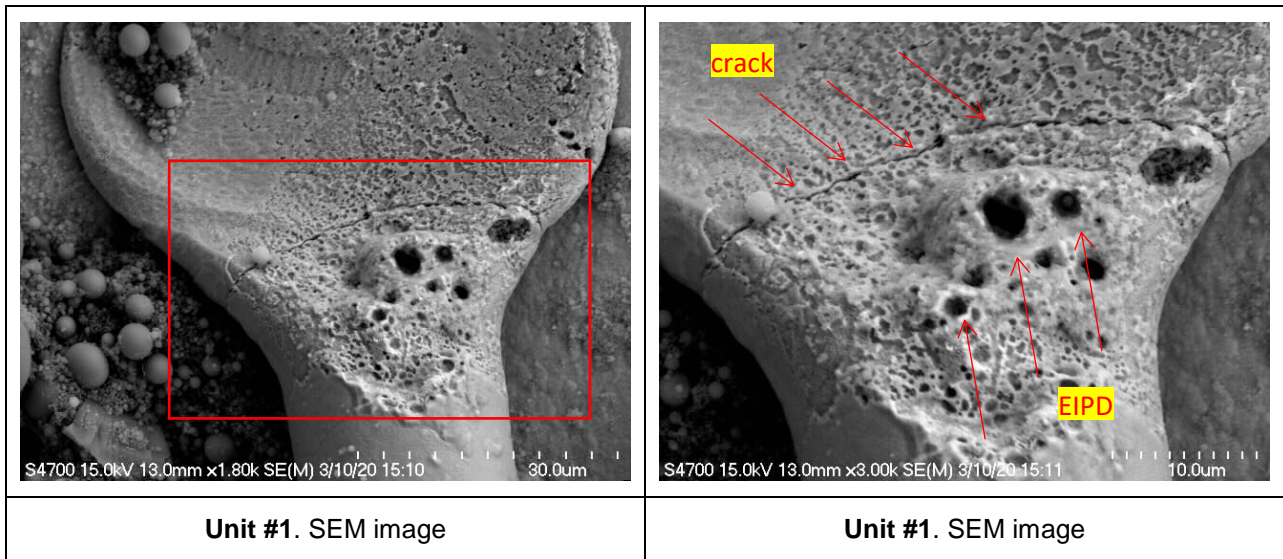
EIPD was observed on wedge.

<p><b>Unit #1. Pin1</b></p>	<p><b>Unit #1. EIPD at wedge</b></p>

<p><b>Unit #1. EIPD at wedge</b></p>

**Fig.6:** Optical image of the returned unit#1 after de-capsulation.

PFA showed EIPD and crack at wedge of fail pin1.

The damage is typically indicative of electrical induced physical damage (EIPD).

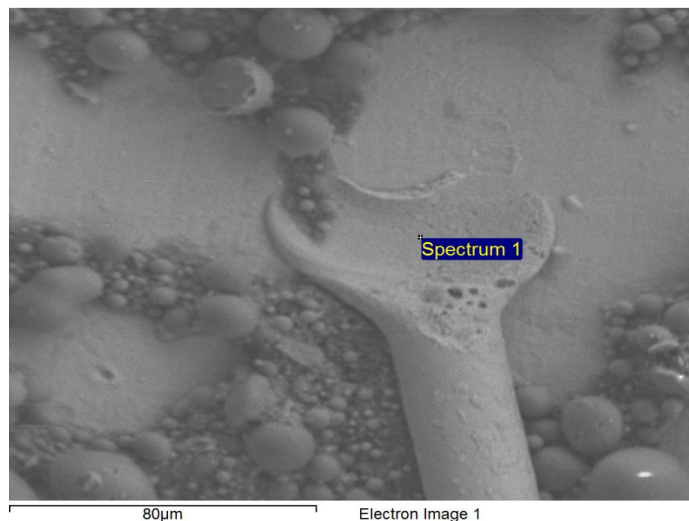
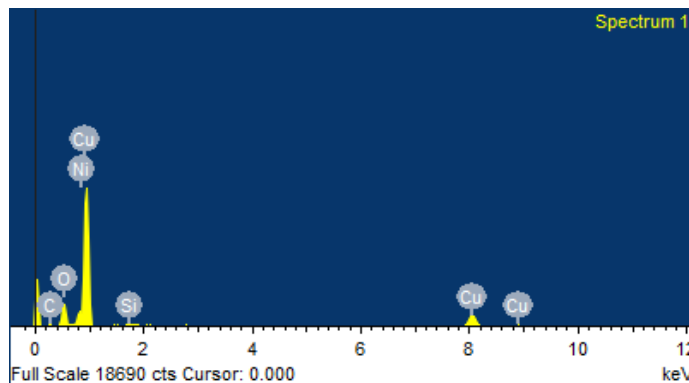
Unit#1 was submitted to EDX analysis. No abnormal element was detected.
