TAS5711 click(pop) noise when PWM on

2015/2/25

Objective : Remove the click(pop) noise when PWM on in BD mode.

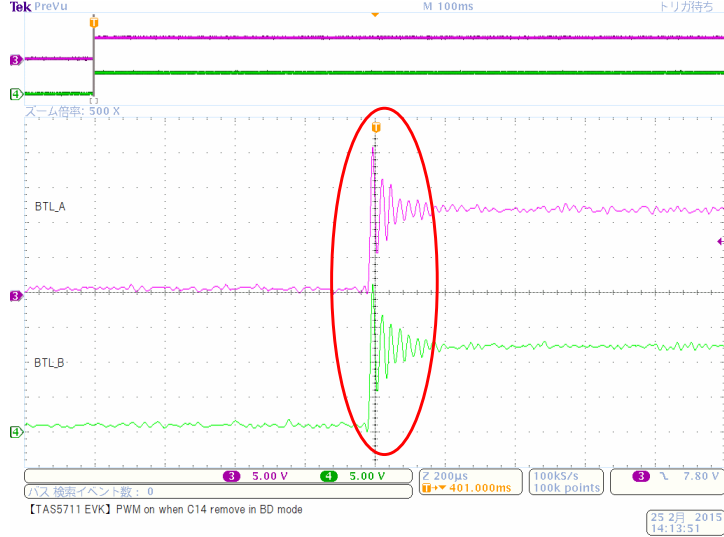
1. Remove C14 in BD mode

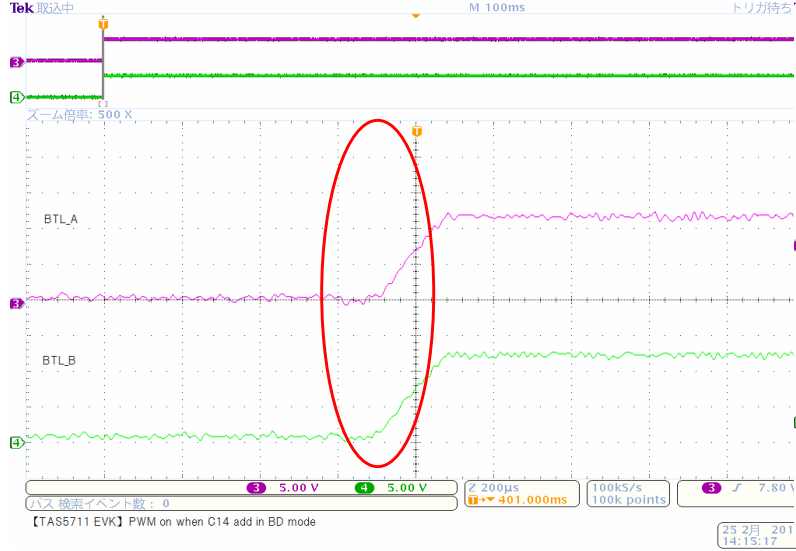
2. Add C14 in BD mode

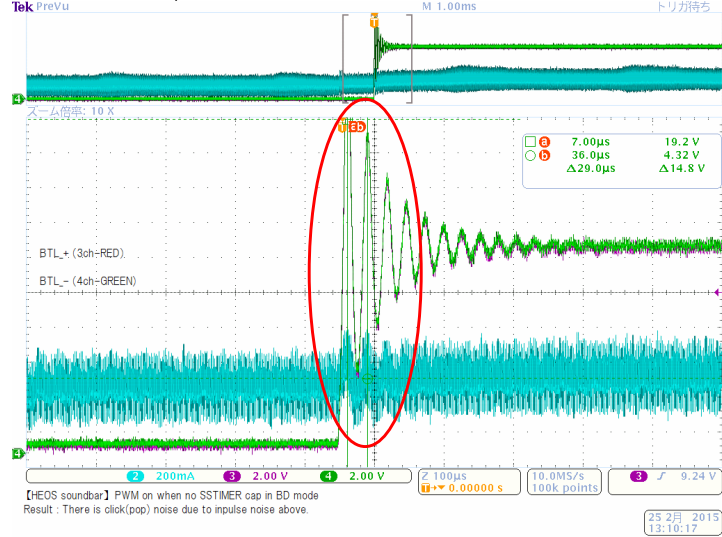
1. Remove SSTIMER cap in BD mode

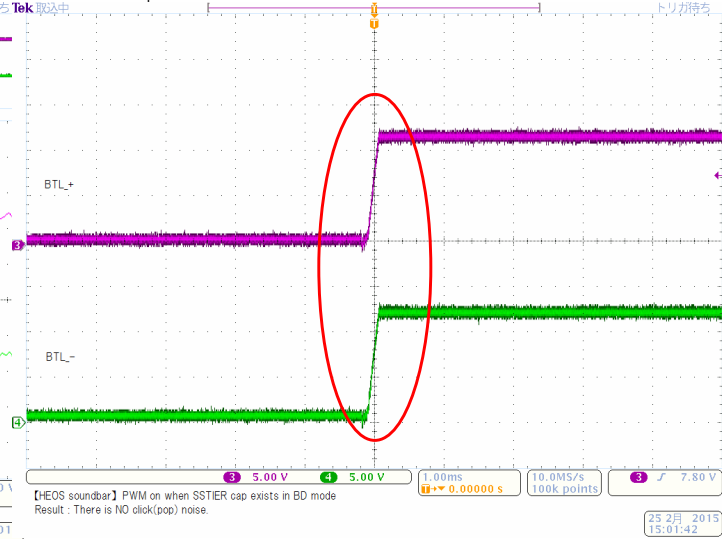
2. Add SSTIMER cap in BD mode
