1. Current design analyze regarding noise
2. Further design check regarding remaining noise
3. General Layout improvement

1. Current design analyze regarding noise

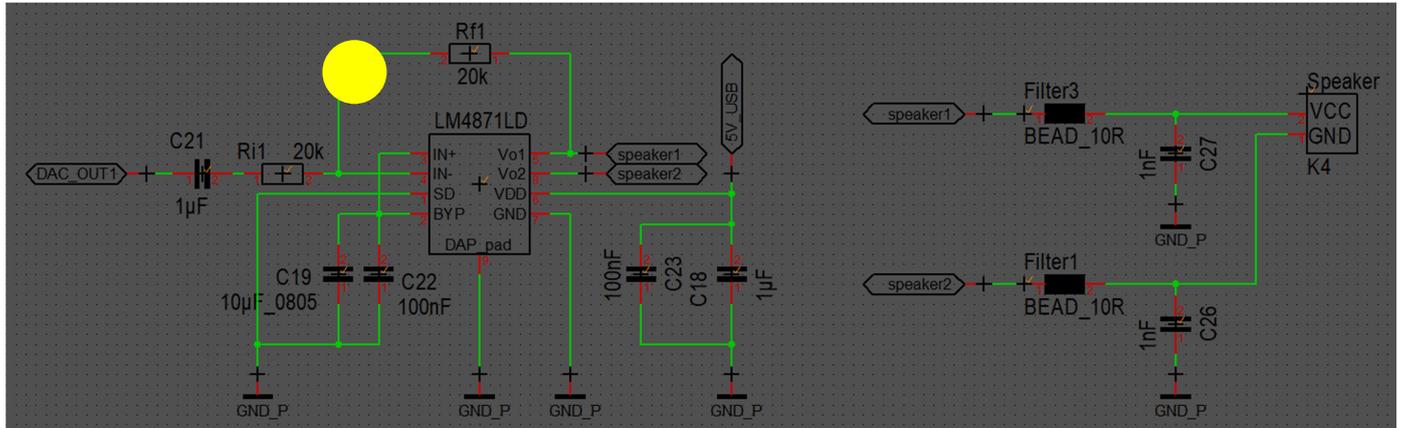
(current design for the LM4871 on all PCBs)

A STM32F405 reads data from wav-files of a µSDcard and applies the voltage over the internal 12bit DAC to the LM4871. The sound output is overlain by a “scratchy” noise. The shown schematic is used on different PCBs. Some show that noise and others do not show that noise. Touching the yellow marked area on the PCB removes the noise almost completely.

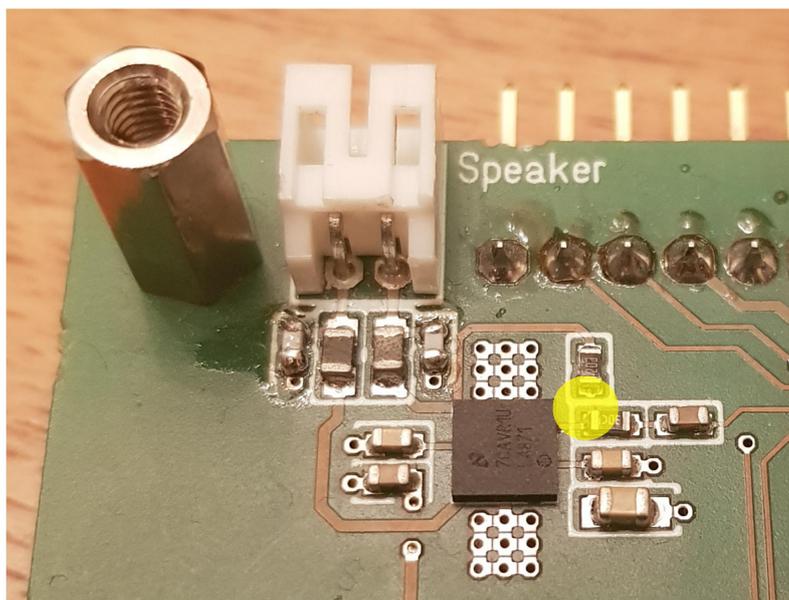
(PCB example)

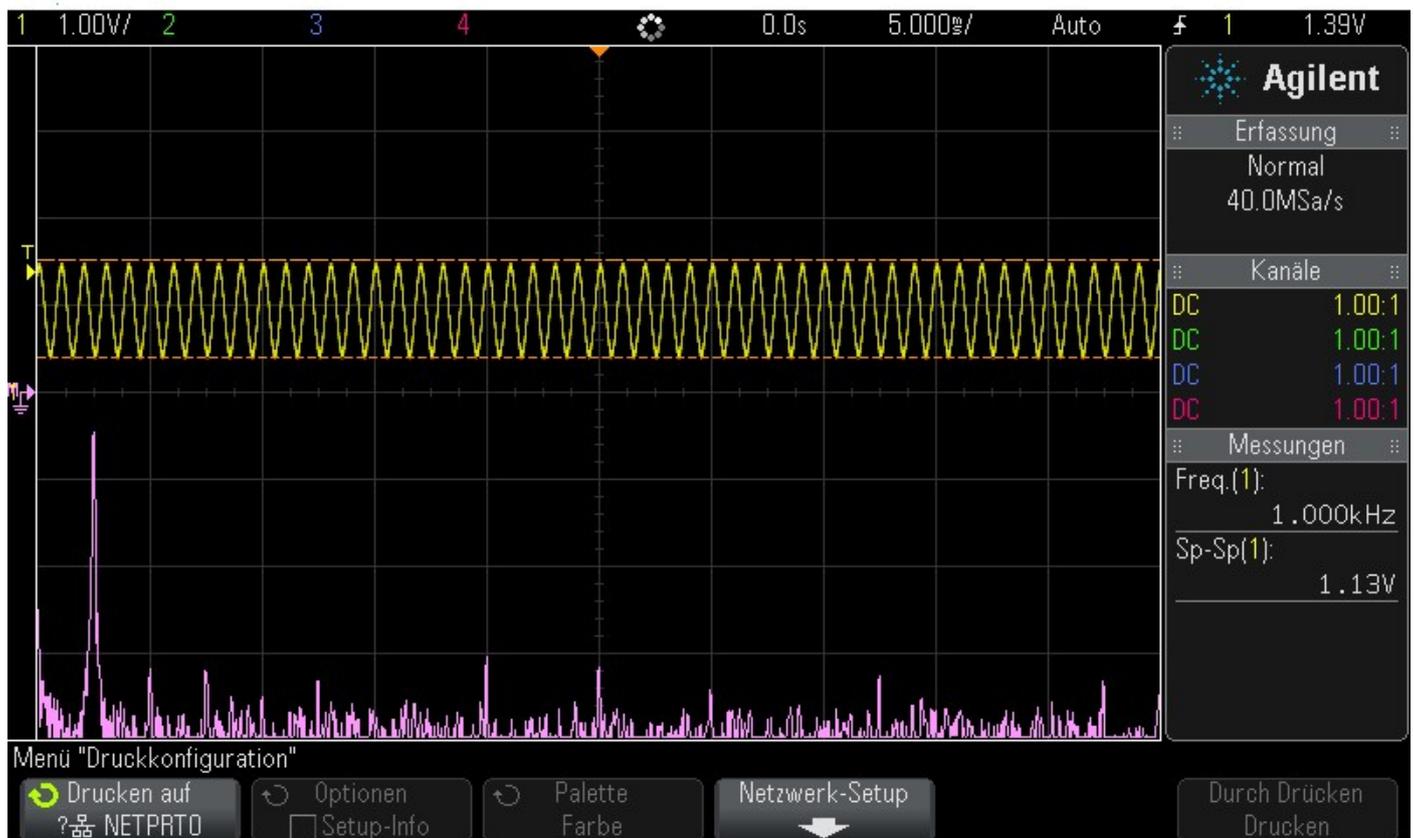
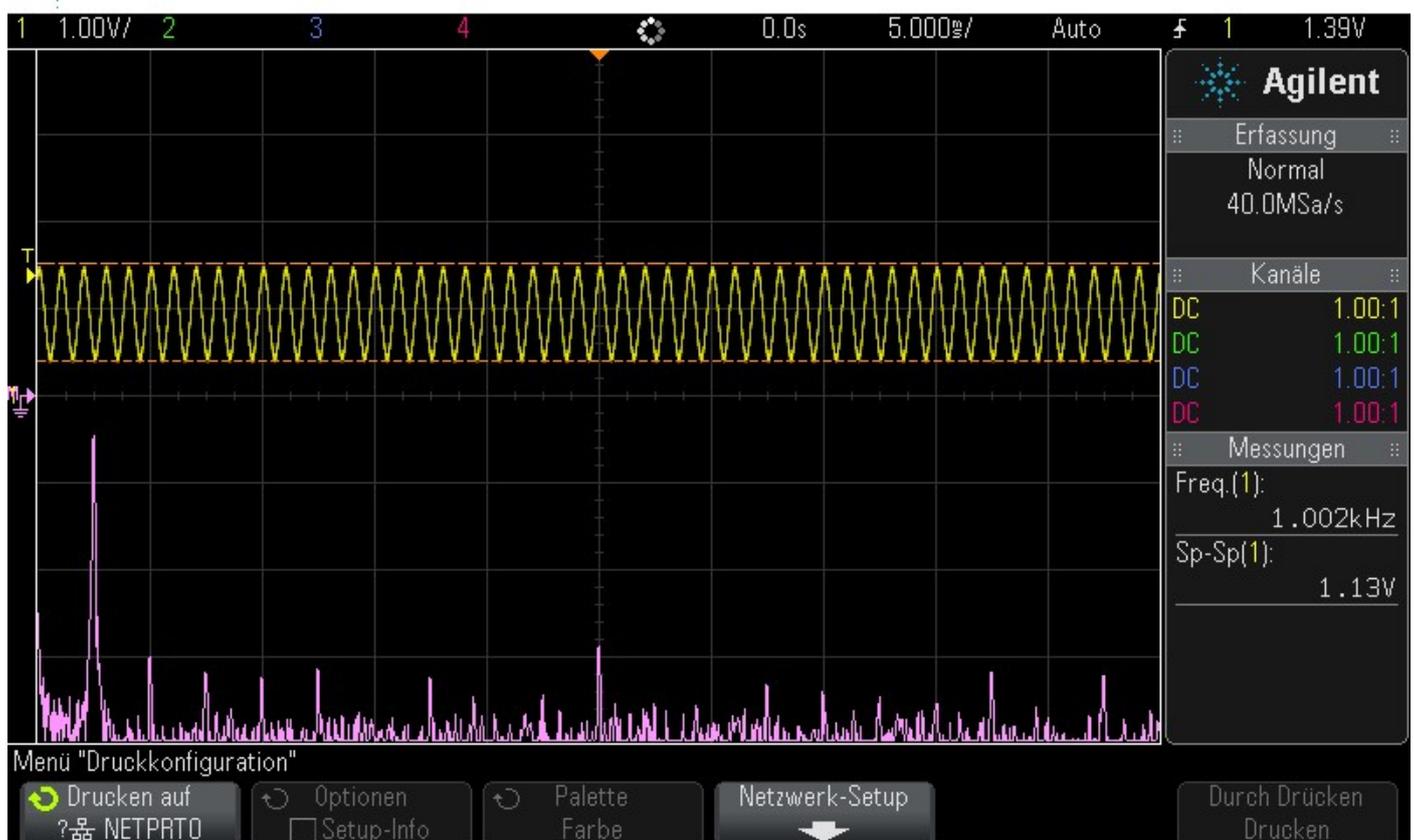
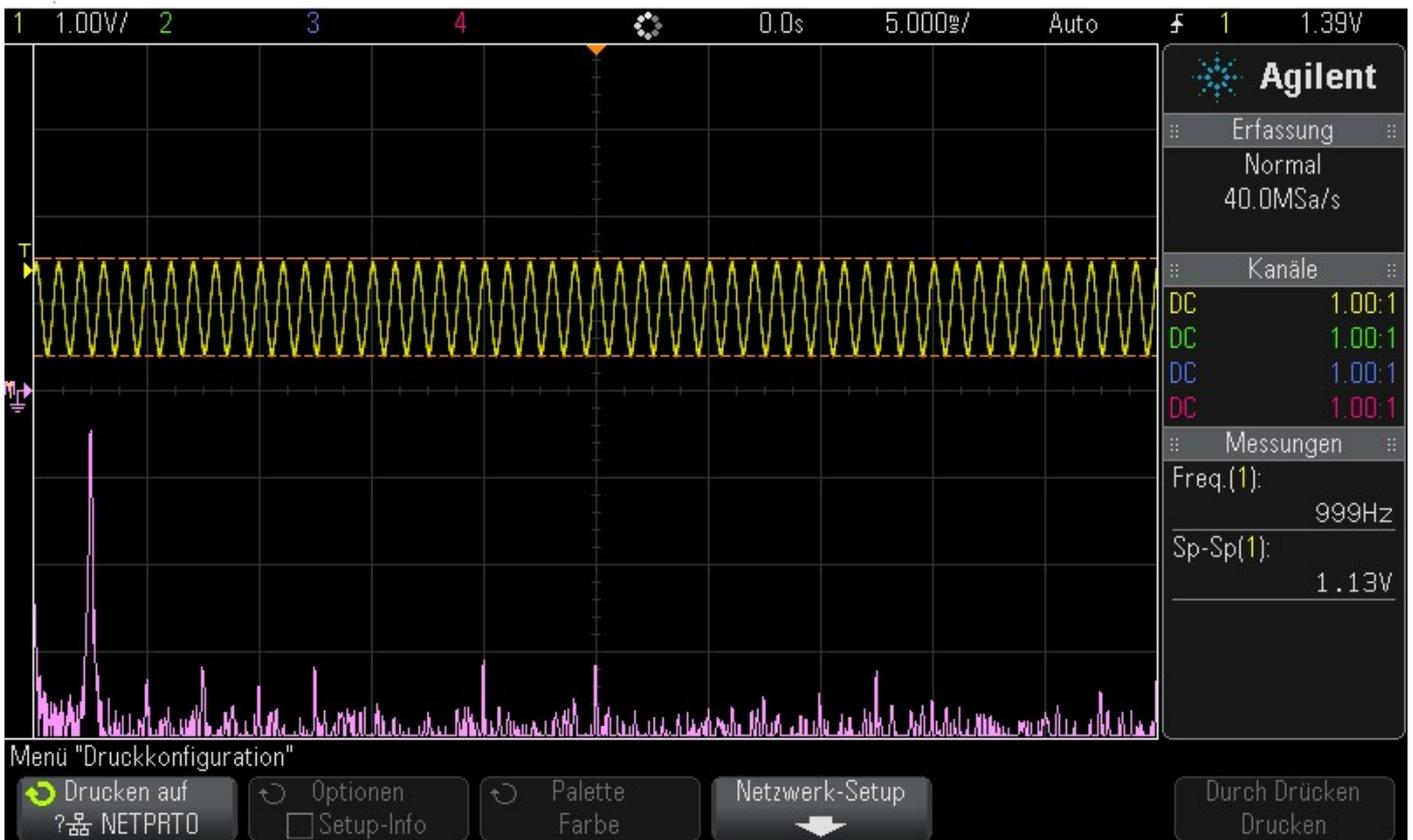
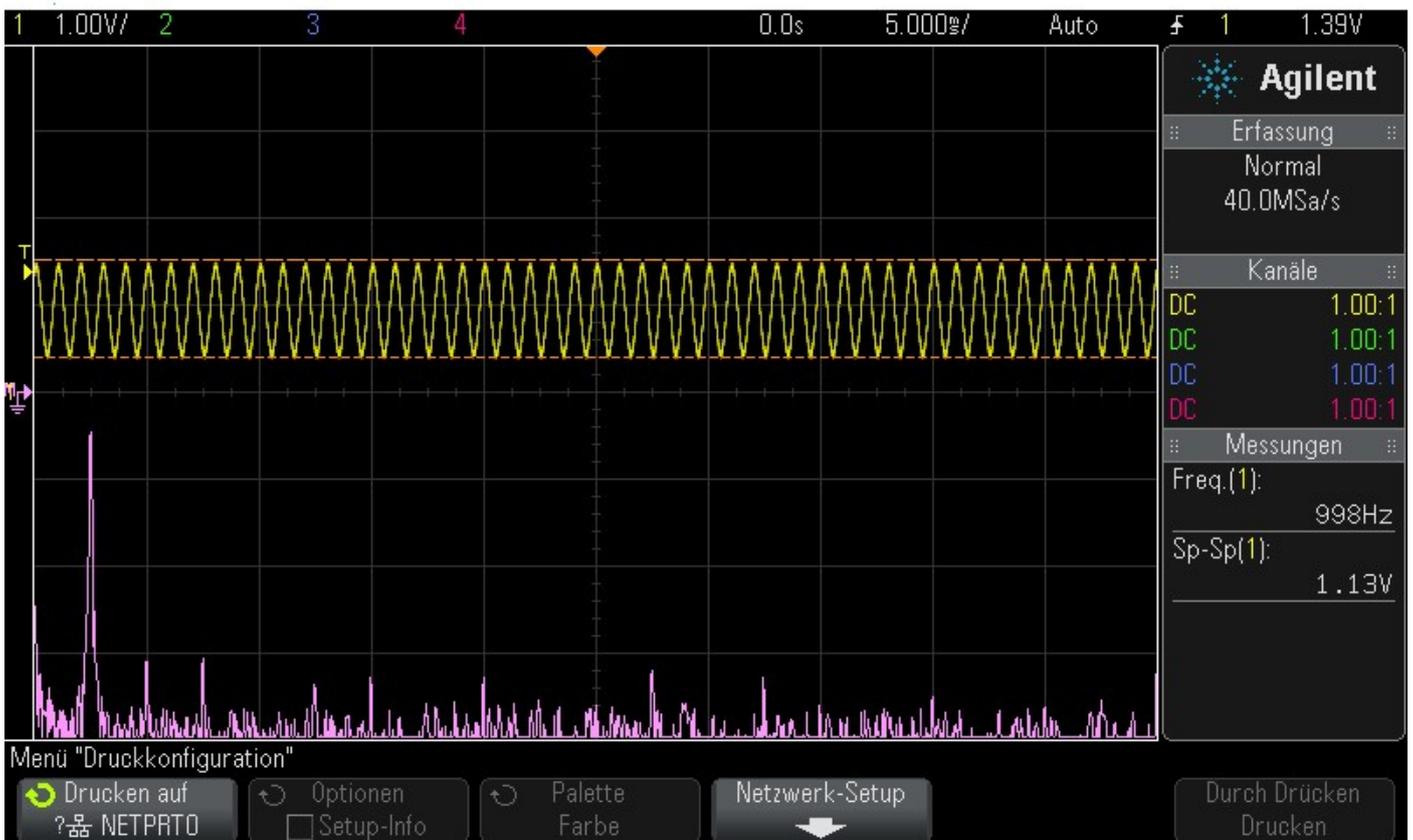
The STM32 was off and a 1kHz Signal was attached to the input capacitor C21 of the audio amplifier. Yellow shows the input signal and pink the FFT measured on the speaker pins (y: -20dB/div, x: 2kHz/div).

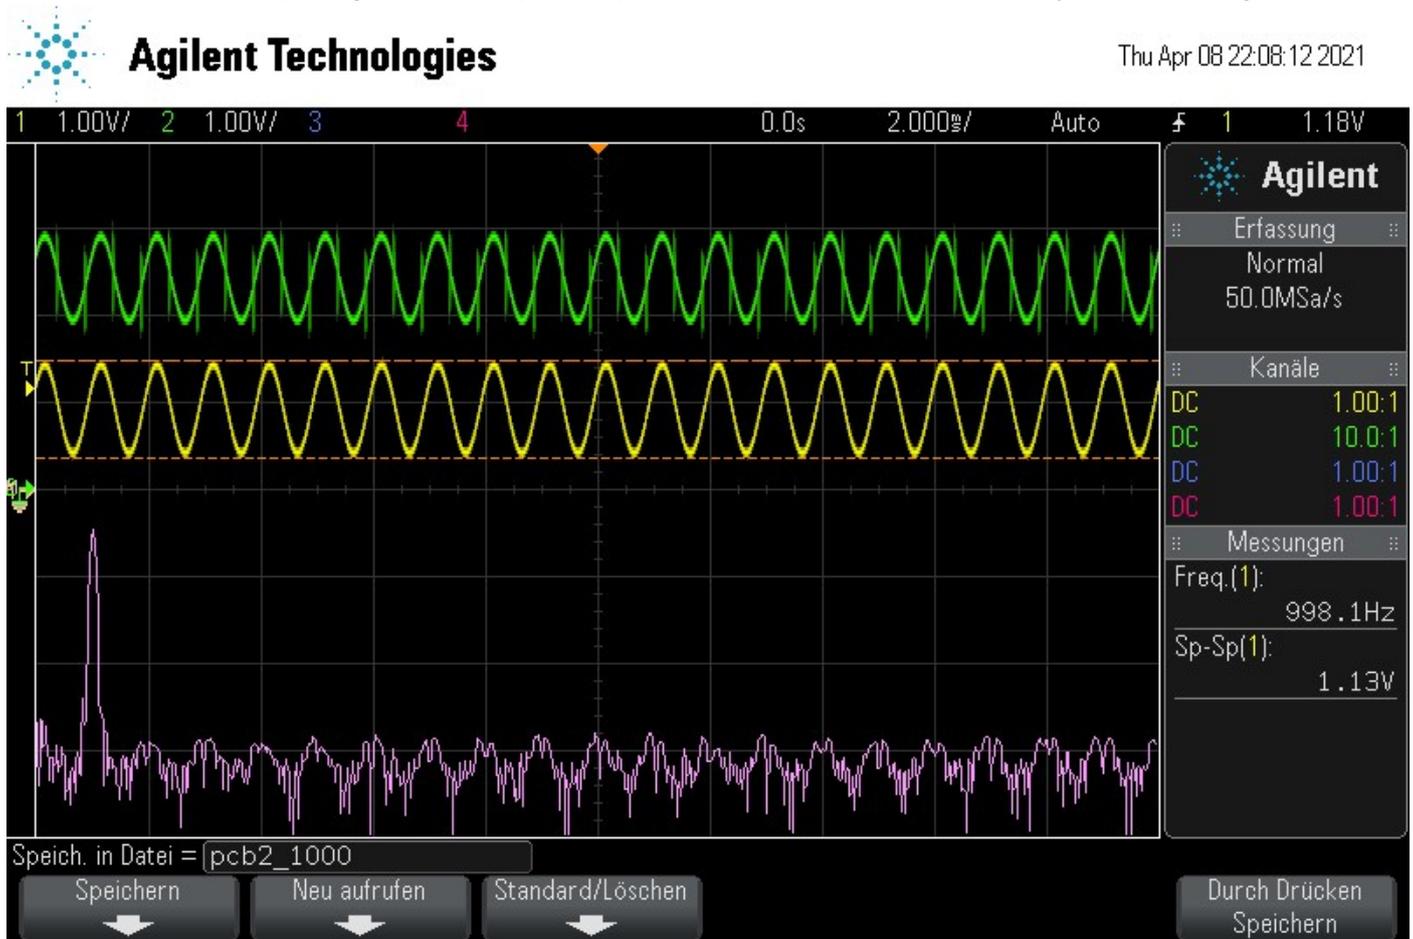
Green shows the output signal on the speaker pins. The noise shows up on every zero-crossing.

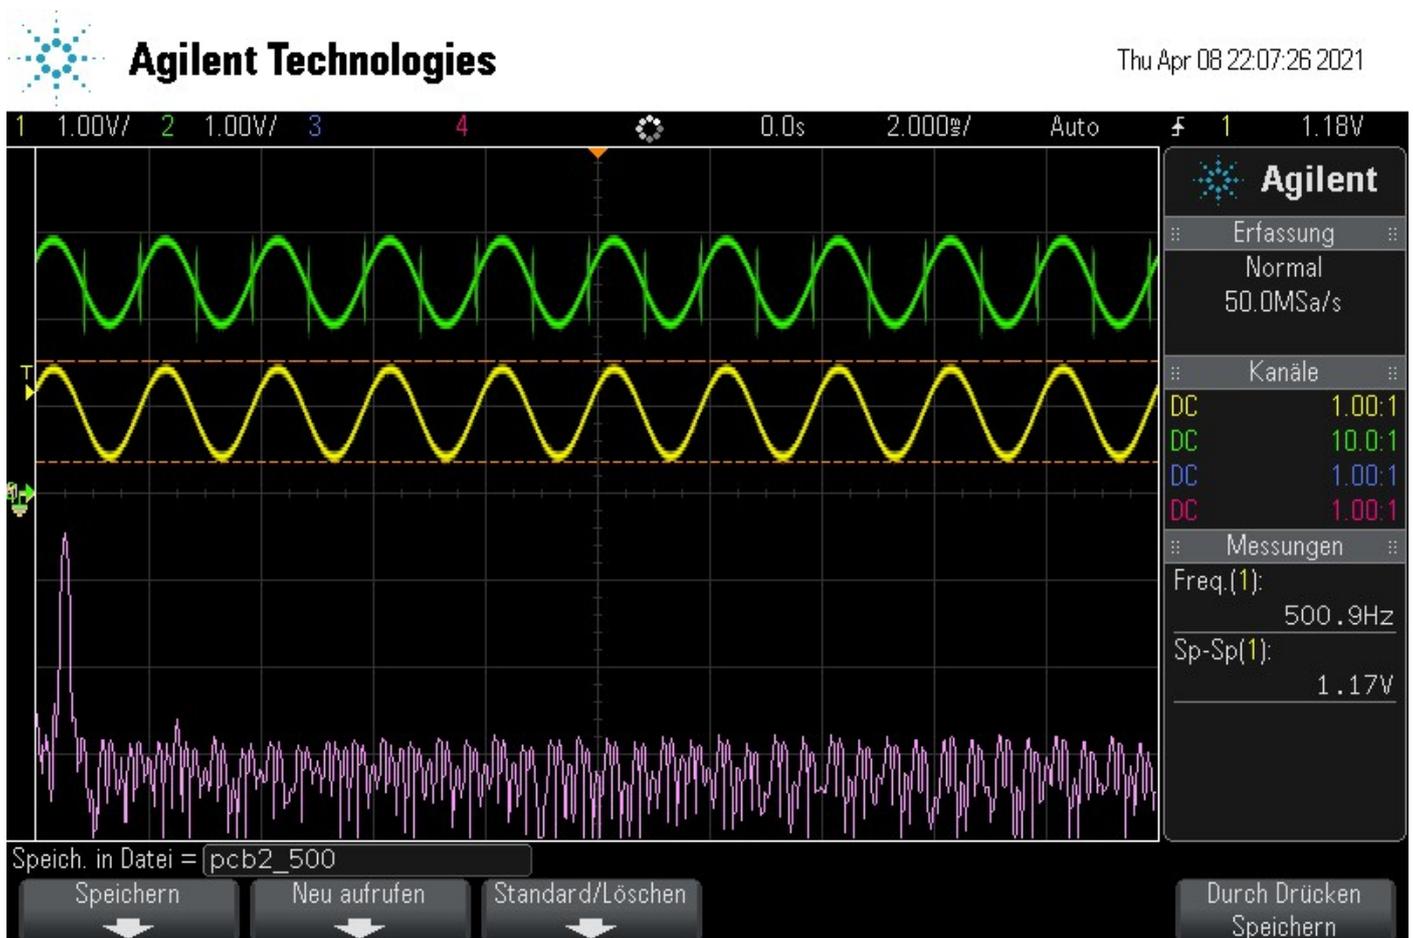
The same behavior with a 500 Hz input signal.

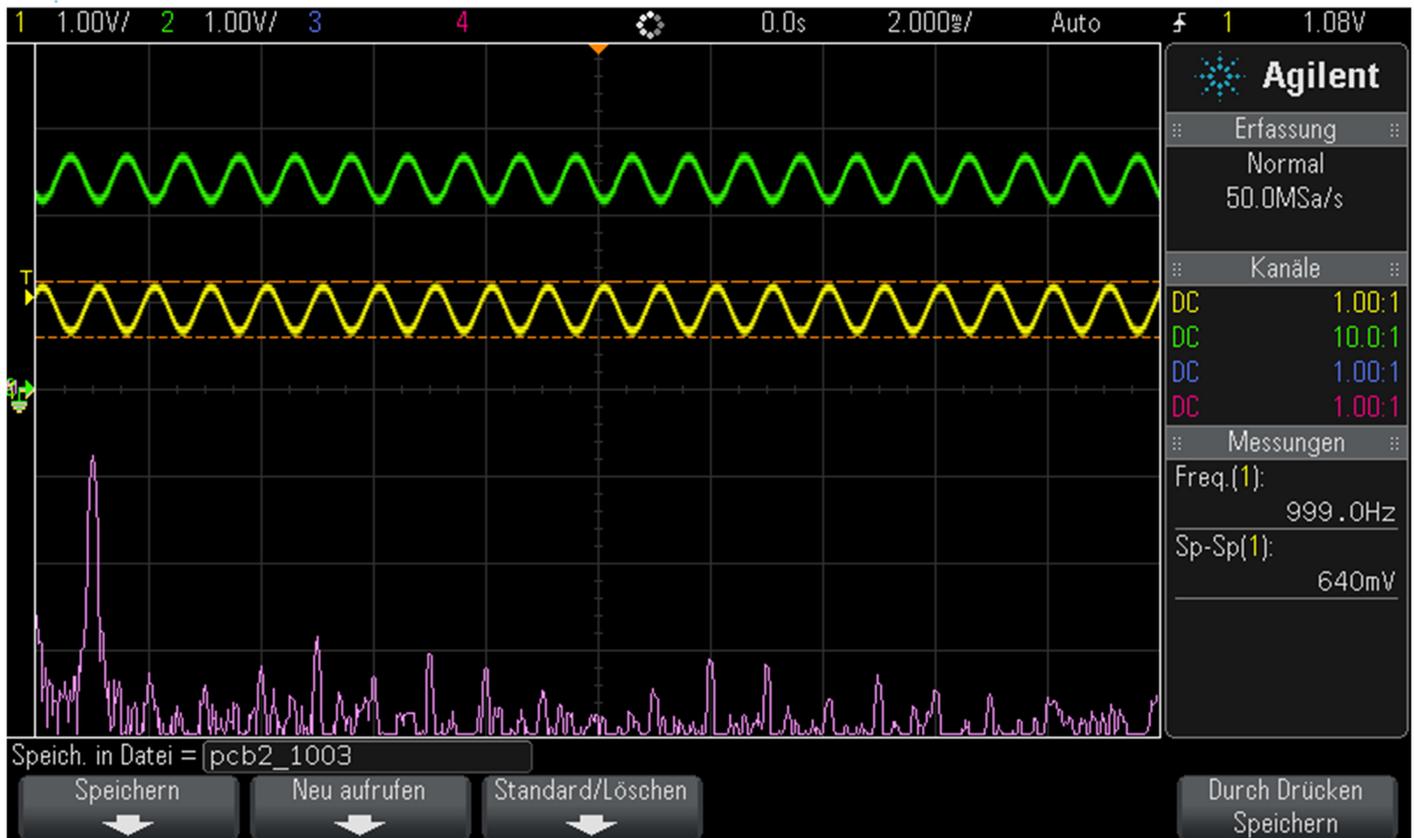
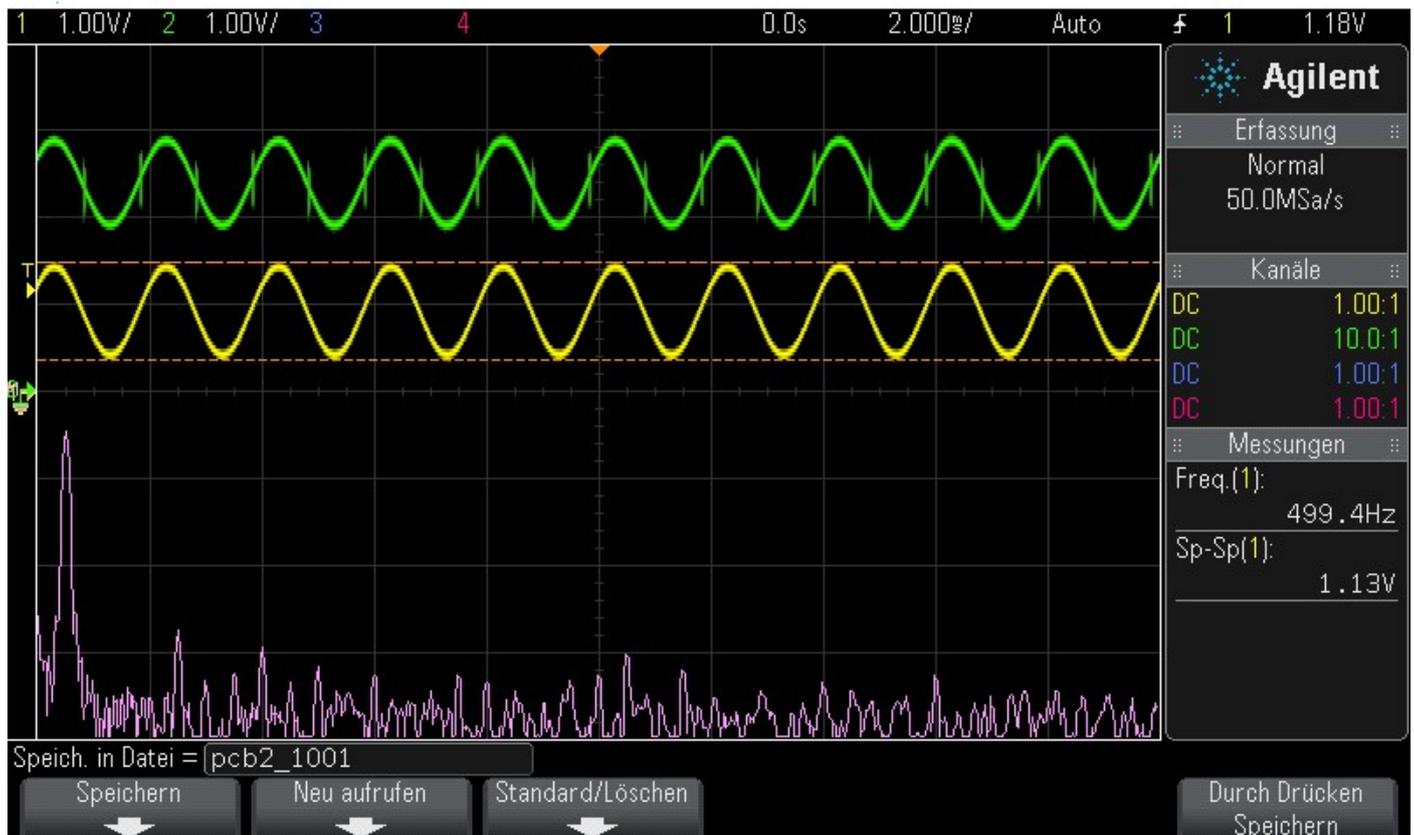
The noise disappears/decreases when the yellow marked area (see schematic and PCB picture) is touched. The noise intensity depends on the finger pressure on the PCB, more pressure results in less noise.

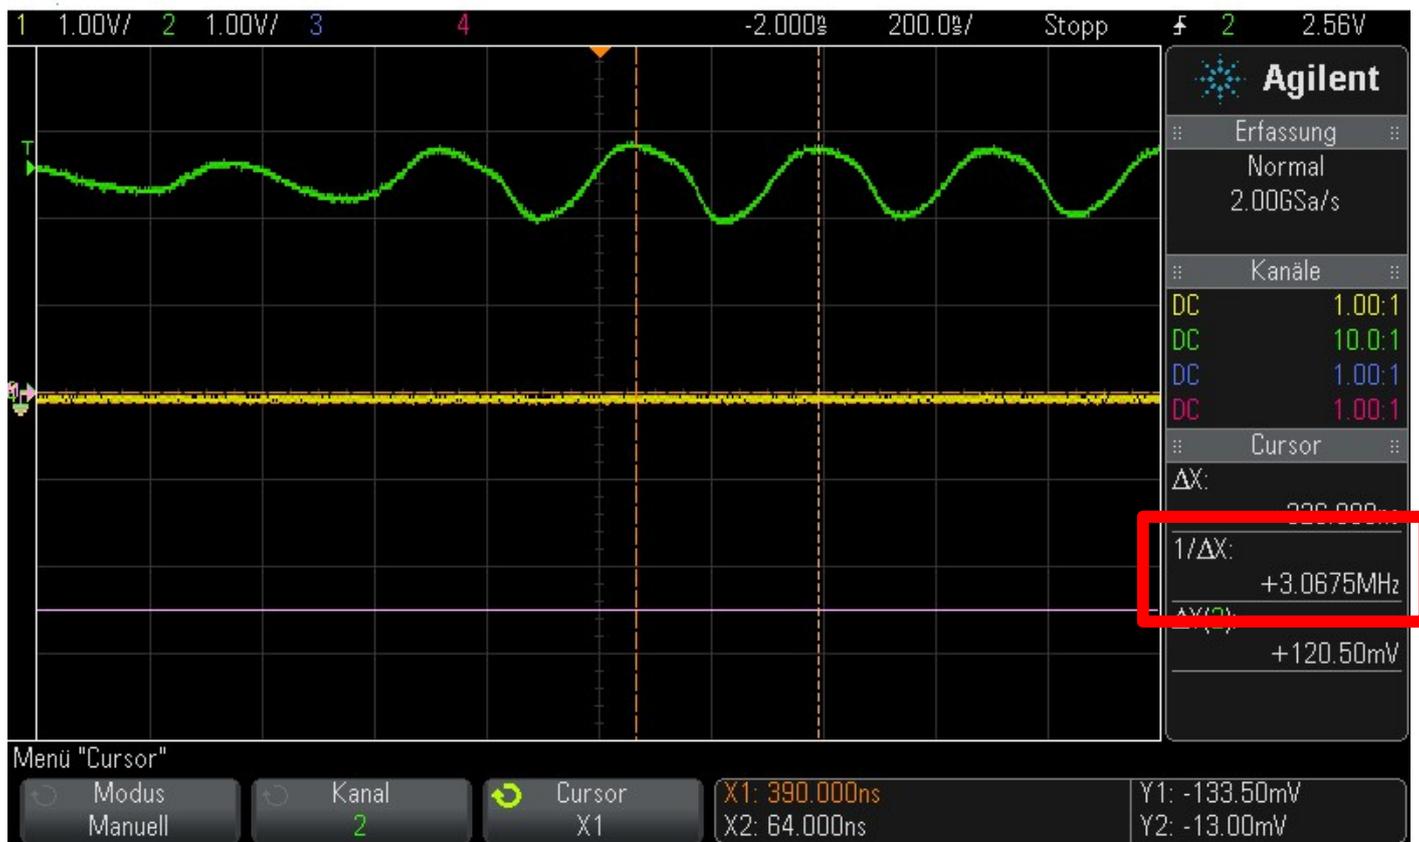
The periodic noise has a frequency of about 3 MHz, when zoomed into the noise peaks.

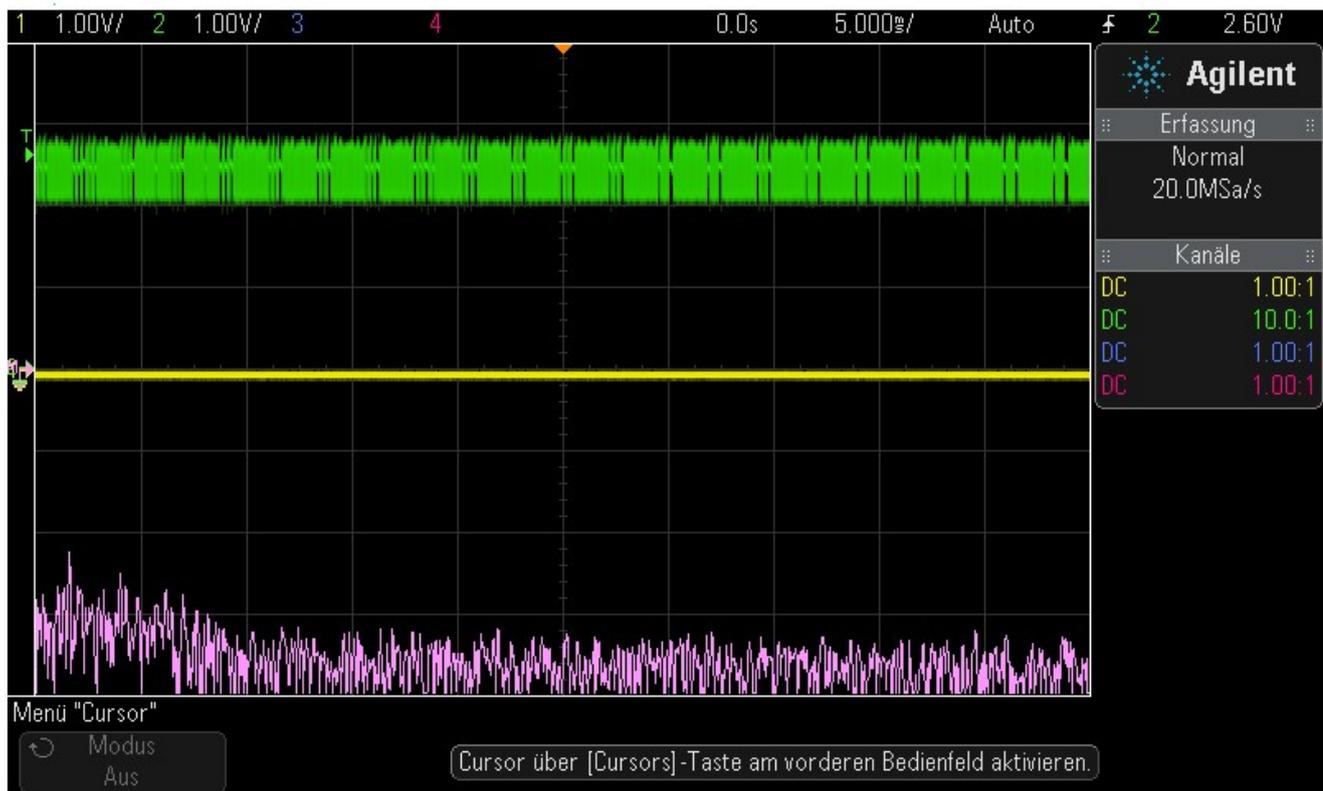
When playing a real sound file (ACDCs *highway to hell*) via the DAC of the STM32 the behavior is the same. Noise overlays the sound output.

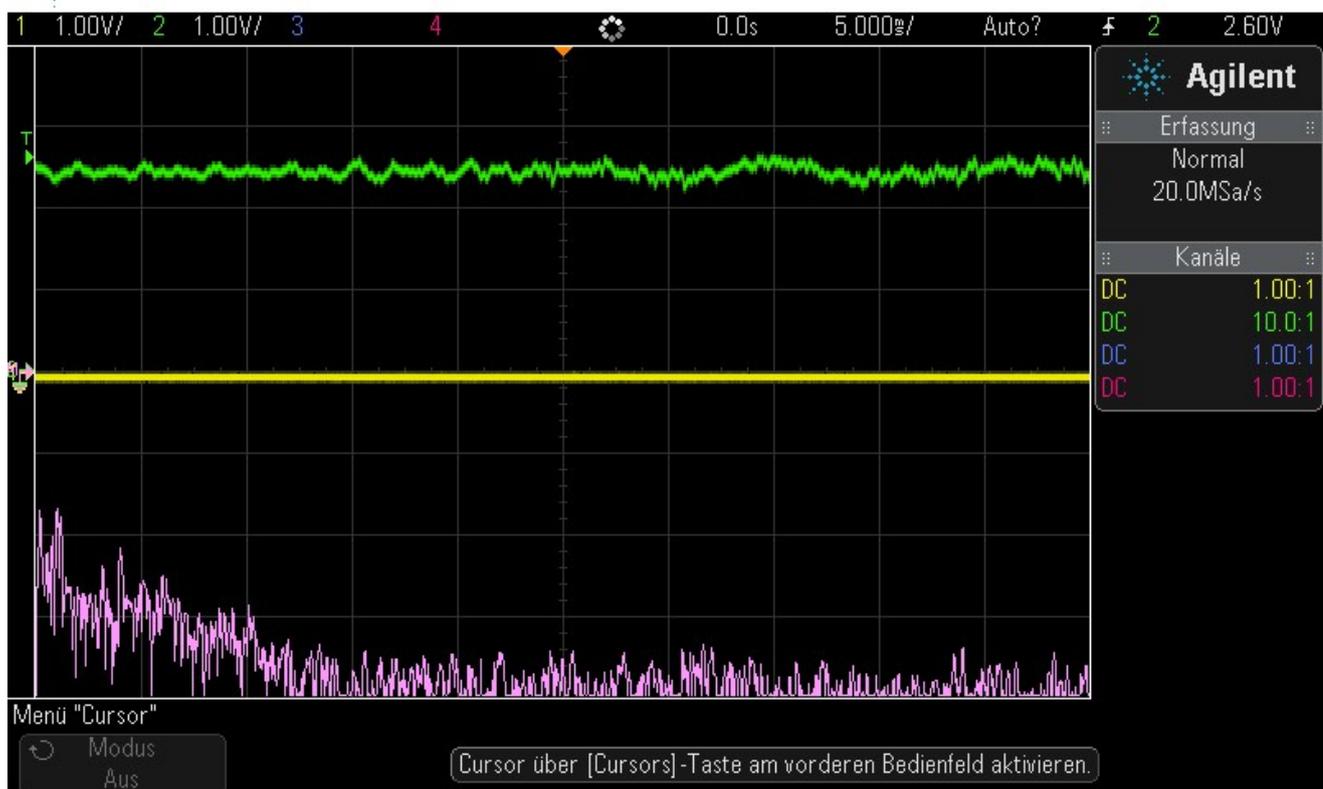
It is removed/decreased when touched with the finger:

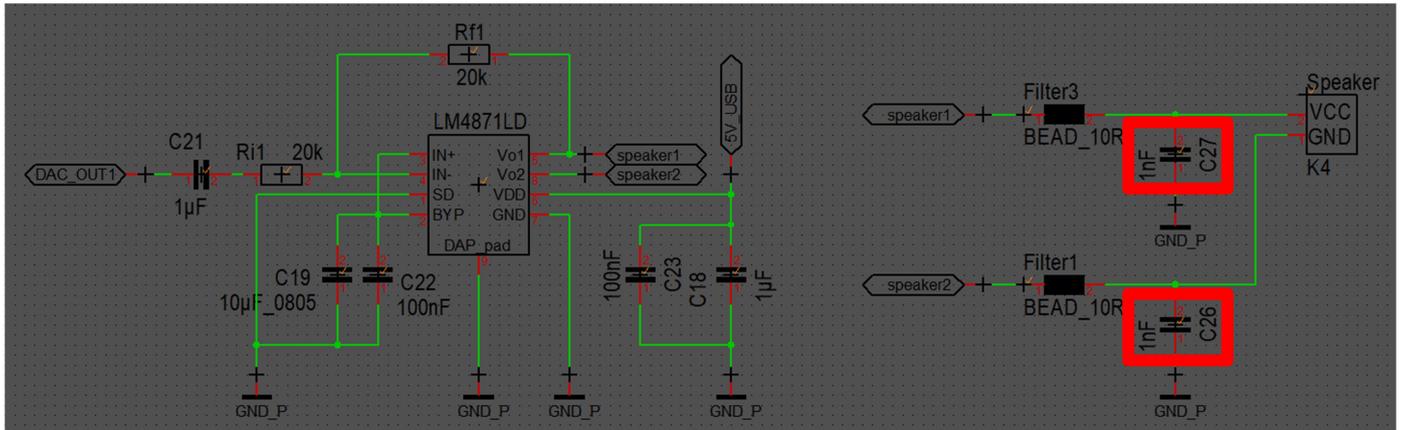
The noise disappears completely when the two red marked capacitors are removed. The right part of the schematic (beads and capacitors) was found on some sources on the internet to “improve the audio output”. As mentioned in the LM4871 datasheet an additional improvement is not needed but we thought it would be good. It was not unfortunately...

When the two marked capacitors are removed the sound quality improved on all PCBs with the LM4871.

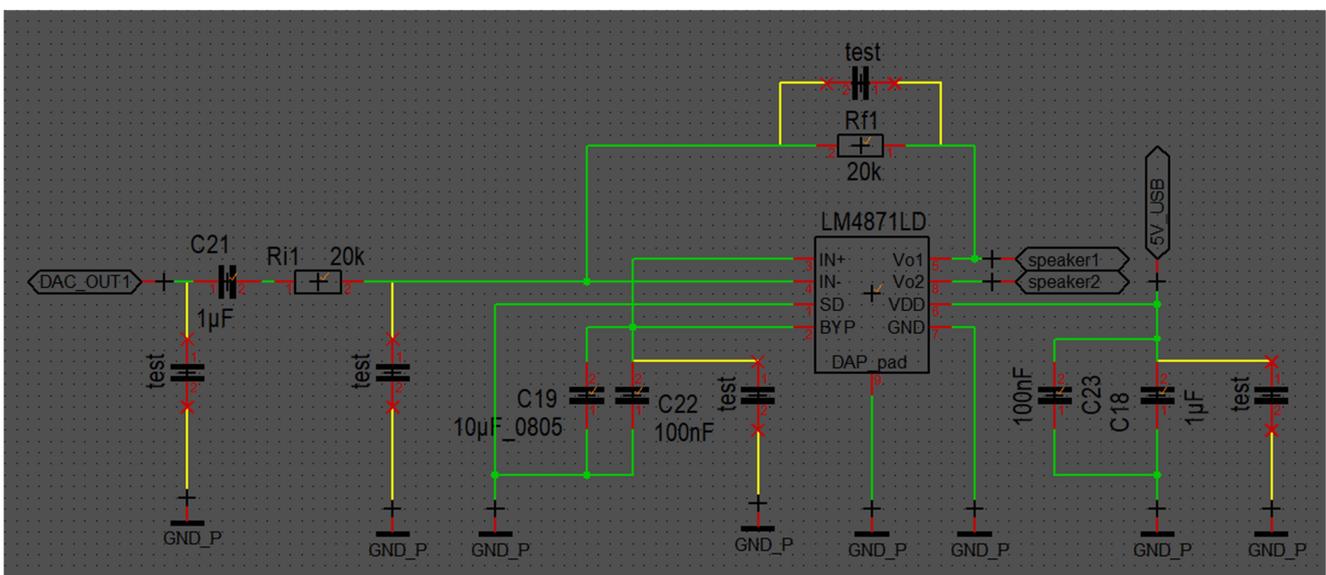
The main noise problem is solved, but we recognized that there is still some small scratchy sound left when you are close to the speaker with your ear when the audio output signal of the STM32 is forced to constant 1650mV ( $VCC/2 = \text{mean sinus}$ ).

Replacing the remaining beads with 0R resistors has no effect.

We placed some additional capacitors on various places around the LM4871 as shown in the picture. Only one “test” capacitor was soldered on the PCB at once. We tested 48pF and 680pF. Both values had no effect on the remaining noise. Is it possible that that remaining noise is generated internally by the LM4871?

When the sound volume is increased, the remaining noise remains constant (it is not amplified). When sound is played and the volume is loud enough the remaining noise is inaudible.

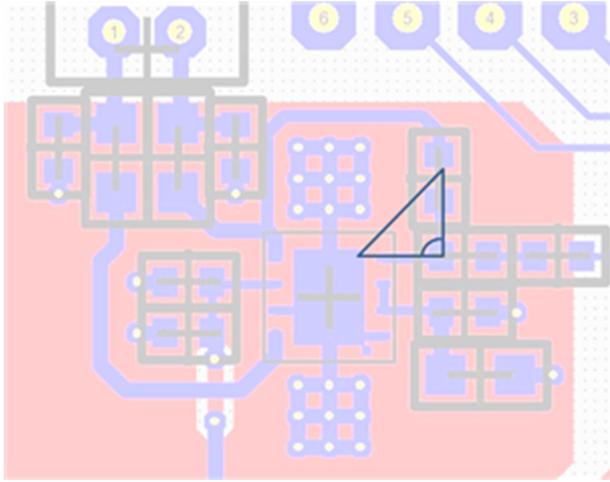
You mentioned the layout improvement regarding the (to avoid) 90° traces at Ri and Rf.

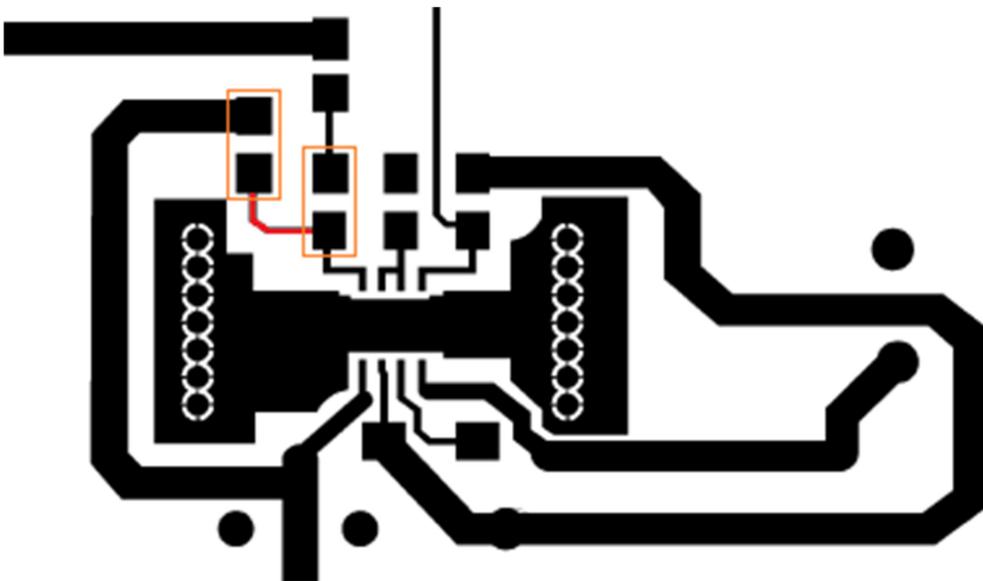
This is the TI layout example from the datasheet (figure 29, page 13). I think you prefer this placement and traces?

Can you give more insight why to avoid the 90° angle as shown above?
