# Failure Analysis Report

## Device Analysis Services

FA QEM-CCR-1706-01197

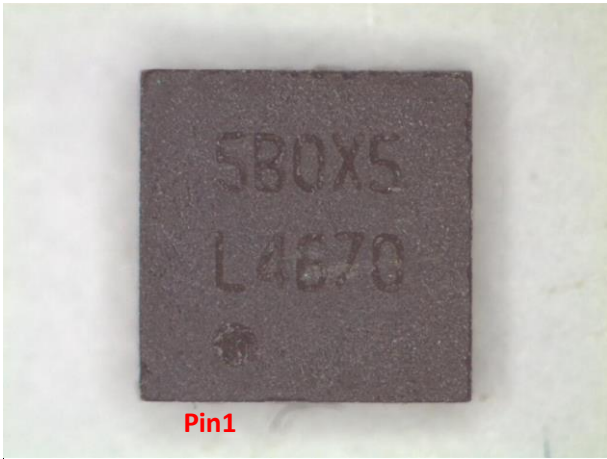
The failing unit was inspected optically. No anomaly was observed.

<p style="text-align: center; color: red;">Pin1</p>
<p><b>Figure 1.</b> Optical image of the top of the device. No anomaly was observed.</p>	<p><b>Figure 2.</b> Optical image of the bottom of the device. No anomaly was observed.</p>

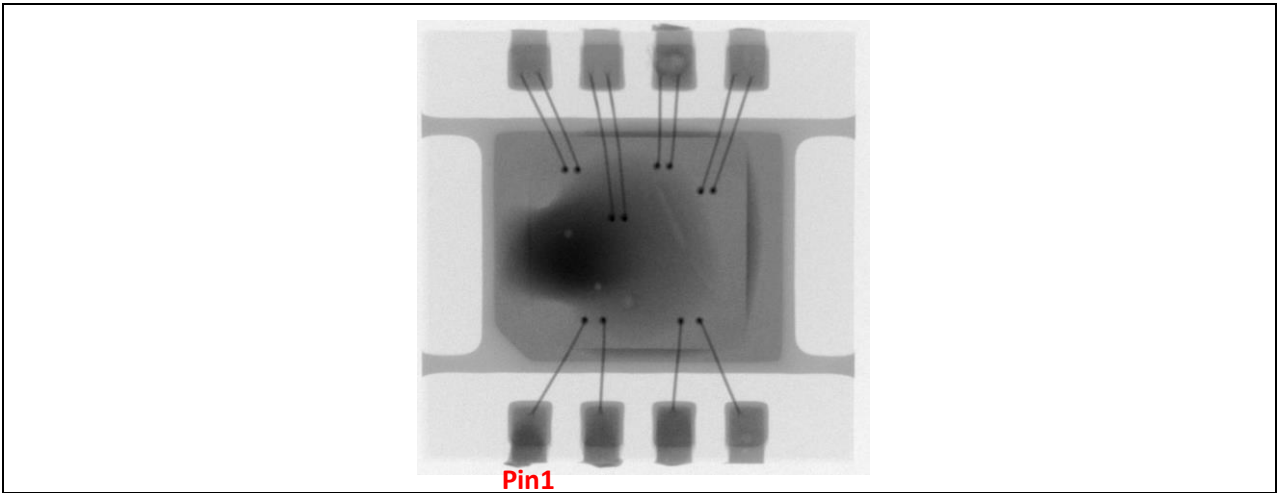
**Figure 3.**

Top view by X-ray. No anomaly was observed.

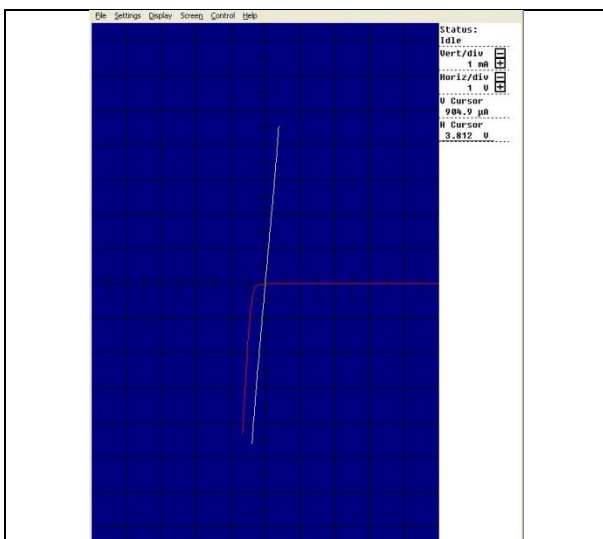
**Figure 4:**

Measurement result for returned unit through curve tracer was as below:  
Pin5 (VO1) shorted to pin4 (GND).

IV curve revealed pin5 shorted to pin4 (GND).

The red curve indicated a correlation unit.

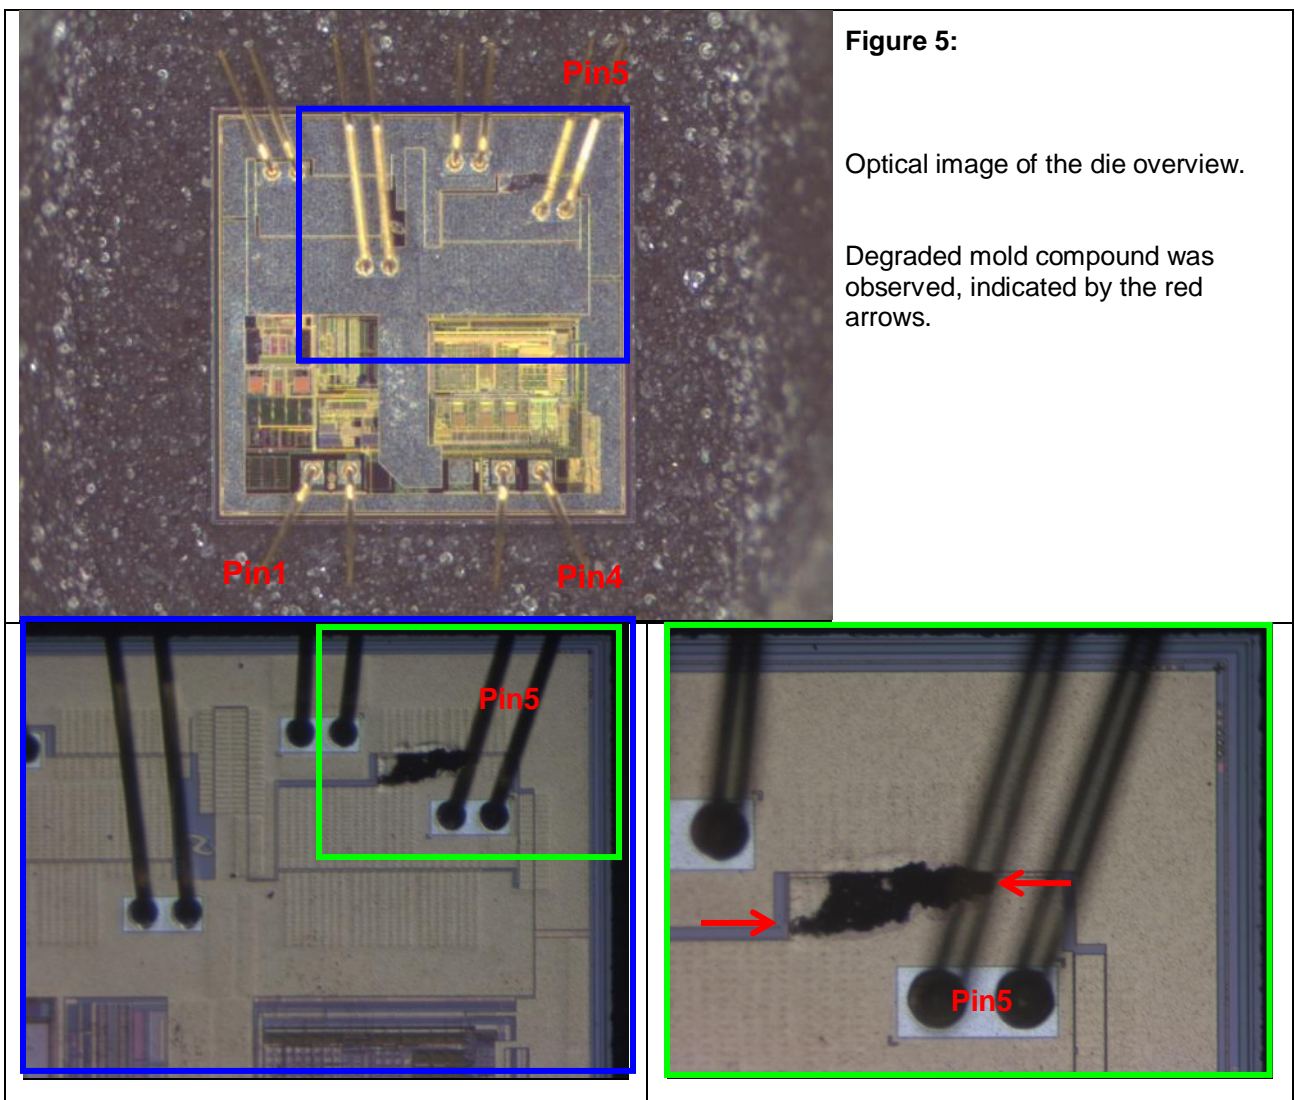
Optical inspection of the de-capsulated unit revealed EOS damage in the form of degraded mold compound was observed.

EOS damage in the form of degraded mold compound was observed.

The unit failed due to the EOS damage observed. An over-voltage/over-current condition or event is the most likely cause of failure and we recommend that the customer evaluate the application environment for possible sources of transient or steady-state Electrical Overstress. Detailed analysis and measurement of the customer's board environment and the customer's test environment will be required to identify the specific cause of the EOS. Please consult the below fishbone diagram for a listing of such possible causes.
