Problem :Customer encountered market feedback of D-amp IC broken(IC pin lead broken)

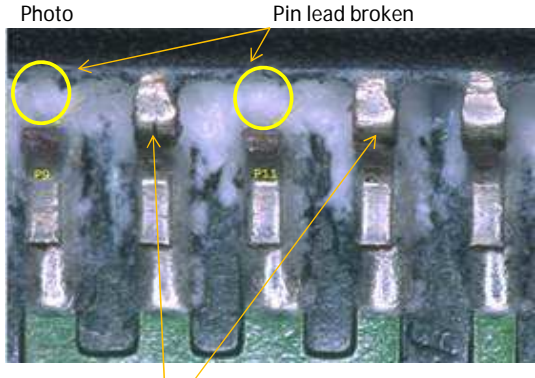
IC #1 : Damp IC pin 9 & 11 broken

For this IC, customer set is shut down (suspect the portion of broken pin lead caused shorting and trigger the protection).
When QA received the set and checked again, the set function normally (as pin 9 & 11 actually are GND pins which is connected with pin 10 & 12).
QA unable to find the small portion of broken pin lead.

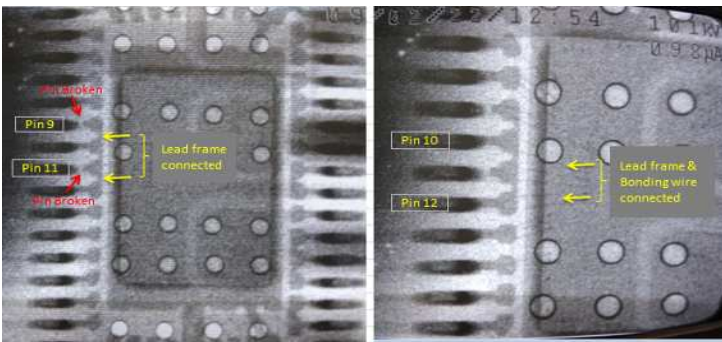
X-ray photo shows lead frame and bonding wire of pin 9 & 11 are still connected

Also, adjacent pins are observed having symptom of overstress

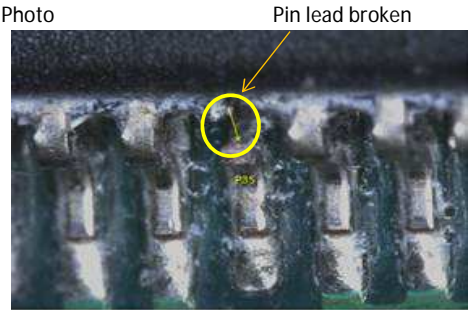
IC #2 : Damp IC pin 35 broken

For this IC, pin 35 is output B pin. So it is unable to check whether the IC is still functioning.

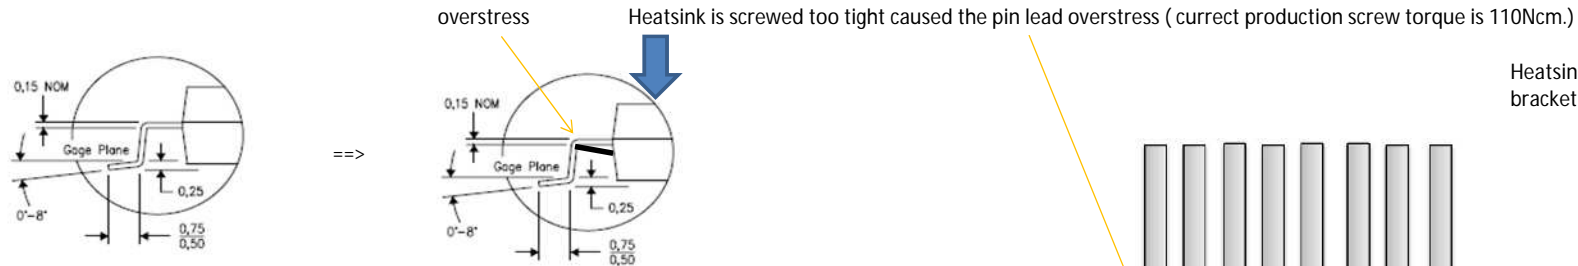
Based on IC#1 phenomena, customer suspect the IC pin lead broken is due to pin lead overstress + the vibration of IC and heatsink

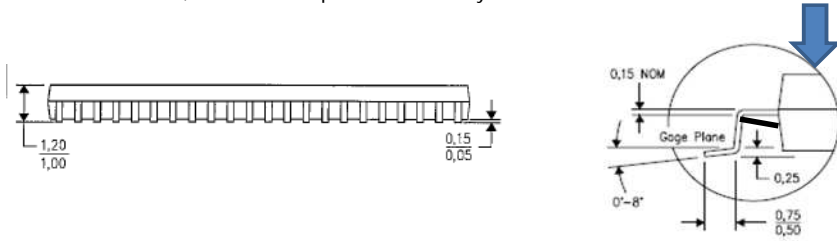
Based on datasheet, the maximum pin lead to IC body is 0.15mm.

What is the maximum displacement before IC lead broken?
Is it possible to simulate ?

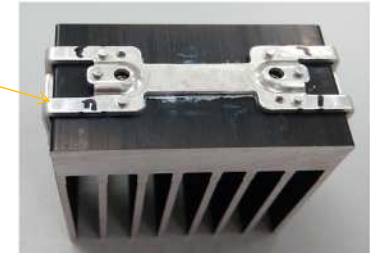
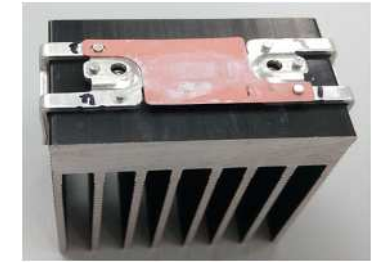
Heatsink bracket

2) Is it possible the vibration of IC or heatsink at resonance frequency caused the IC pin lead broken?

So customer suspect the IC vibrate at resonance frequency and overstress condition causing the pin lead broken.

Also current failure detected so far happened on pins at middle IC. Pins at side of IC may have less vibration due to near to screw points.
