2 X 15W AMPLIFIER FOR PA SYSTEM

APPROVALS	DATE	PROJECT	Smart Systems
ENG: -		*	quarters - Cochin
DSN: -			legality Road,
CHK: -			Trivandrum - 682021, India
		PROJECT REVISION:	DOCUMENT REVISION:
		TITLE:	DESIGN ITEM:
		*	
BOM:		REFERENCE DOCUMENTS	
ASSY DWG:	SIZE:	CAGE CODE:	DWG NO.
FAB DWG:	B		
PCBDWG:	SCALE:	FILE NAME:	40 2X15W AMP.SchDoc
		SHEET:	40 OF 54

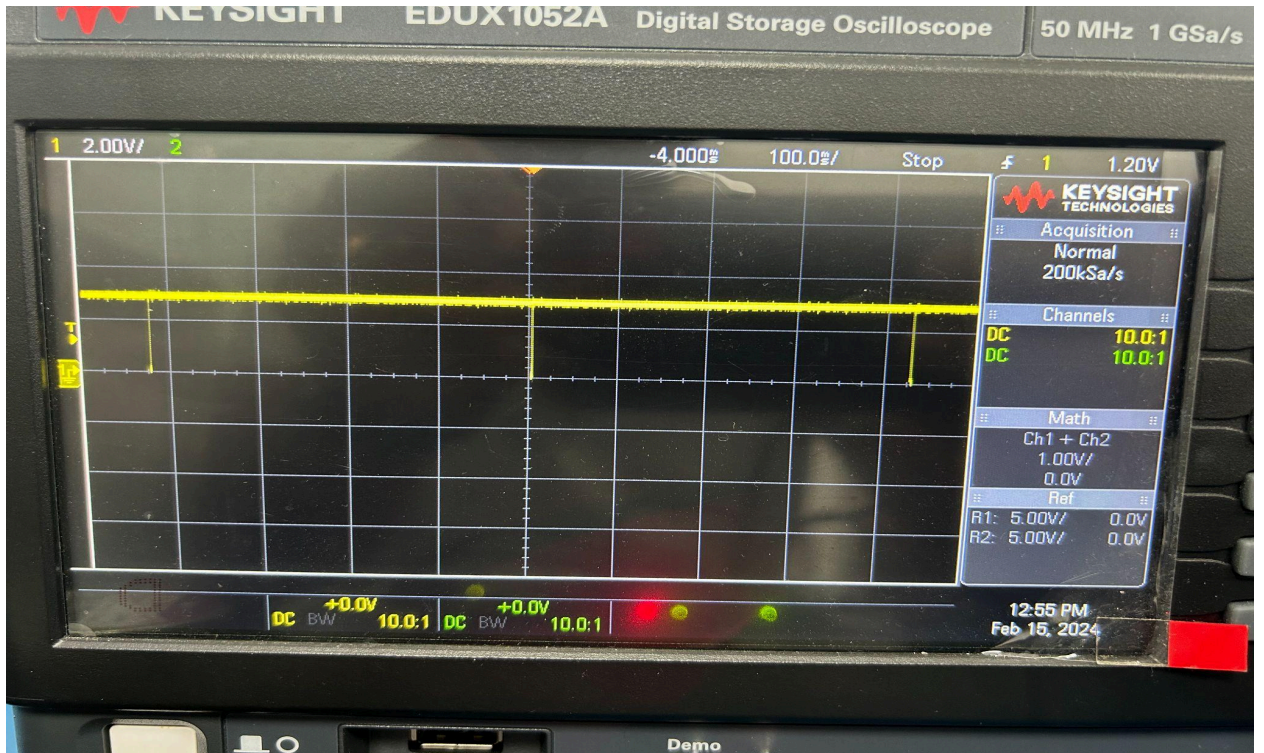
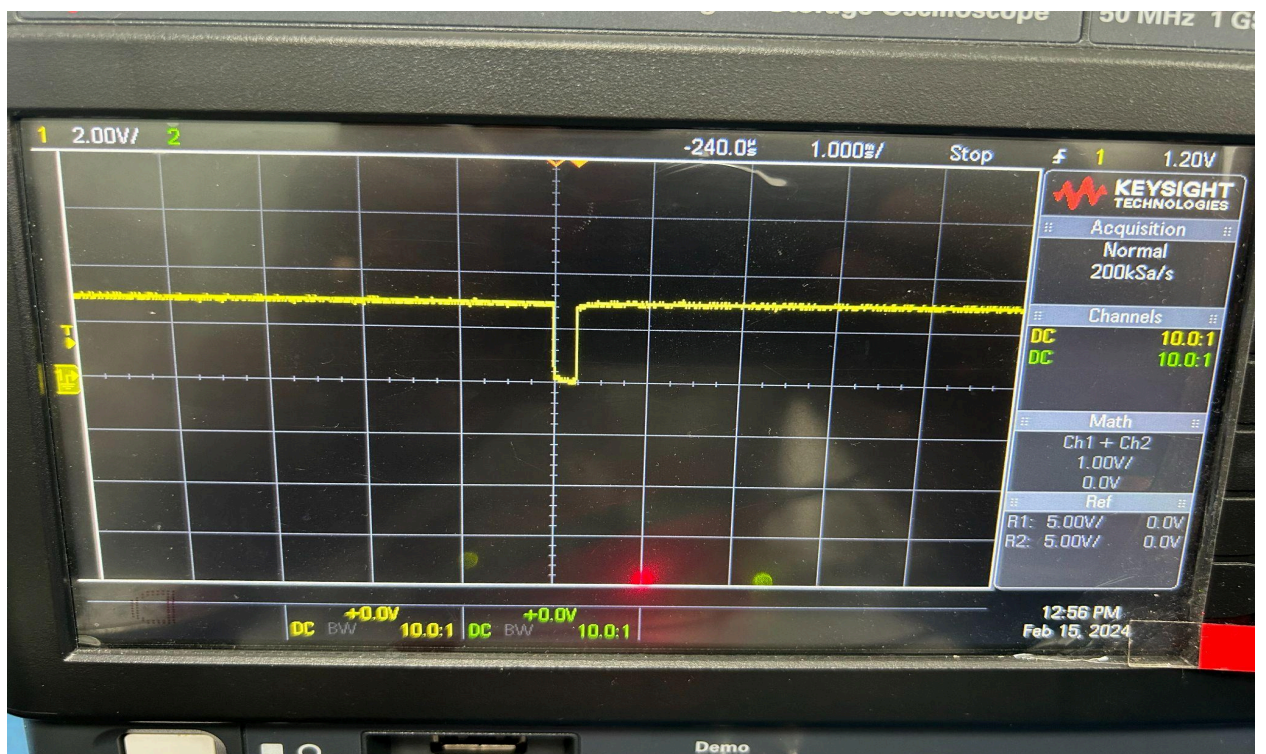
- 1) While probing the LINP and RINP pins without providing any inputs, the pins show 2.5V and then drop to 0V every 420 milliseconds. (Since the SD and FAULT pins are shorted in the circuit, I suspect this behavior is due to the chip restarting because of the DC fault detection.) Is the 2.5V observed the bias voltage?

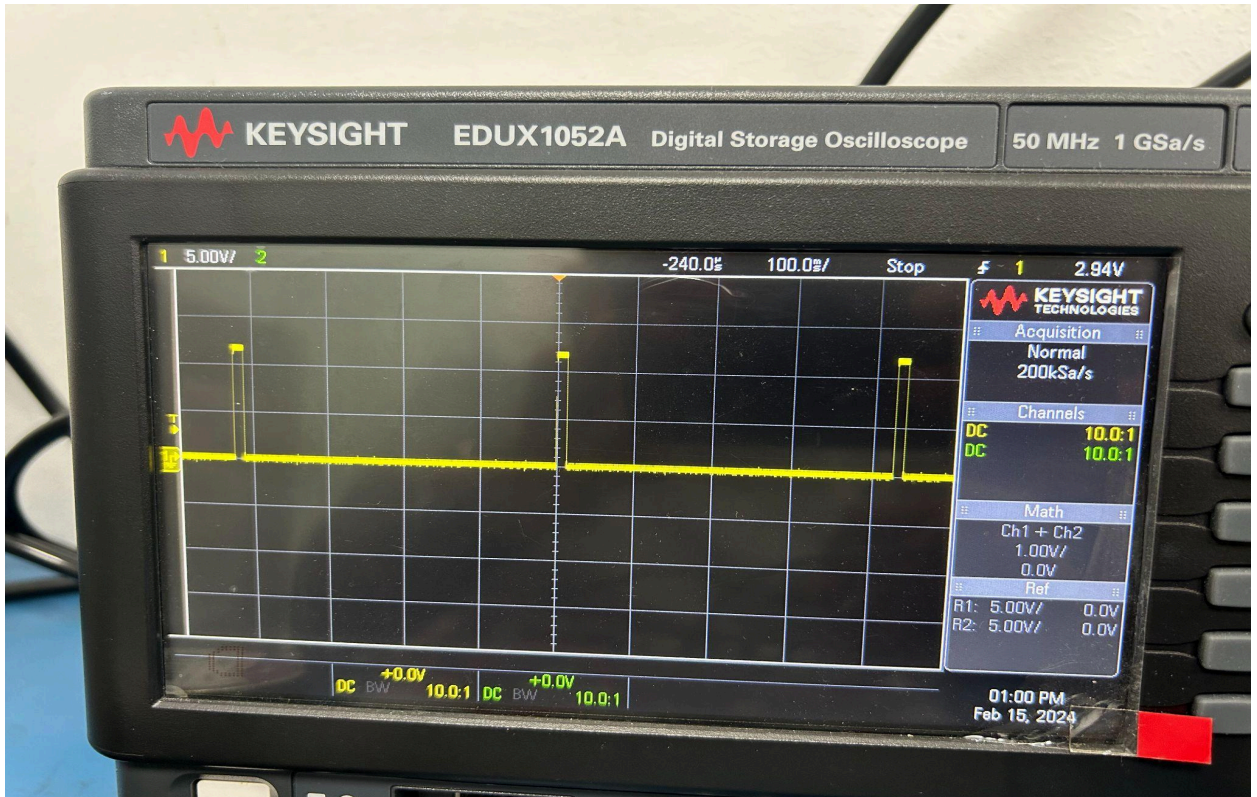
- 2) In our circuit, we have shorted the SD and FAULT pins. While probing these pins, it shows a pulled-down state for 420 milliseconds and released for 2.5 milliseconds. (I believe this is due to a DC fault.)

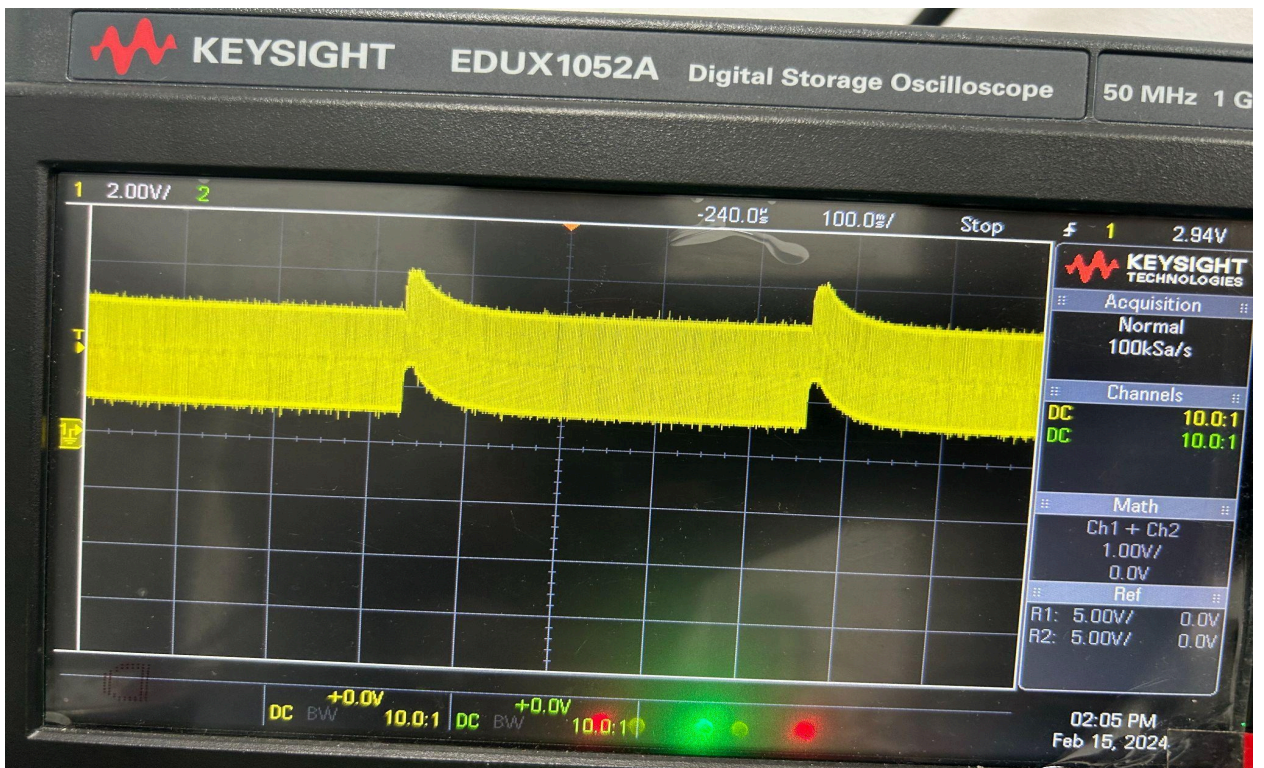
- 3) While providing an input to the LINP and RINP, the probed LINP and RINP voltages are below...

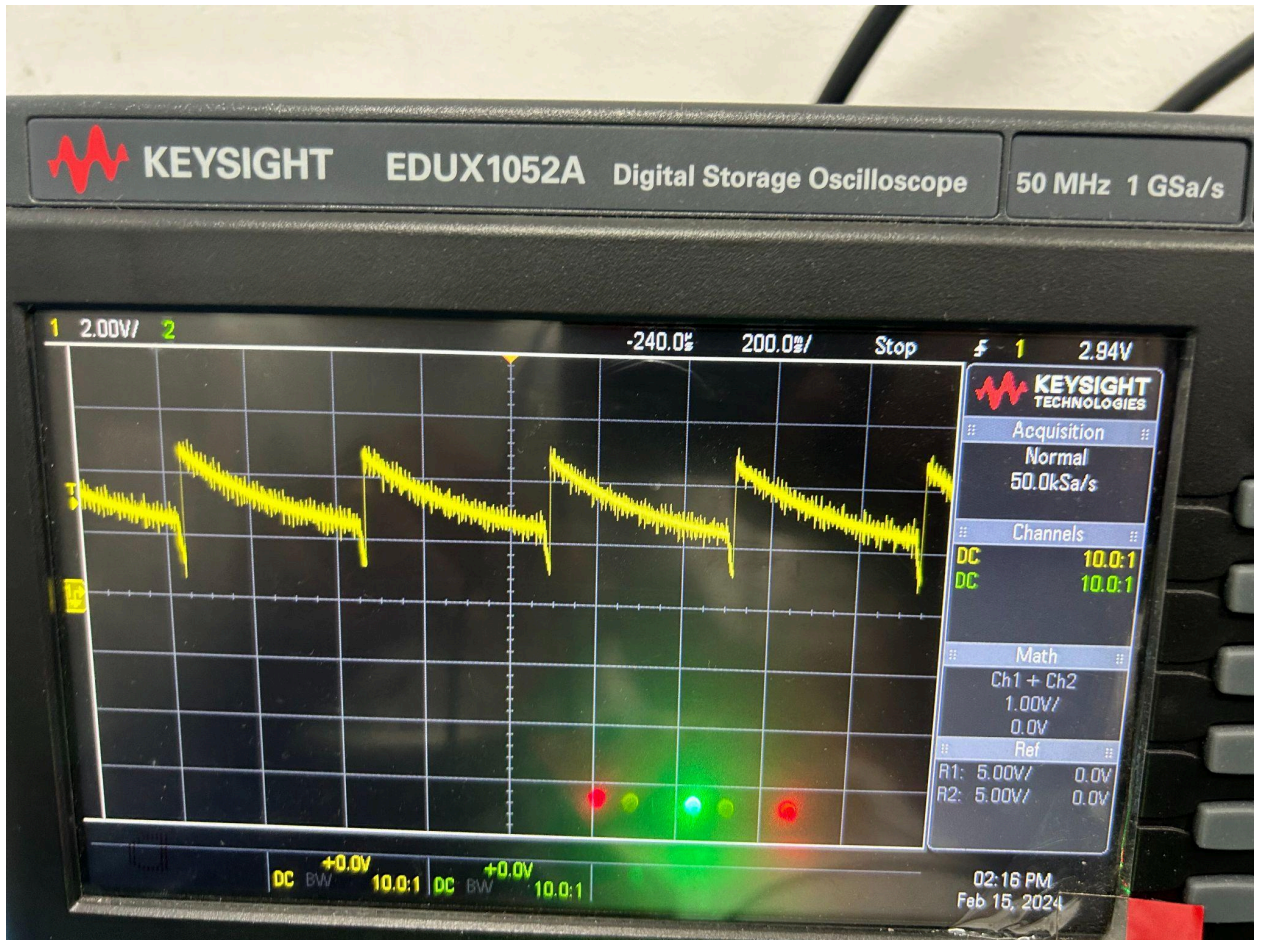
- 4) Probing the speaker point without any data given to LINP and RINP, the speaker terminal shows...
