# Clock issues (EN)

# Clock issues from customers I

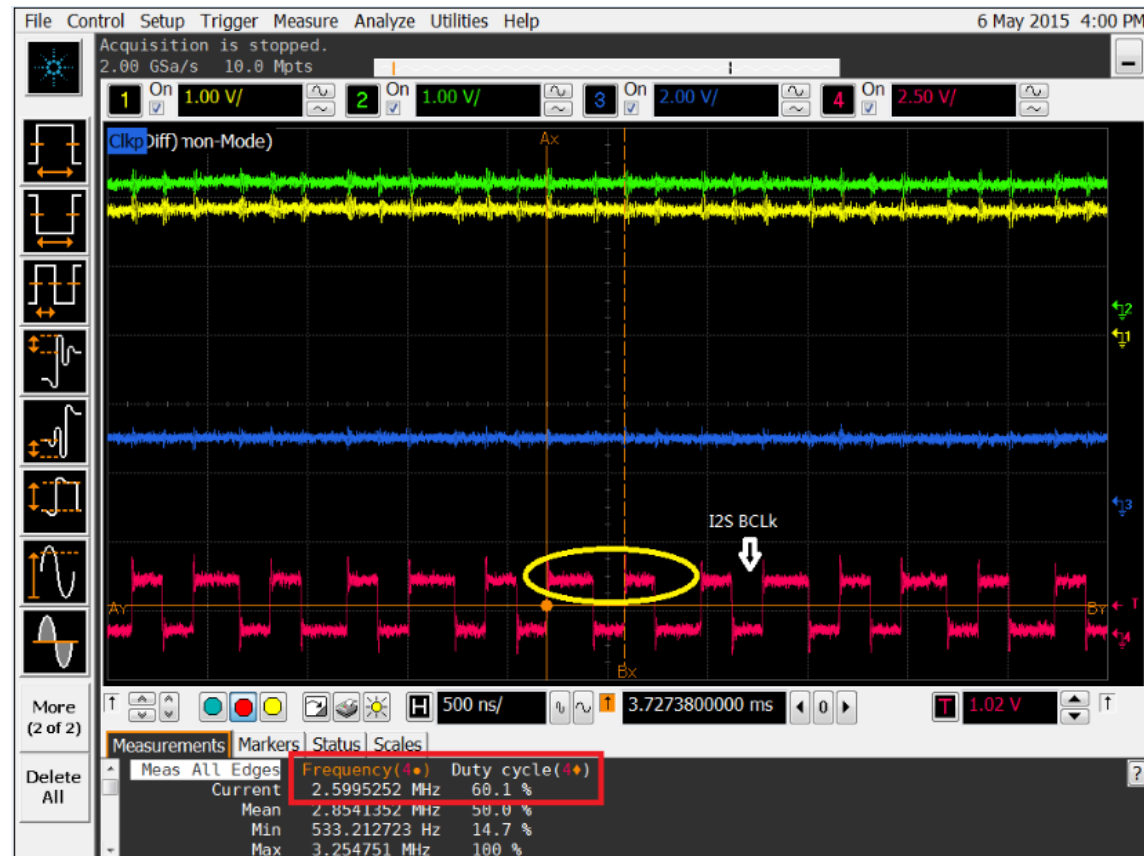
# Clock issues from customers II

- **Case 2: In one mobile phone platform, the freq of I2S BCLK for hand-off tone playback is extremely abnormal during handsfree hangup. The actual value measured by scope in 2.6xxMHz, while the correct value must be 2.822MHz ( $44.1\text{kHz} \times 64$ ) and the duty cycle of the clk is also abnormal, while the correct value must be 50%. See the waveform at next page.**

**Analysis:** I2S clk is one of the important clock sources for smartamp, any issue from I2S clk is the potential risk, which will cause smartamp doesn't work well, such as no sound issue, noise issue audio volum fluctuation, or even speaker voice coil burnt. The duty cycle and freq of bck from the platform is so abnormal that smartamp couldn't work well.

**Solution:** Kindly consult platform vendor for further support.

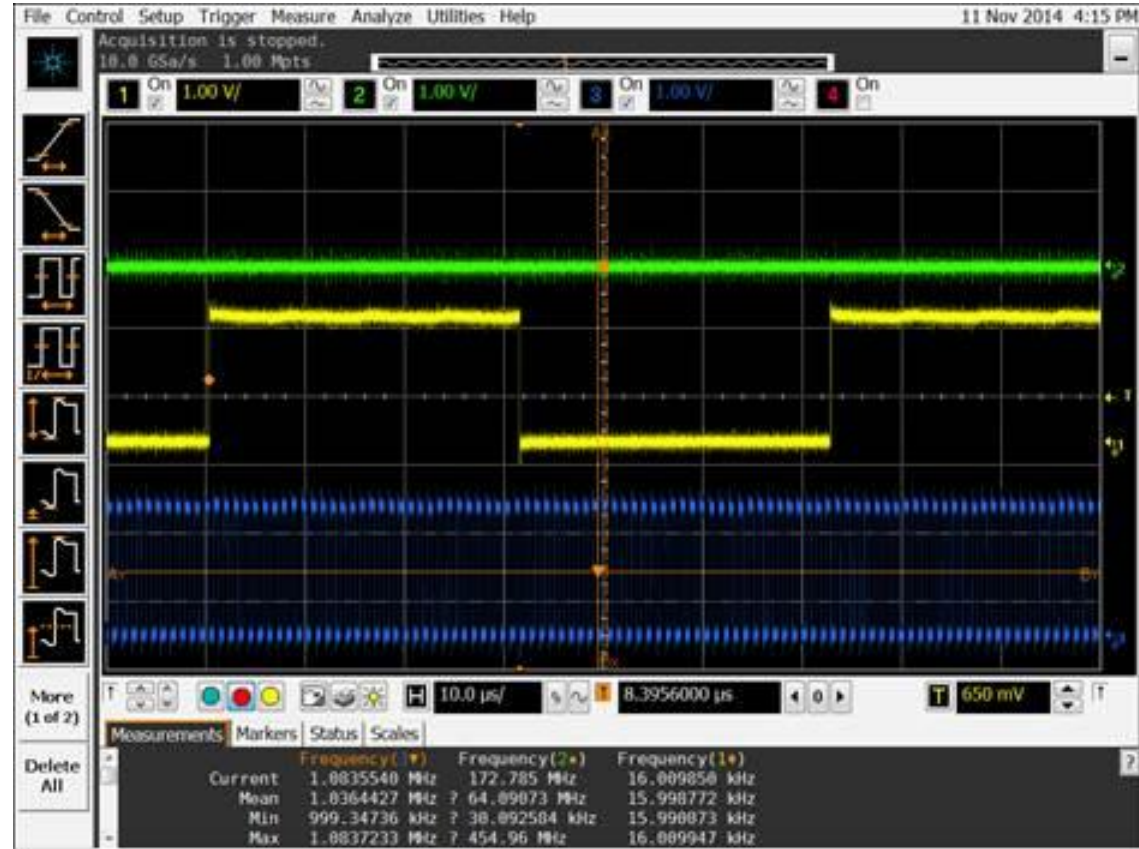
# Clock issues from customers III

- **Case 3:** In one mobile phone platform, the freq of I2S BCLK in mode is extremely unstable, the error is  $\pm 2\%$  of the correct value, which cause dsp can't calculate the correct temperature of the speaker voice coil, finally the voice coil was burnt.

coil temperature

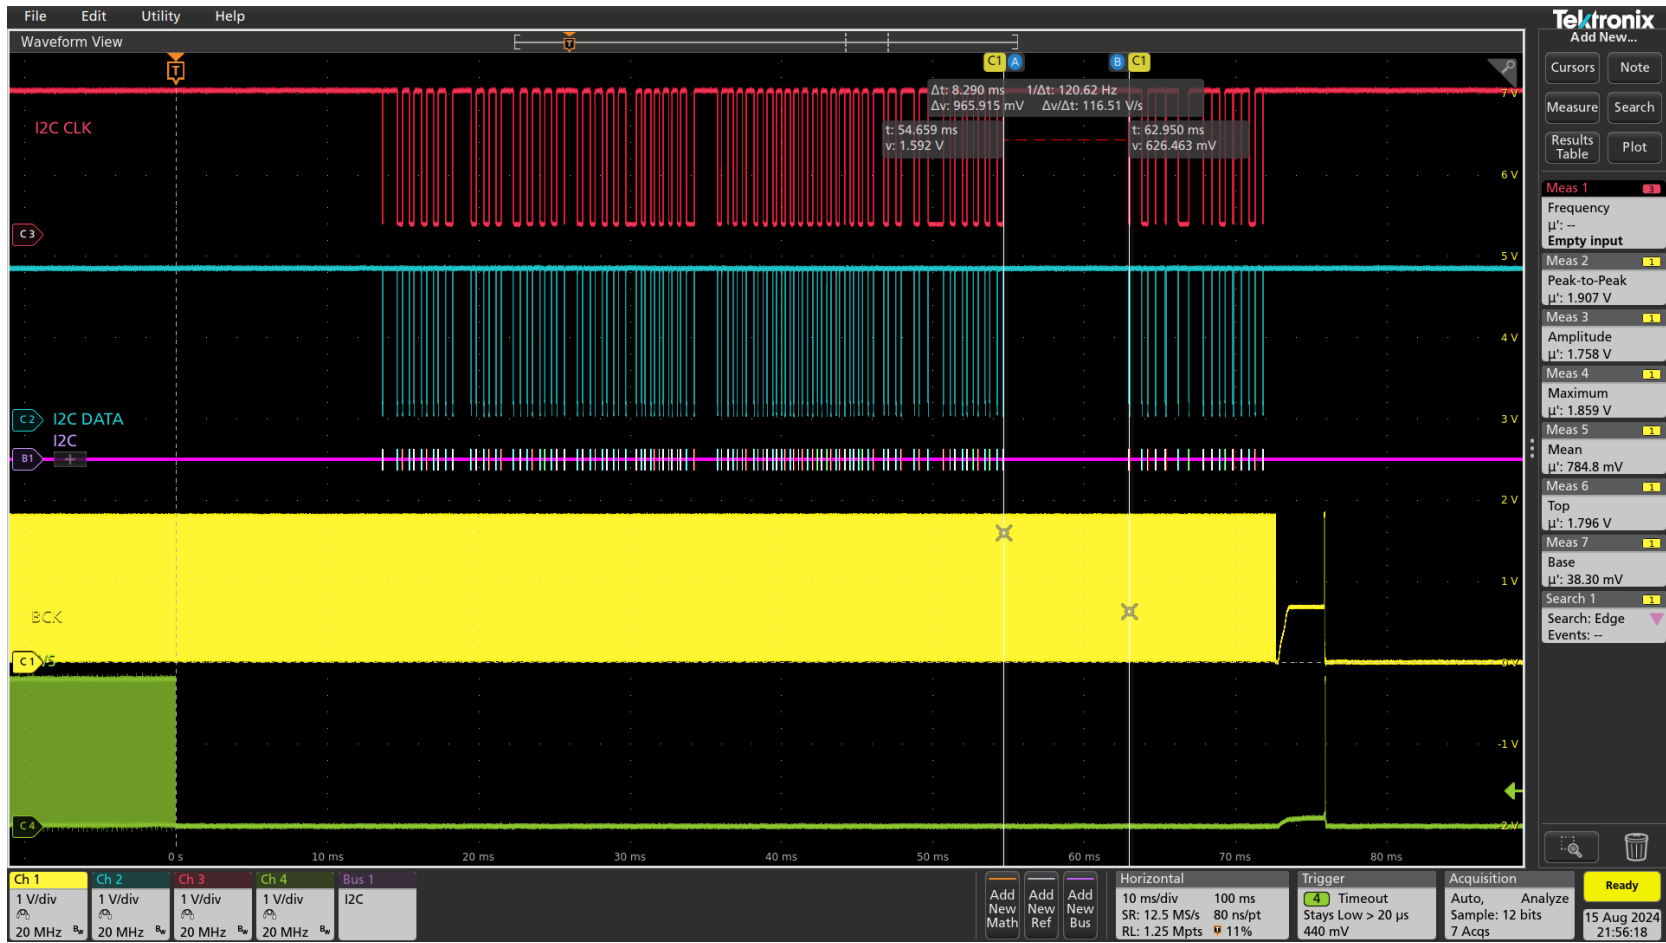
# Clock issues from customers VII | wrong sequence I

The root cause is the i2c/i2s sequence issue during playback pause. After measuring the i2s and i2c clk with scope during, we found that ws clk has been shutdown before tas2563s power off. Sometimes the i2c bck has been already shutdown, while the all of the tas2563s were not shutdown. For the sequence plot, see next three pages, [Clock issues from customers VII | wrong sequence I](#), [Clock issues from customers VIII | wrong sequence II](#), [Clock issues from customers IX | wrong sequence III](#).

After consultant from platform vendor, this sequence issue has been fixed. For the correct power off sequence, see [Clock issues from customers X | correct sequence](#).
