# measurement environment

# Oscilloscope observation of SDI and SDO of a **single** ADC

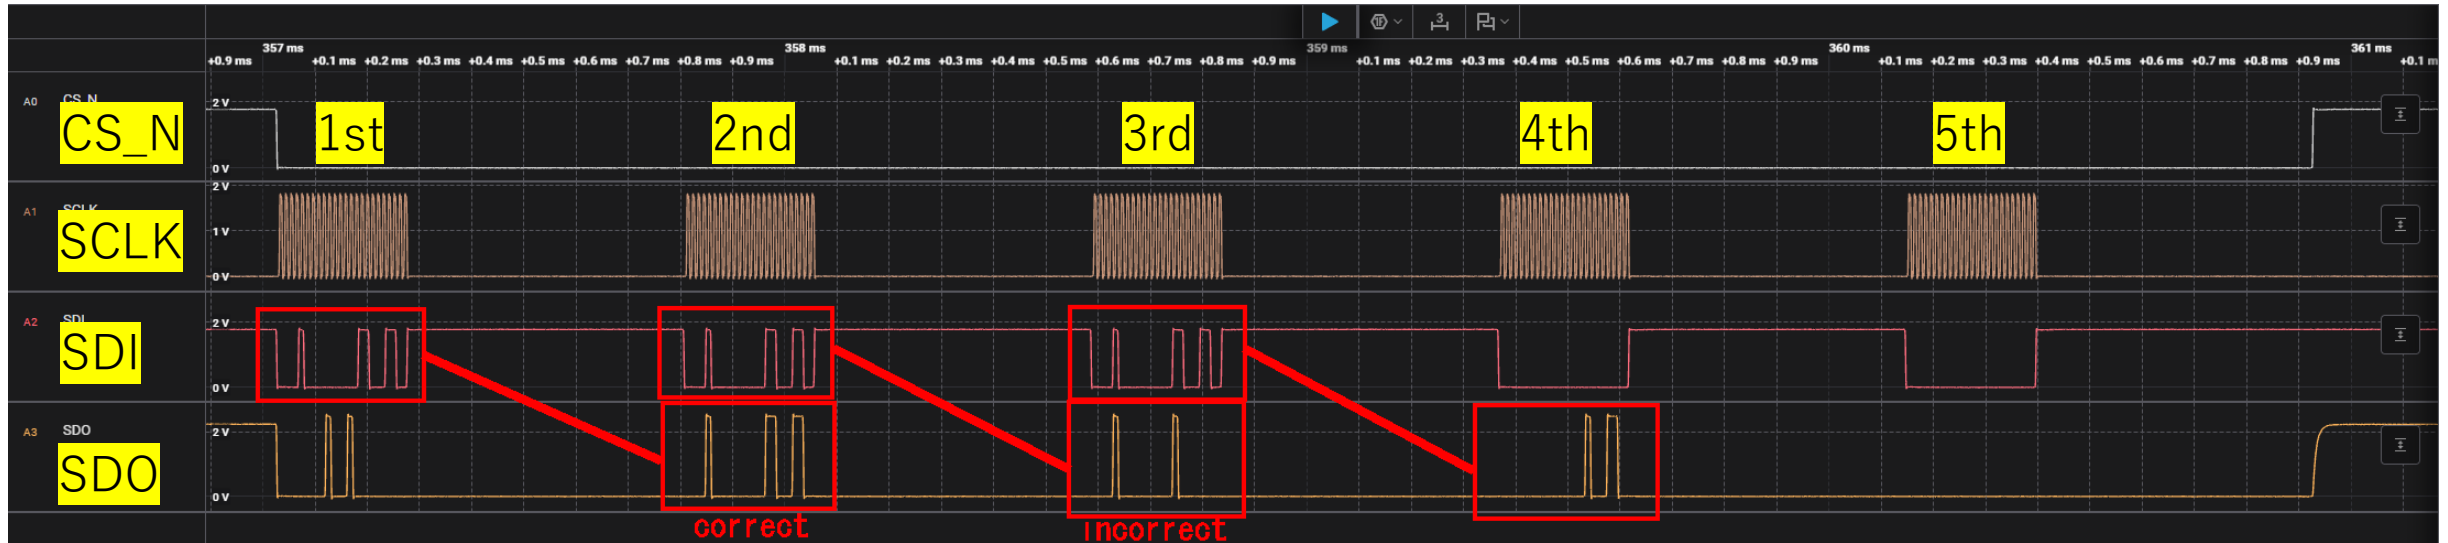
This shows the SDI and SDO signals of a single ADC.  
The waveform represents five frames captured using an analog logic analyzer.

The SCLK frequency is 100 kHz, and the sampling is 2.5 MS/s.

It works fine up until the second frame, so in a daisy chain configuration, the second ADC works fine, but the third ADC doesn't.

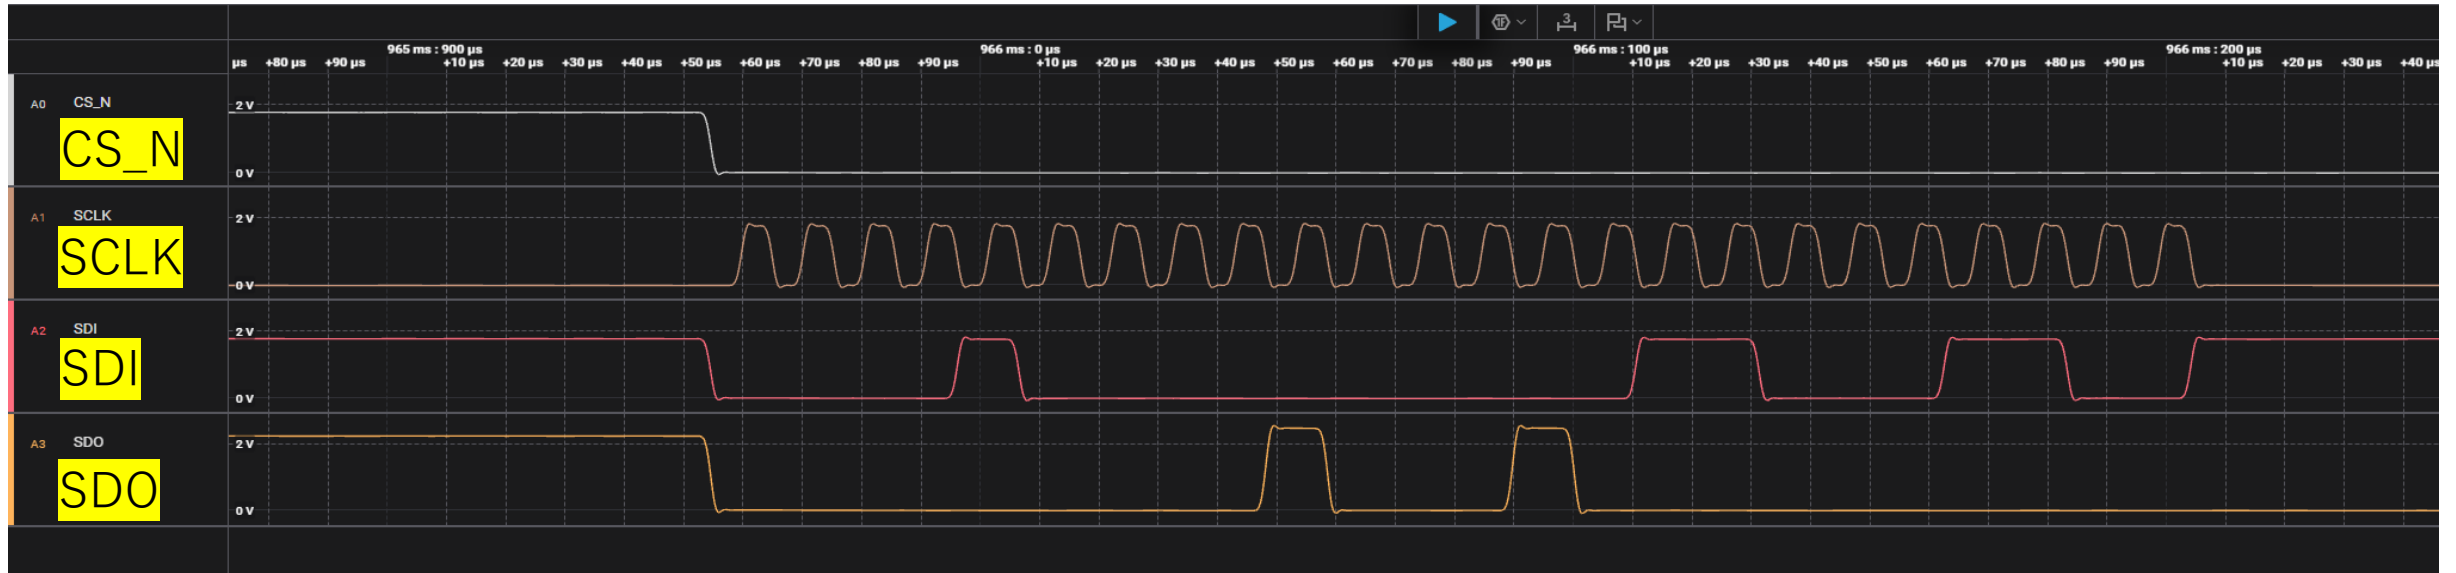
This is the waveform of the 1st frame captured with an analog logic analyzer.

The SCLK frequency is 100 kHz, and the sampling frequency is 2.5 MHz.

SDI is supposed to be latched on the rising edge of SCLK.

Since SDI does not change around the rising edge of SCLK, sufficient setup and hold times are ensured.

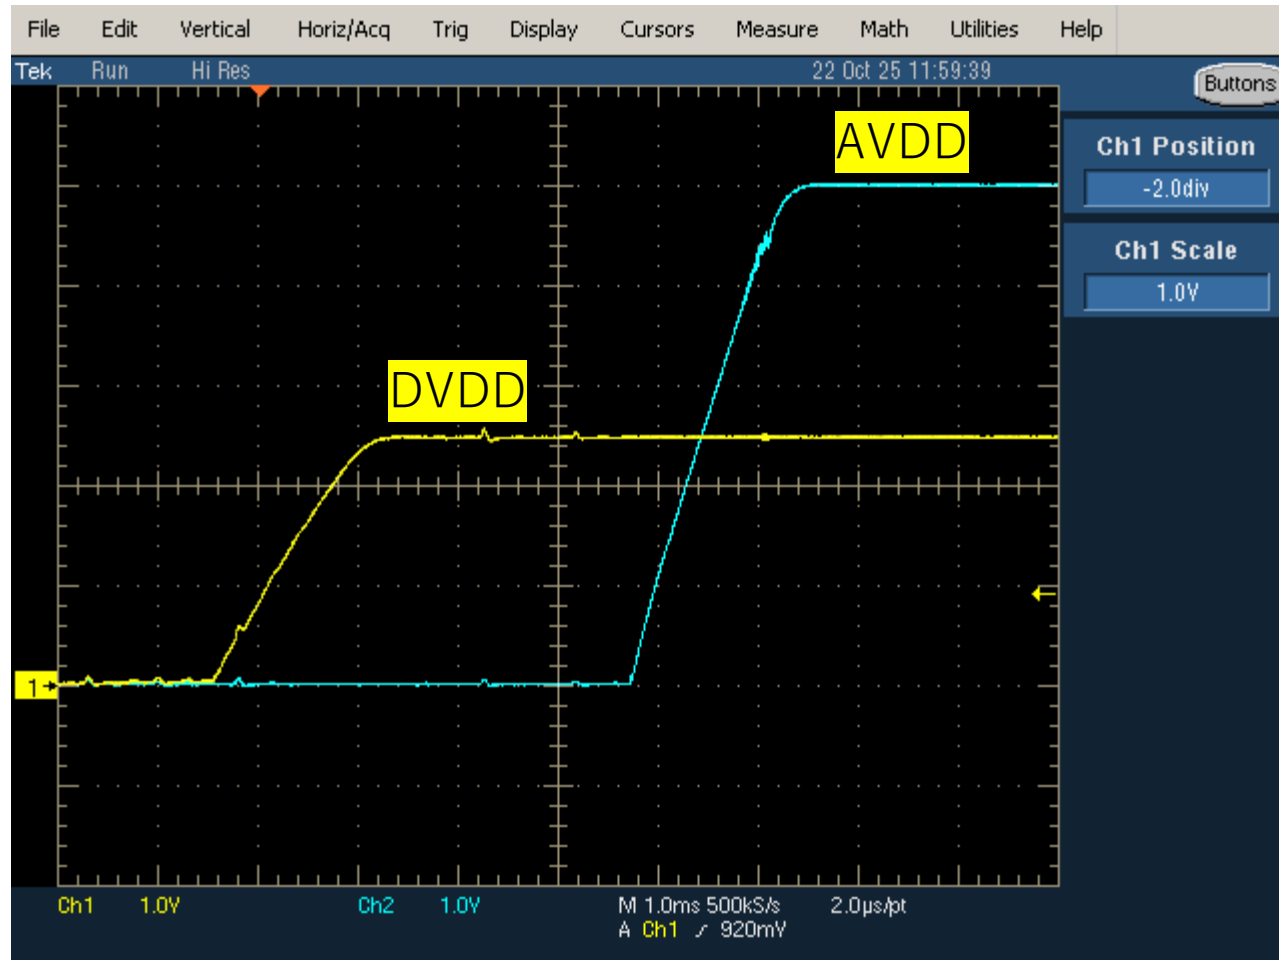
# Power-up waveform of the ADC

1V/Div 1ms/DIV

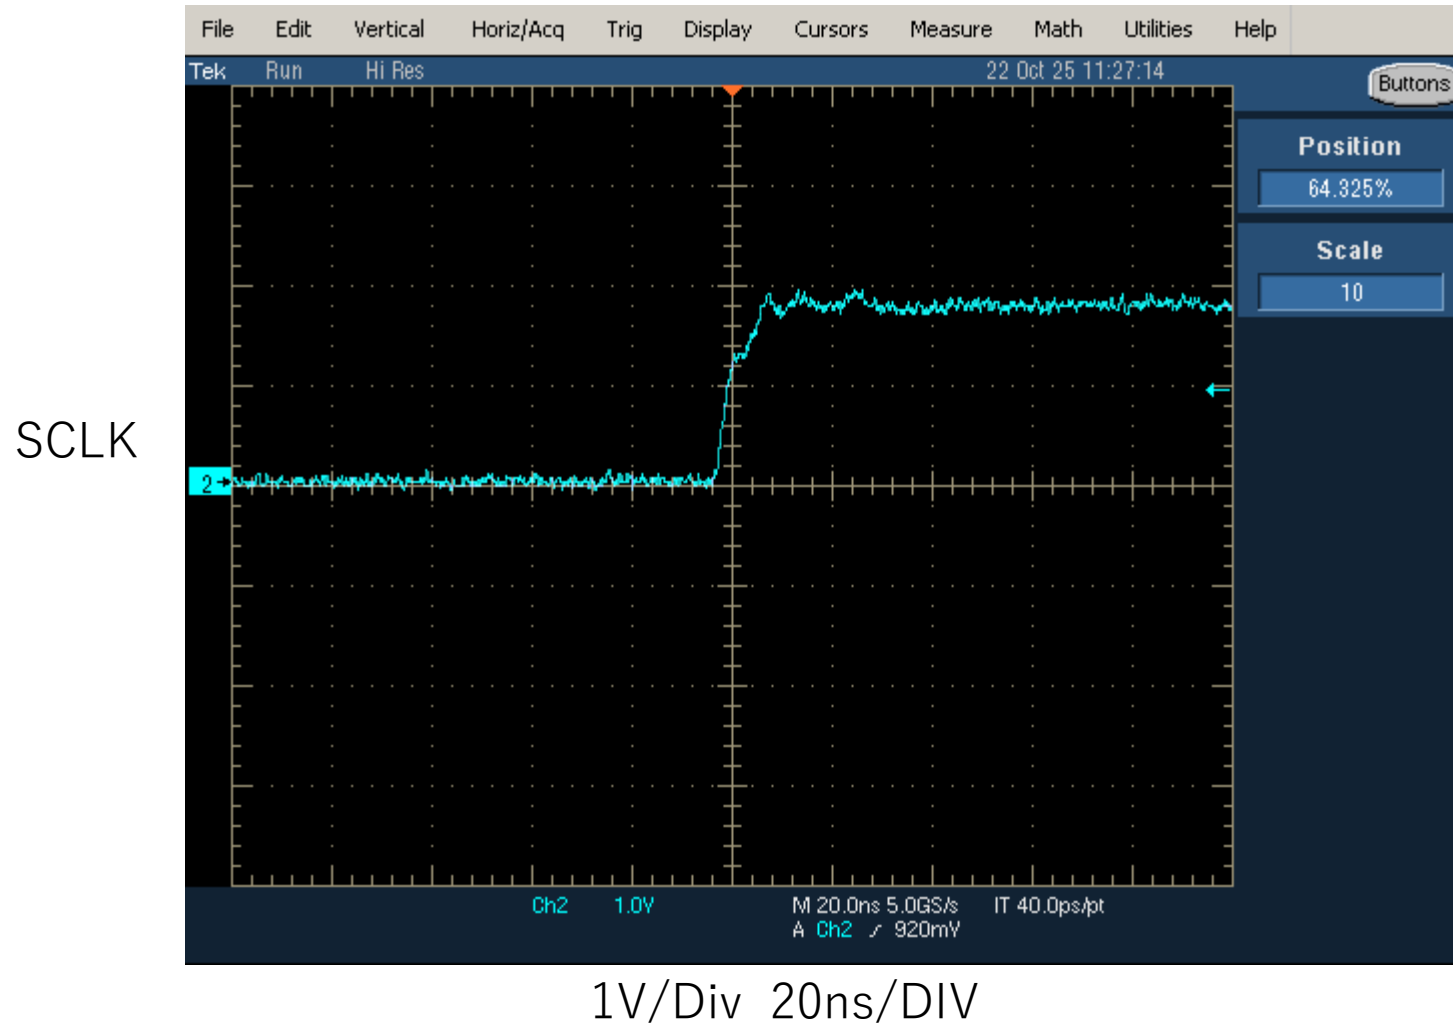
This is the rising-edge waveform of SCLK.

The in-house developed board and the official evaluation board use different signal input paths, but the same issue occurs on both.

Even when varying the SCLK slew rate and the damping resistor, data corruption occurs on the SDO of the 3rd frame.

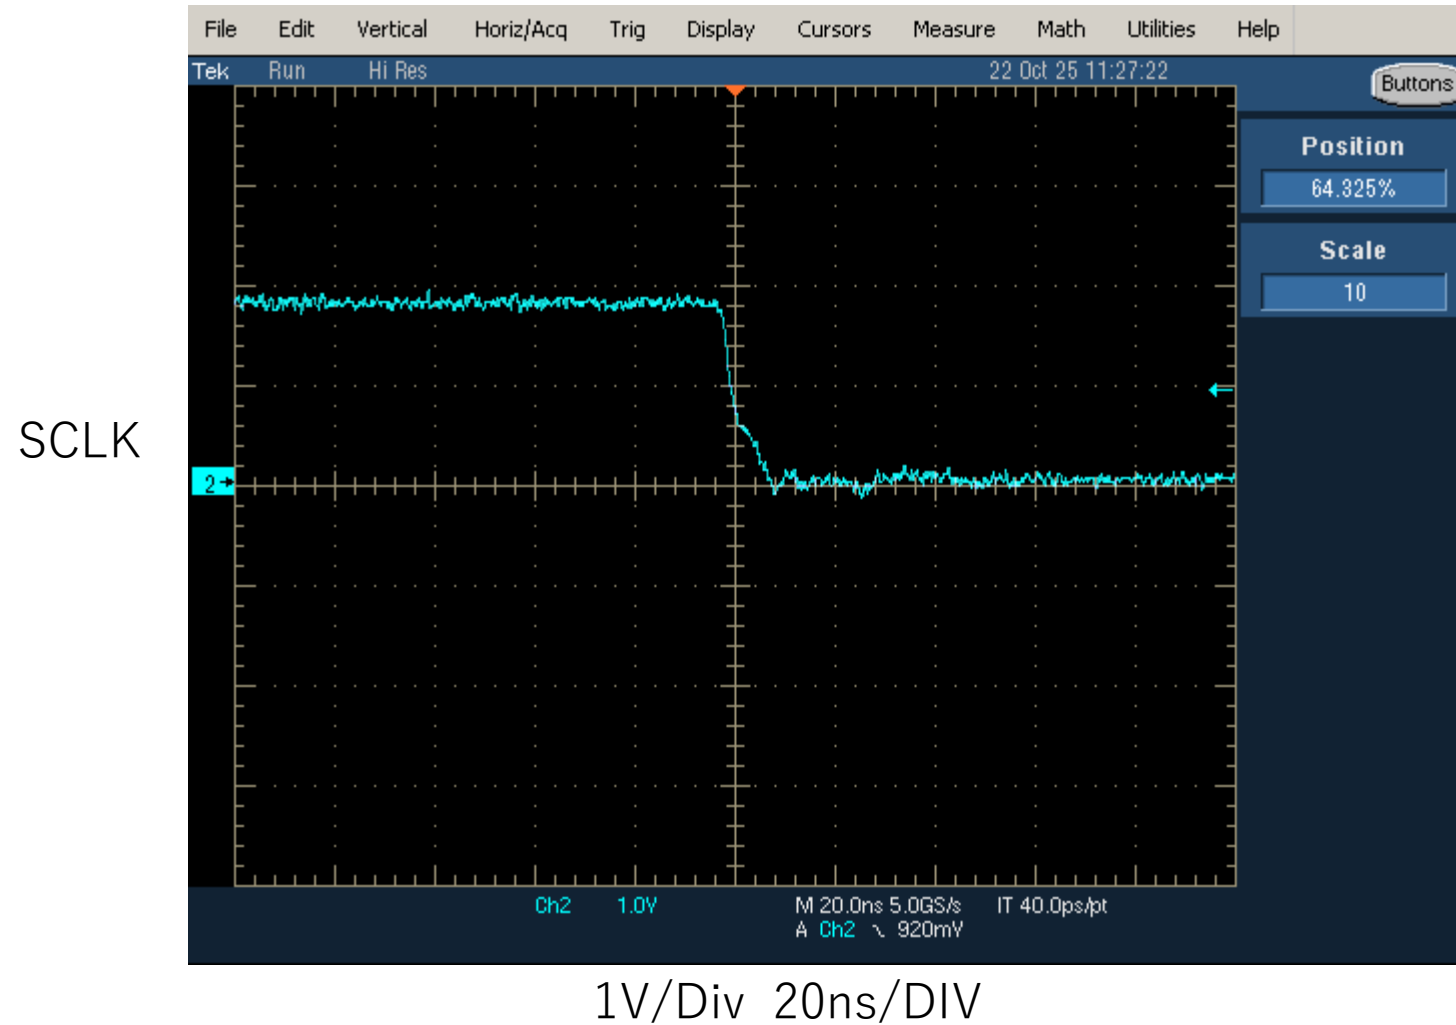
This is the falling-edge waveform of SCLK.

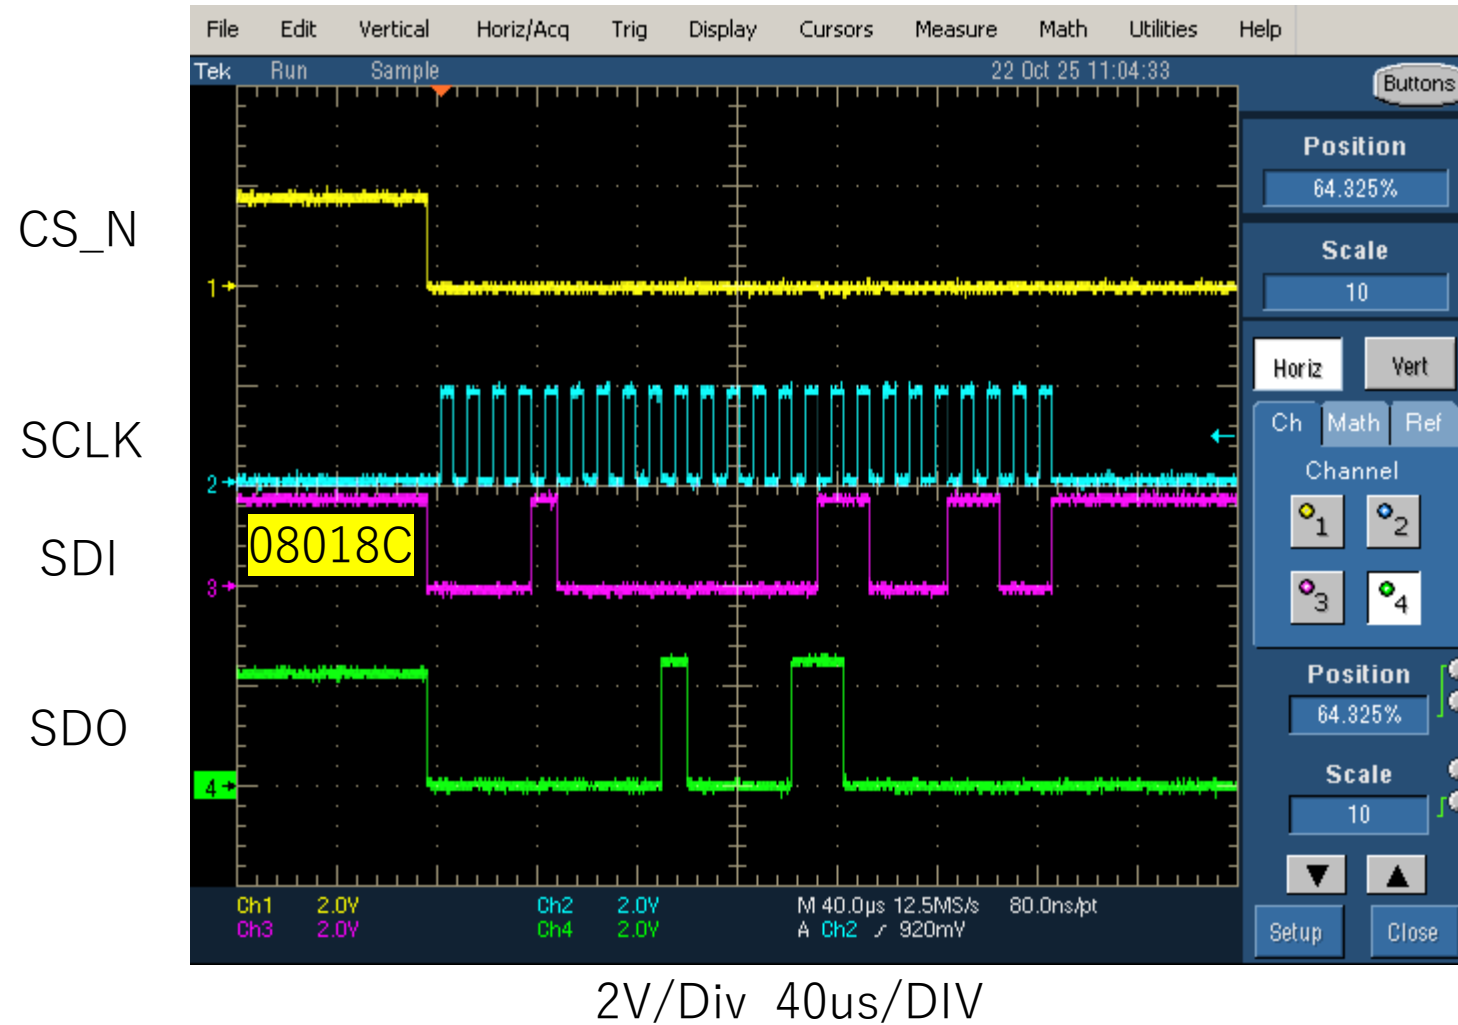
This is an enlarged view of the 1st frame.

08018C is applied to the SDI input during the 1st frame.

Garbage data ? appears on the SDO.

The SCLK frequency is 100 kHz.

SDI is supposed to be latched on the rising edge of SCLK.  
Since SDI does not change around the rising edge of SCLK, sufficient setup and hold times are ensured.

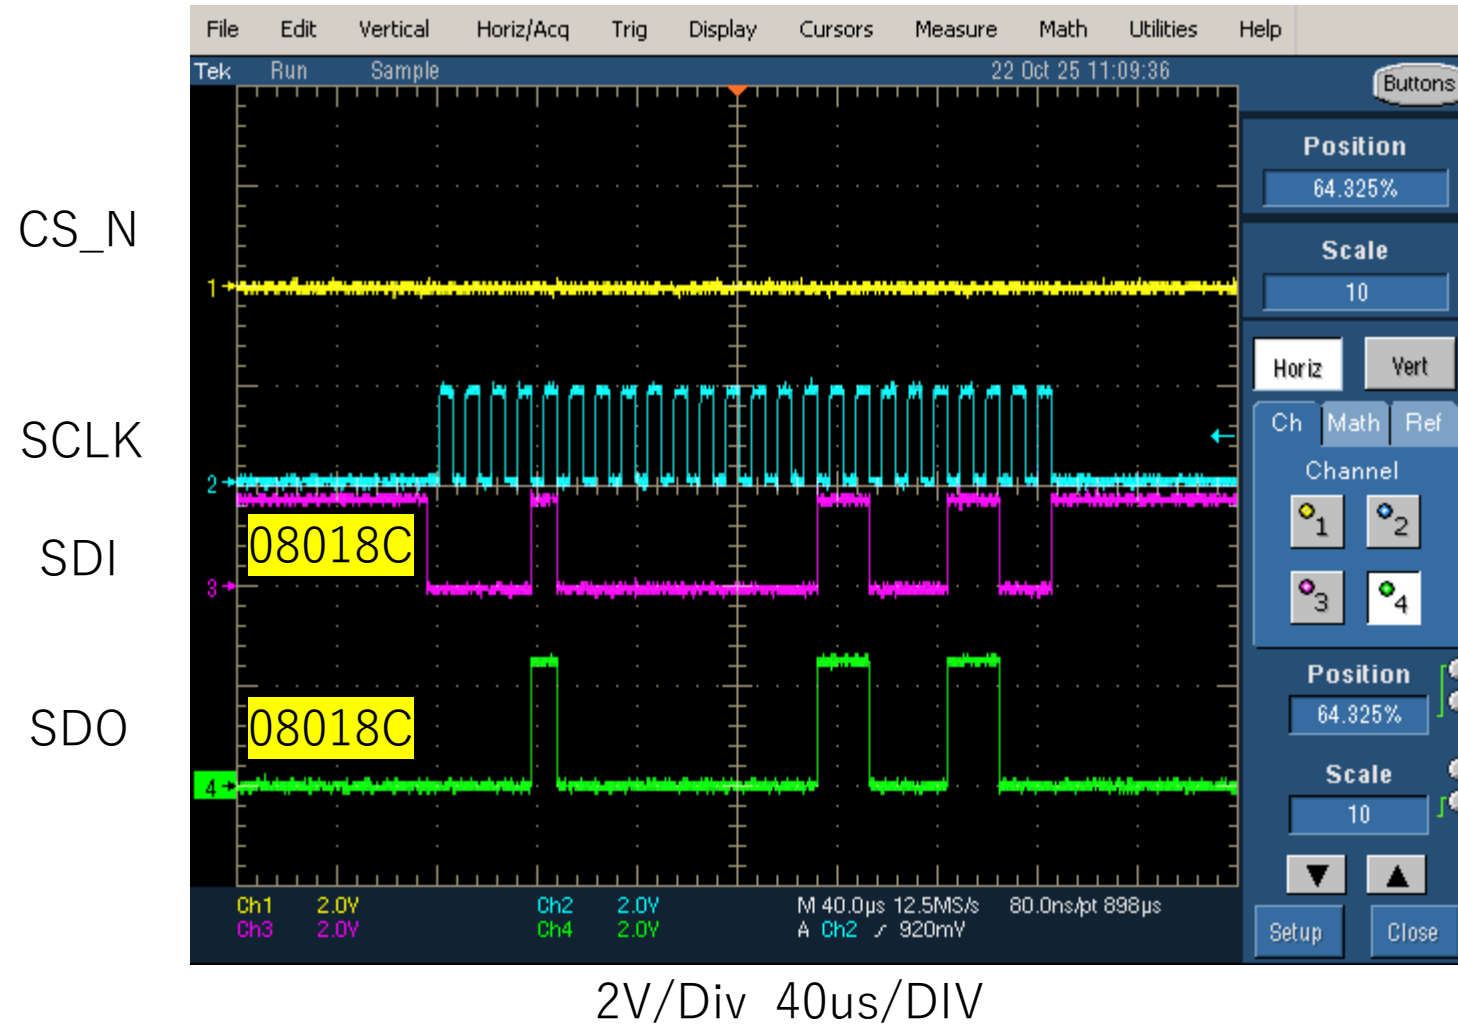
This is an enlarged view of the 2nd frame.

08018C is applied to the SDI input during the 2nd frame.

08018C is output from the SDO. It is the data written in the 1st frame.

This behavior is correct.

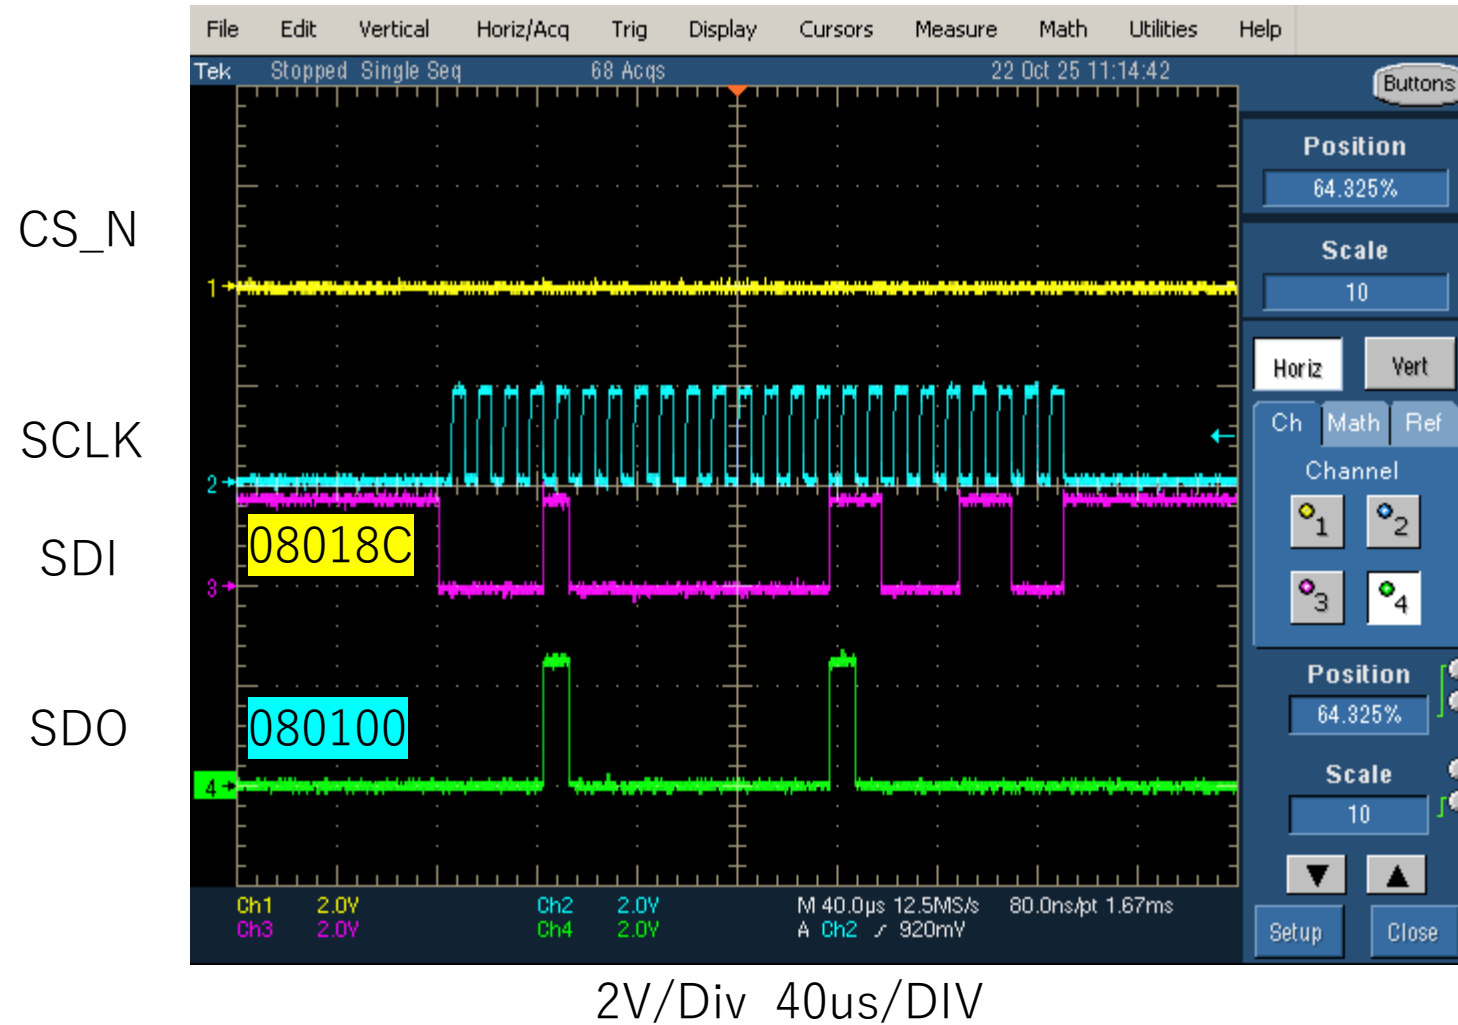
This is an enlarged view of the 3rd frame.

08018C is applied to the SDI input during the 3rd frame.

080100 is output from the SDO.  
**This behavior is incorrect.**

When daisy-chained, the SDO of the 2nd frame is correct, but the SDO of the 3rd frame becomes corrupted. Therefore, the second ADC in the daisy chain operates correctly, whereas the third ADC operates incorrectly.

**These are measurements from a single ADC, which leads to the conclusion that daisy chaining more than three ADCs is not possible.**

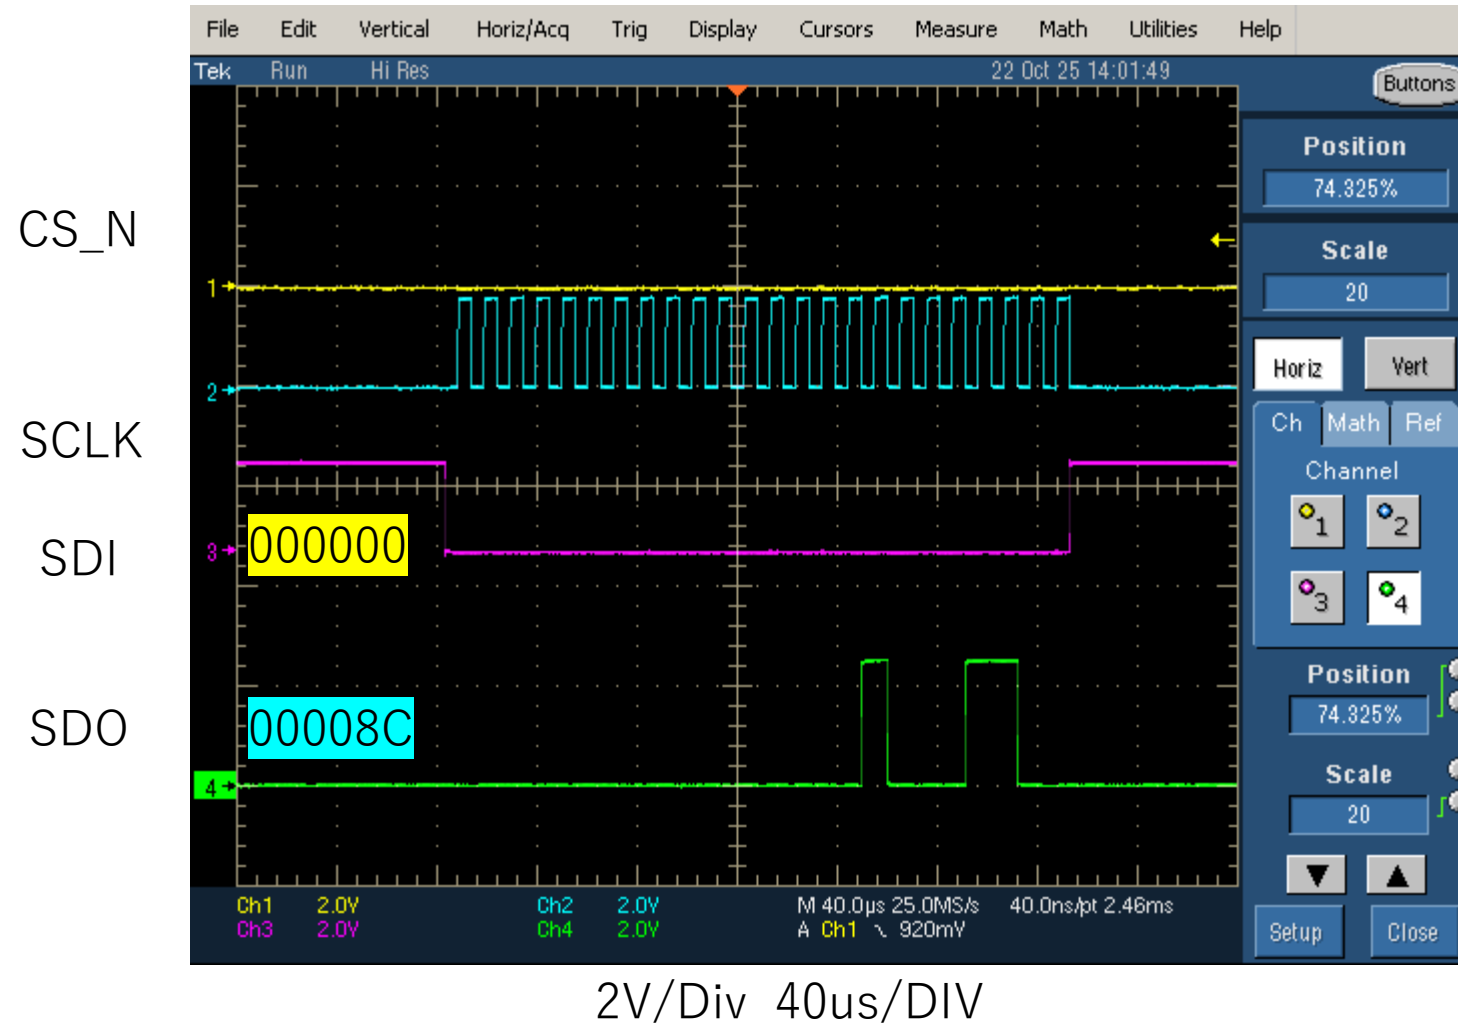
This is an enlarged view of the 4th frame.

SDO should be 000000.

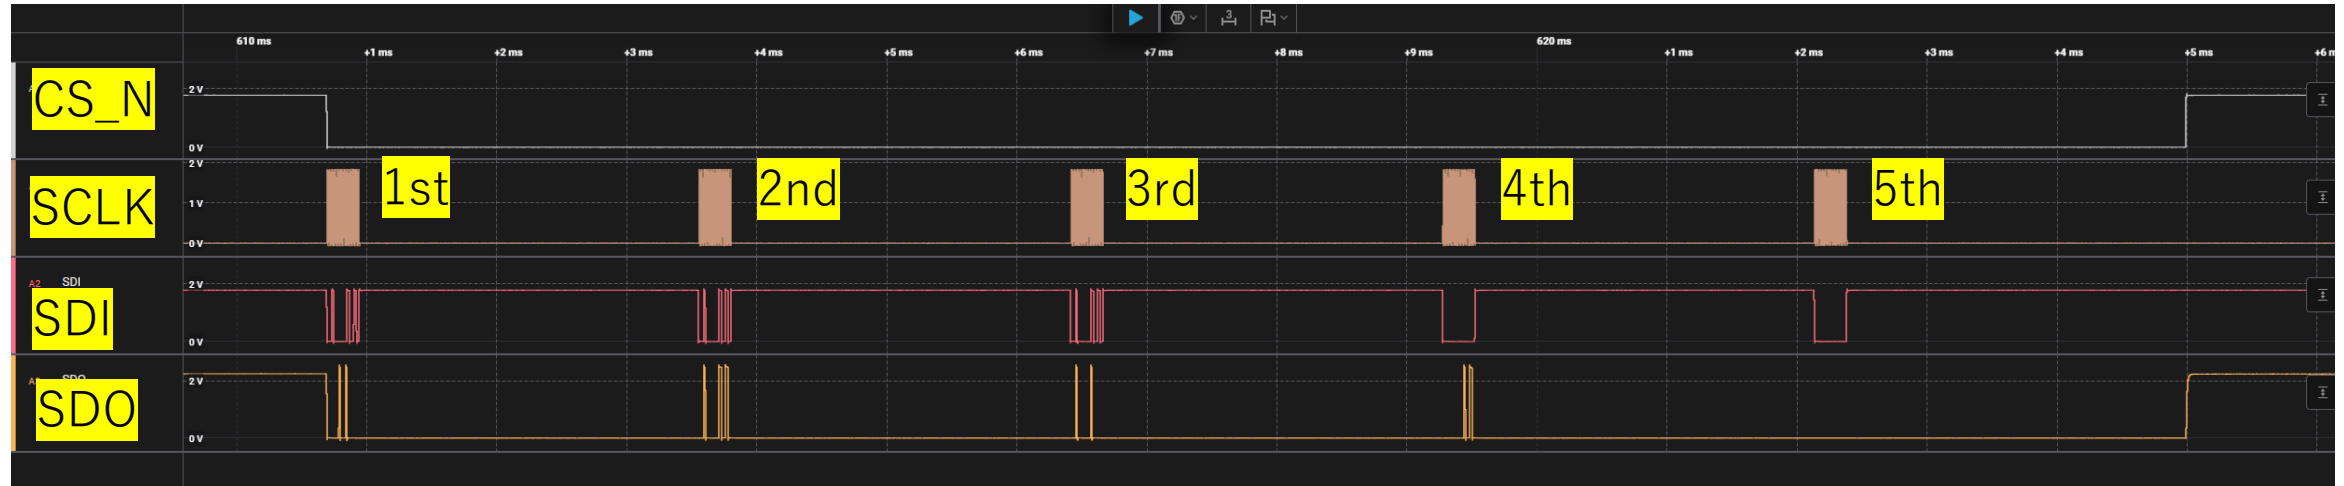
This shows the SDI and SDO signals of a single ADC.  
Increased the wait time between frames.

The result is unchanged.
