# [Issue description]

- DSP hangs up suddenly during image drawing. The issue is observed on two boards so far.
- These failing boards show below behaviors.
  - The issue occurrence seems depending on the condition when these boards are power cycled.
    - Whenever the issue happens, DVDD15(+1.5V\_A) current is ~70mA smaller than normal case.
    - If DVDD15 current is normal, the issue never happens until next power cycle.

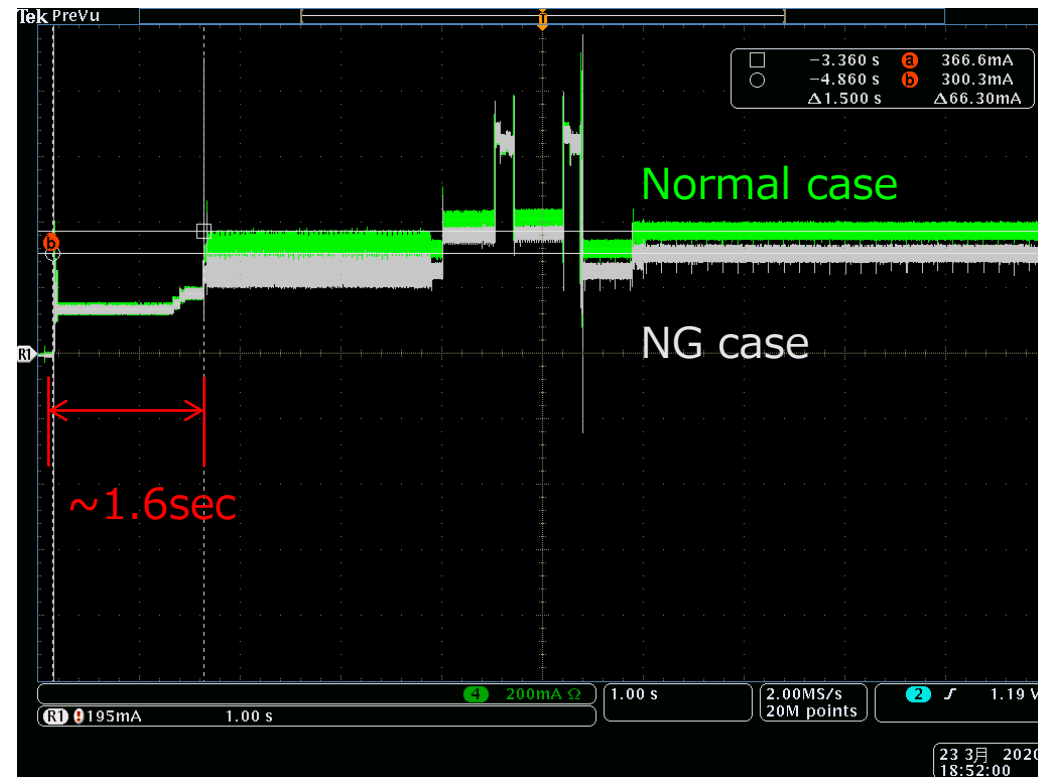
DVDD15 current

| | Meas. point | Current[mA] | |
|---|---|---|---|
| DVDD15/VDDR1-4 (+1.5V_A) | FB15 | <b>300</b> | <b>376</b> |

~70mA difference

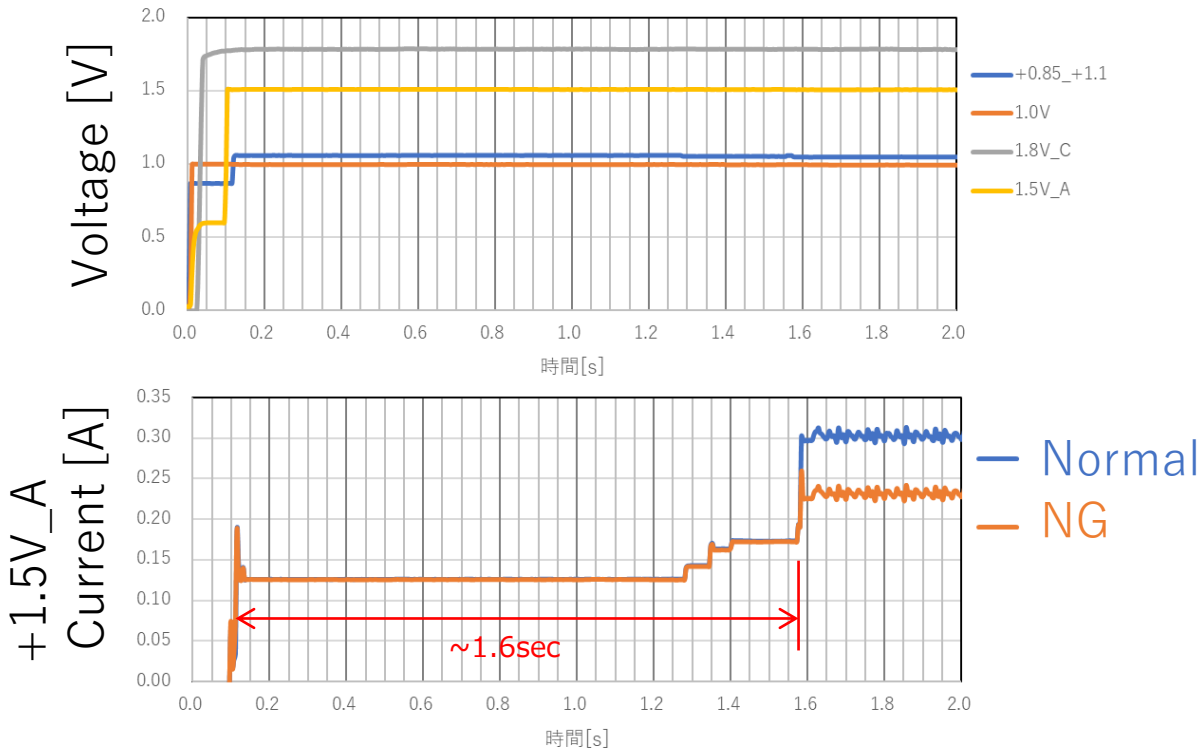
The current difference is observed  $\sim 1.6\text{sec}$  after CVDD(+0.85\_+1.1) is on.

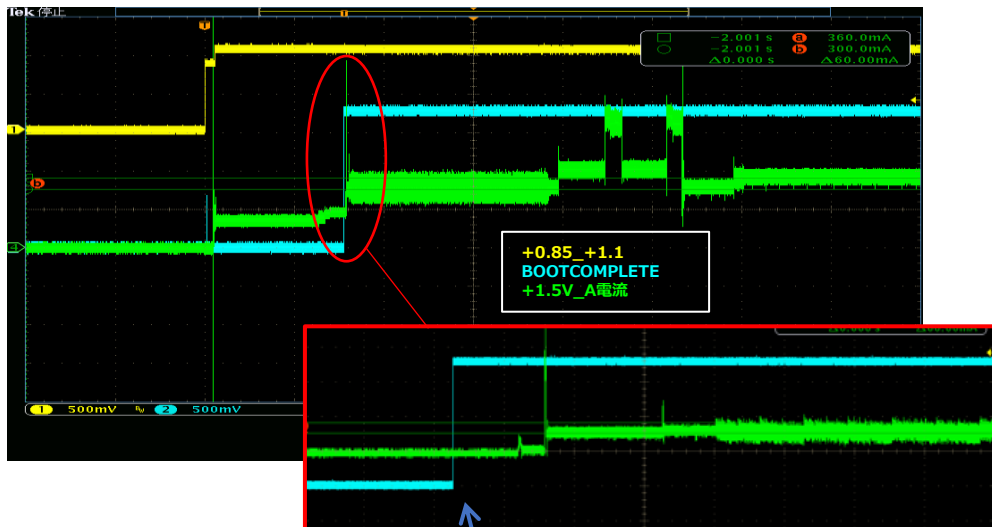
Change the timing when BOOTCOMPLETE is asserted, then found the current change is observed during step#2 above.

BOOTCOMPLETE is just after step#1

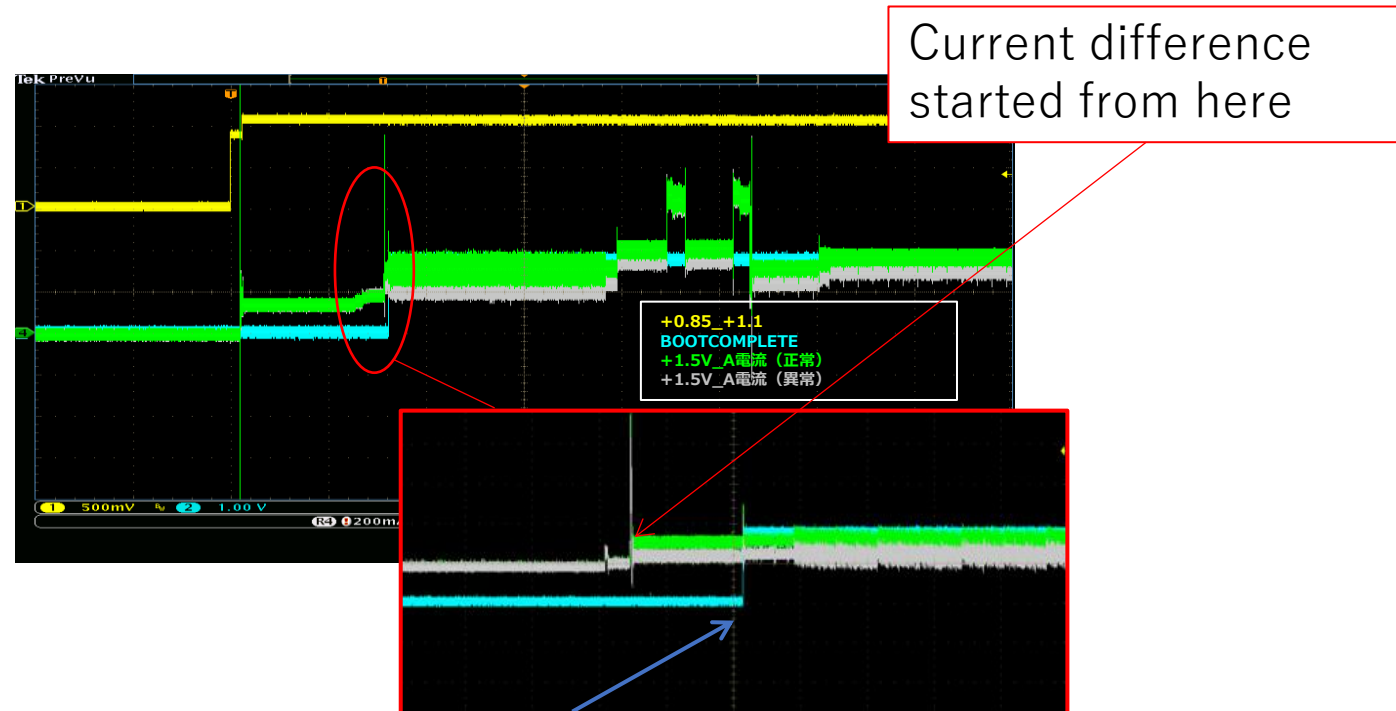
BOOTCOMPLETE is just after step#2

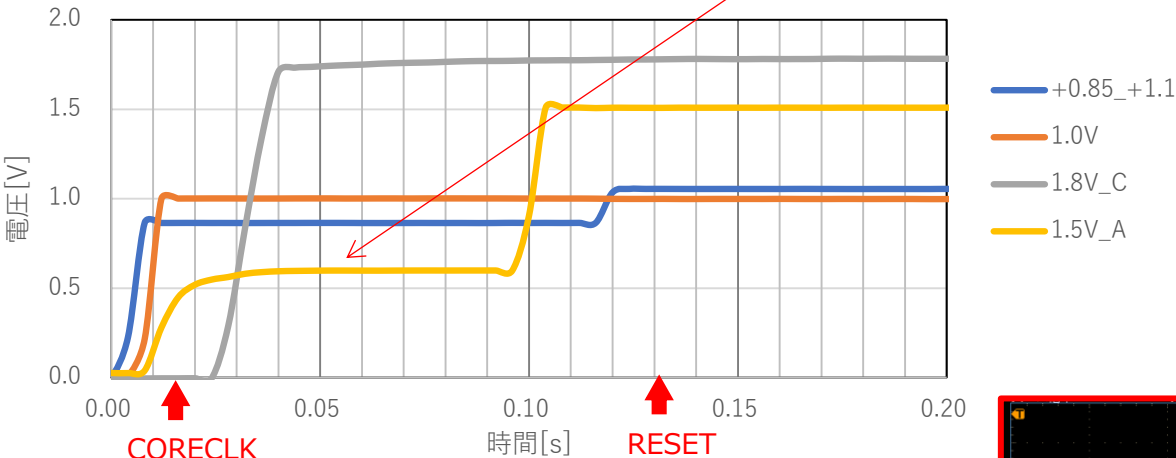
Figure.1

Power-up sequence is the same for both normal case and NG case.
