Centaurus FAE alert

Affected devices

XAM3874BCYE
TMX320DM8148BCYE
TMX320C6A8148BCYE
XDRA6XXBCYE

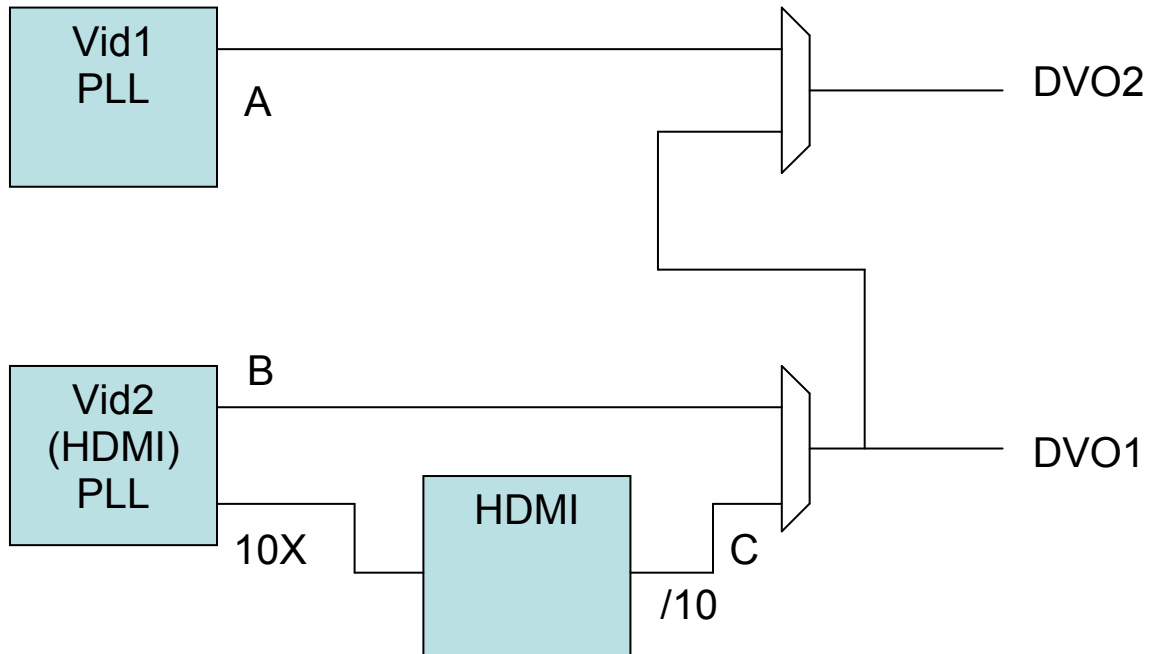
The following clock diagram shows the potential clock sources for each output...

From this diagram it can be seen that DVO2 clock source can be selected from either Vid1 PLL or Vid2 PLL but DVO1 and the HDMI core can only be sourced from Vid2 PLL.

PSP 04.01.00.06 Patch2 release will have the software to configure Vid1 PLL and Vid2 PLL into their higher operating frequencies for given output pixel frequencies to reduce the clock jitter accordingly.
