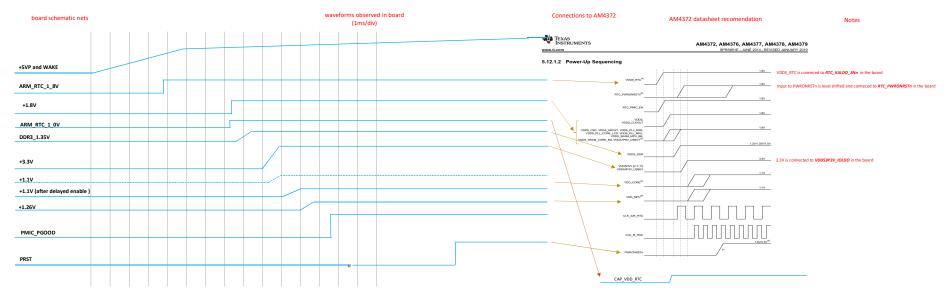
Initially observed that 1.1V is rising along with 3.3V. (Is it a problem ?) Hence we added delay in enable of 1.1V so that the output starts rising only after 3.3V settles to final value.
