Issue: USB Read/Write sometimes fail

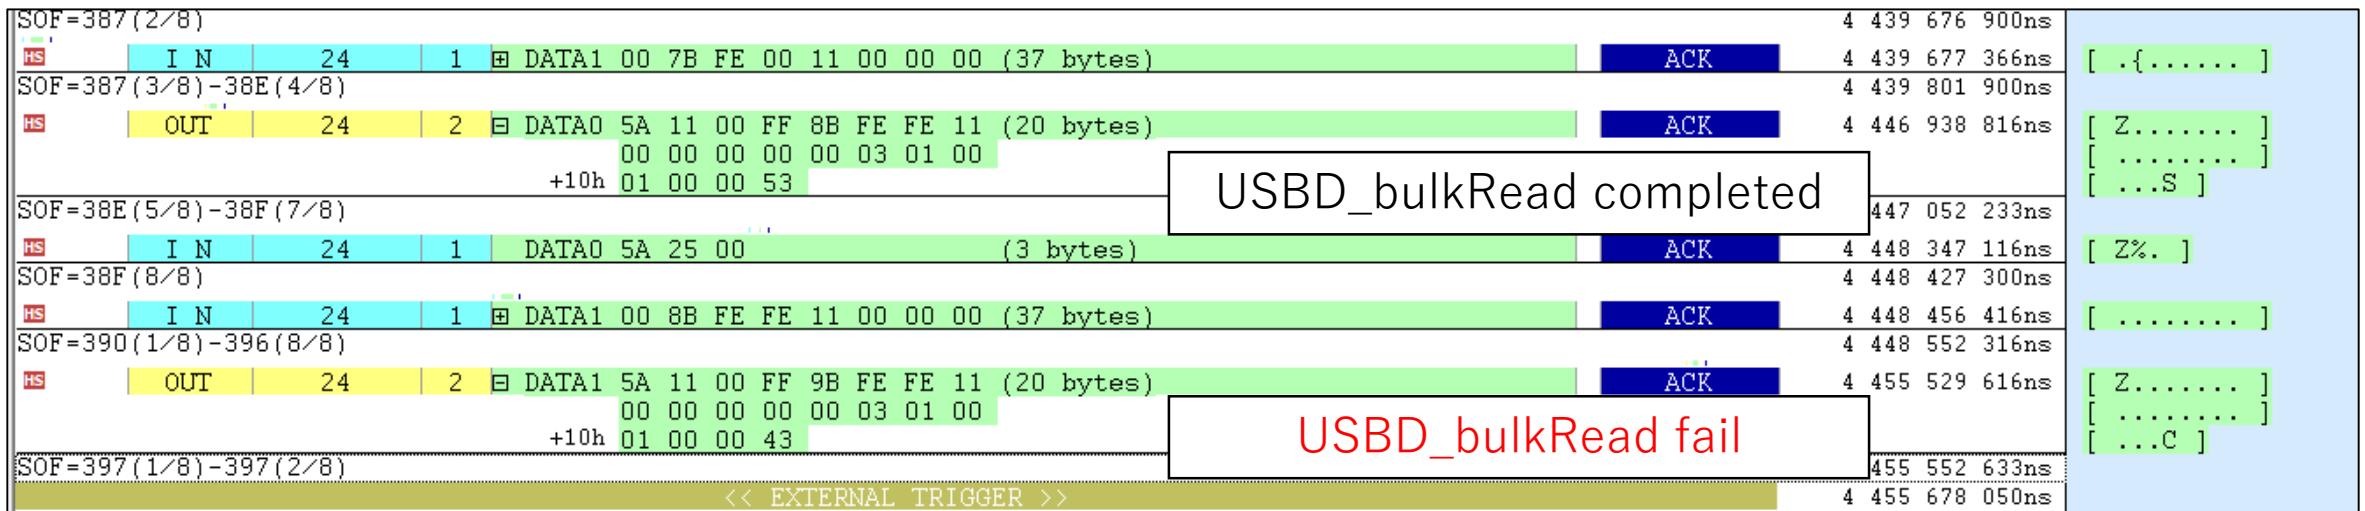
Information of protocol analyzer

Data that could not be received was in the buffer.

TRB area is overwritten (Write back) with cache data. (Probably)

Therefore, the TRB area was set outside the cache area.

Added section (“.bss: extMemNonCache: usbXhci”) to __attribute__ of each memory definition.
