We probed the CAN\_H and CAN\_L lines for both boards and observed the following results:

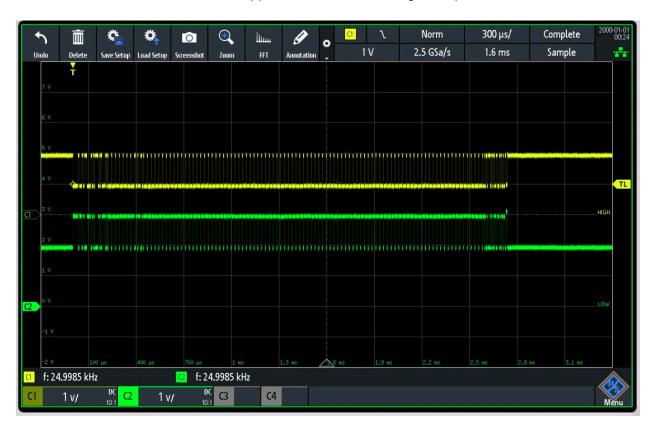
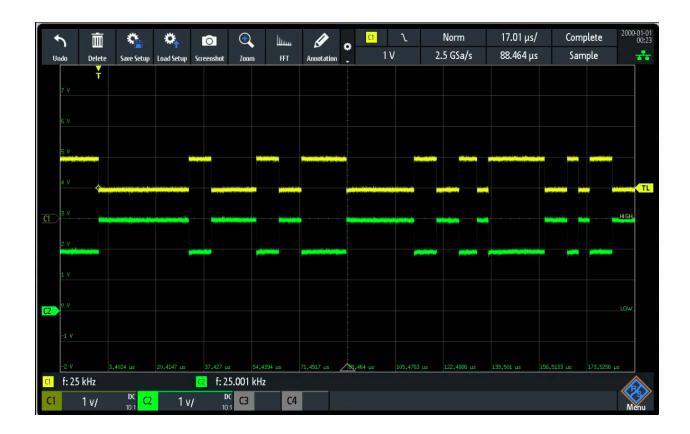
## 1. F28P65X to F28P65X Communication:

Two F28P65X devices were connected, and their CAN signals were observed.
The communication appeared to be functioning as expected.

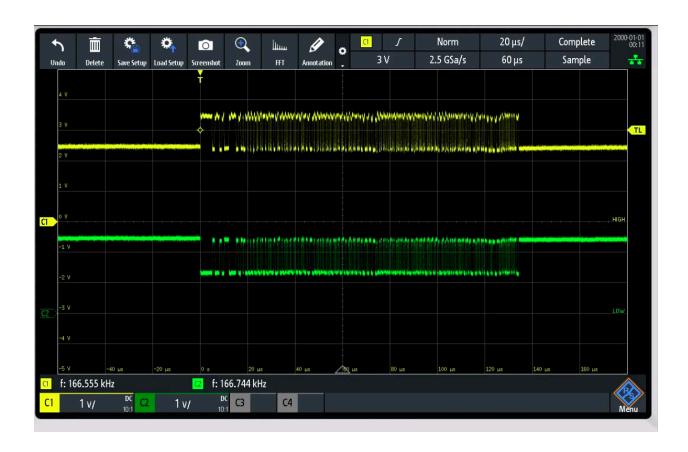
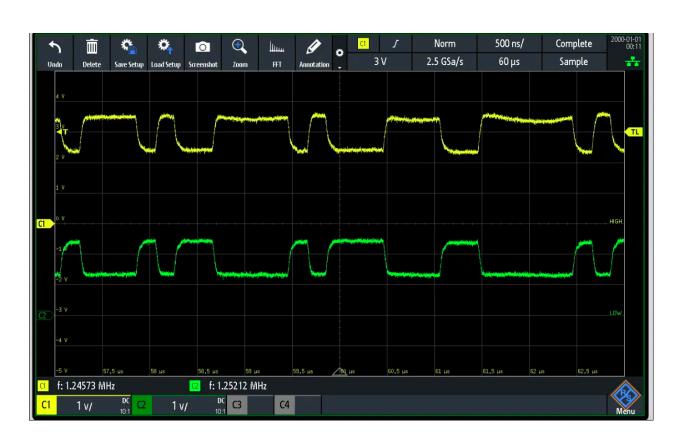
# 2. AM2634 to AM2634 Communication:

Two AM2634 devices were connected, and their CAN signals were observed.
The communication appeared to be functioning as expected.

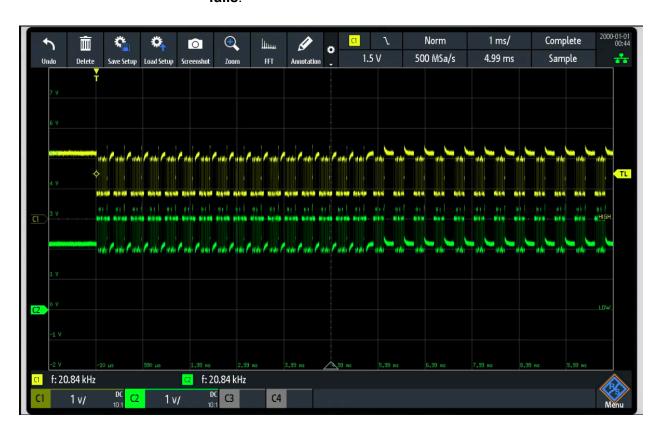
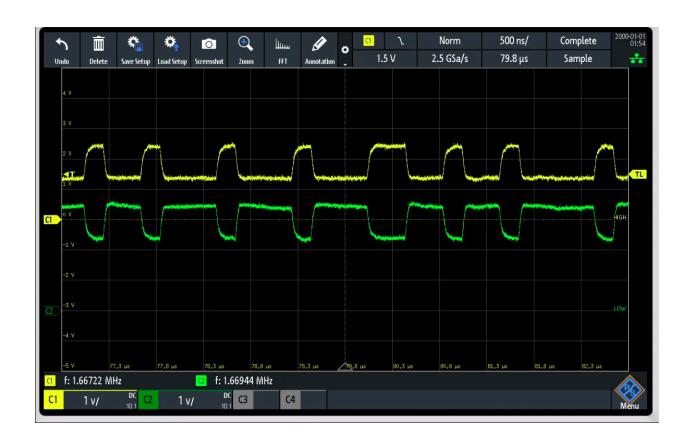
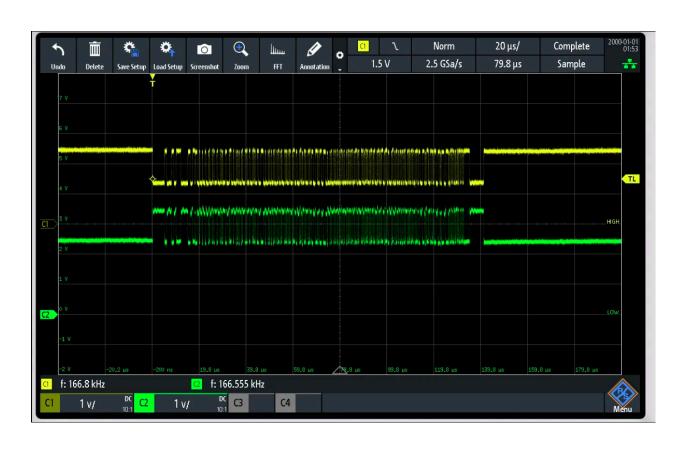
## 3. F28P65X to AM2634 Communication:

- When attempting communication between F28P65X and AM2634, we encountered two different scenarios:
  - F28P65X transmitting to AM2634:
    - The **F28P65X** continuously attempts to send data to the **AM2634**.
    - However, the same transmission process is repeated multiple times until it reaches a timeout, at which point the communication fails.

These observations suggest a potential **compatibility issue** between the **F28P65X and AM2634** in CAN communication. Further debugging may be needed to analyze the potential differences in CAN protocol implementation between the two devices.

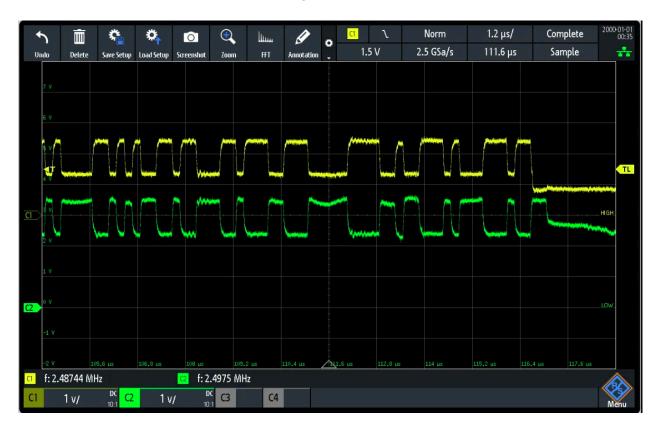
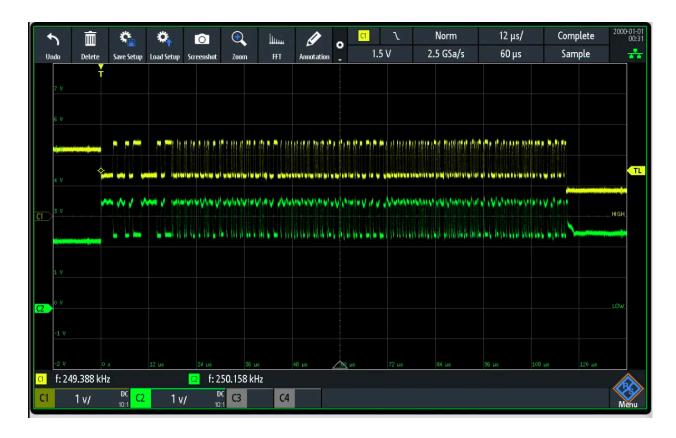
# ■ AM2634 transmitting to F28P65X:

■ When the **AM2634** attempts to send data to the **F28P65X**, the AM2634 reports an **MCAN\_INTR\_SRC\_PROTOCOL\_ERR\_DATA** error, indicating a protocol error in data transmission.
