GPMC Sub-32-bit Read Issue

Problem Statement

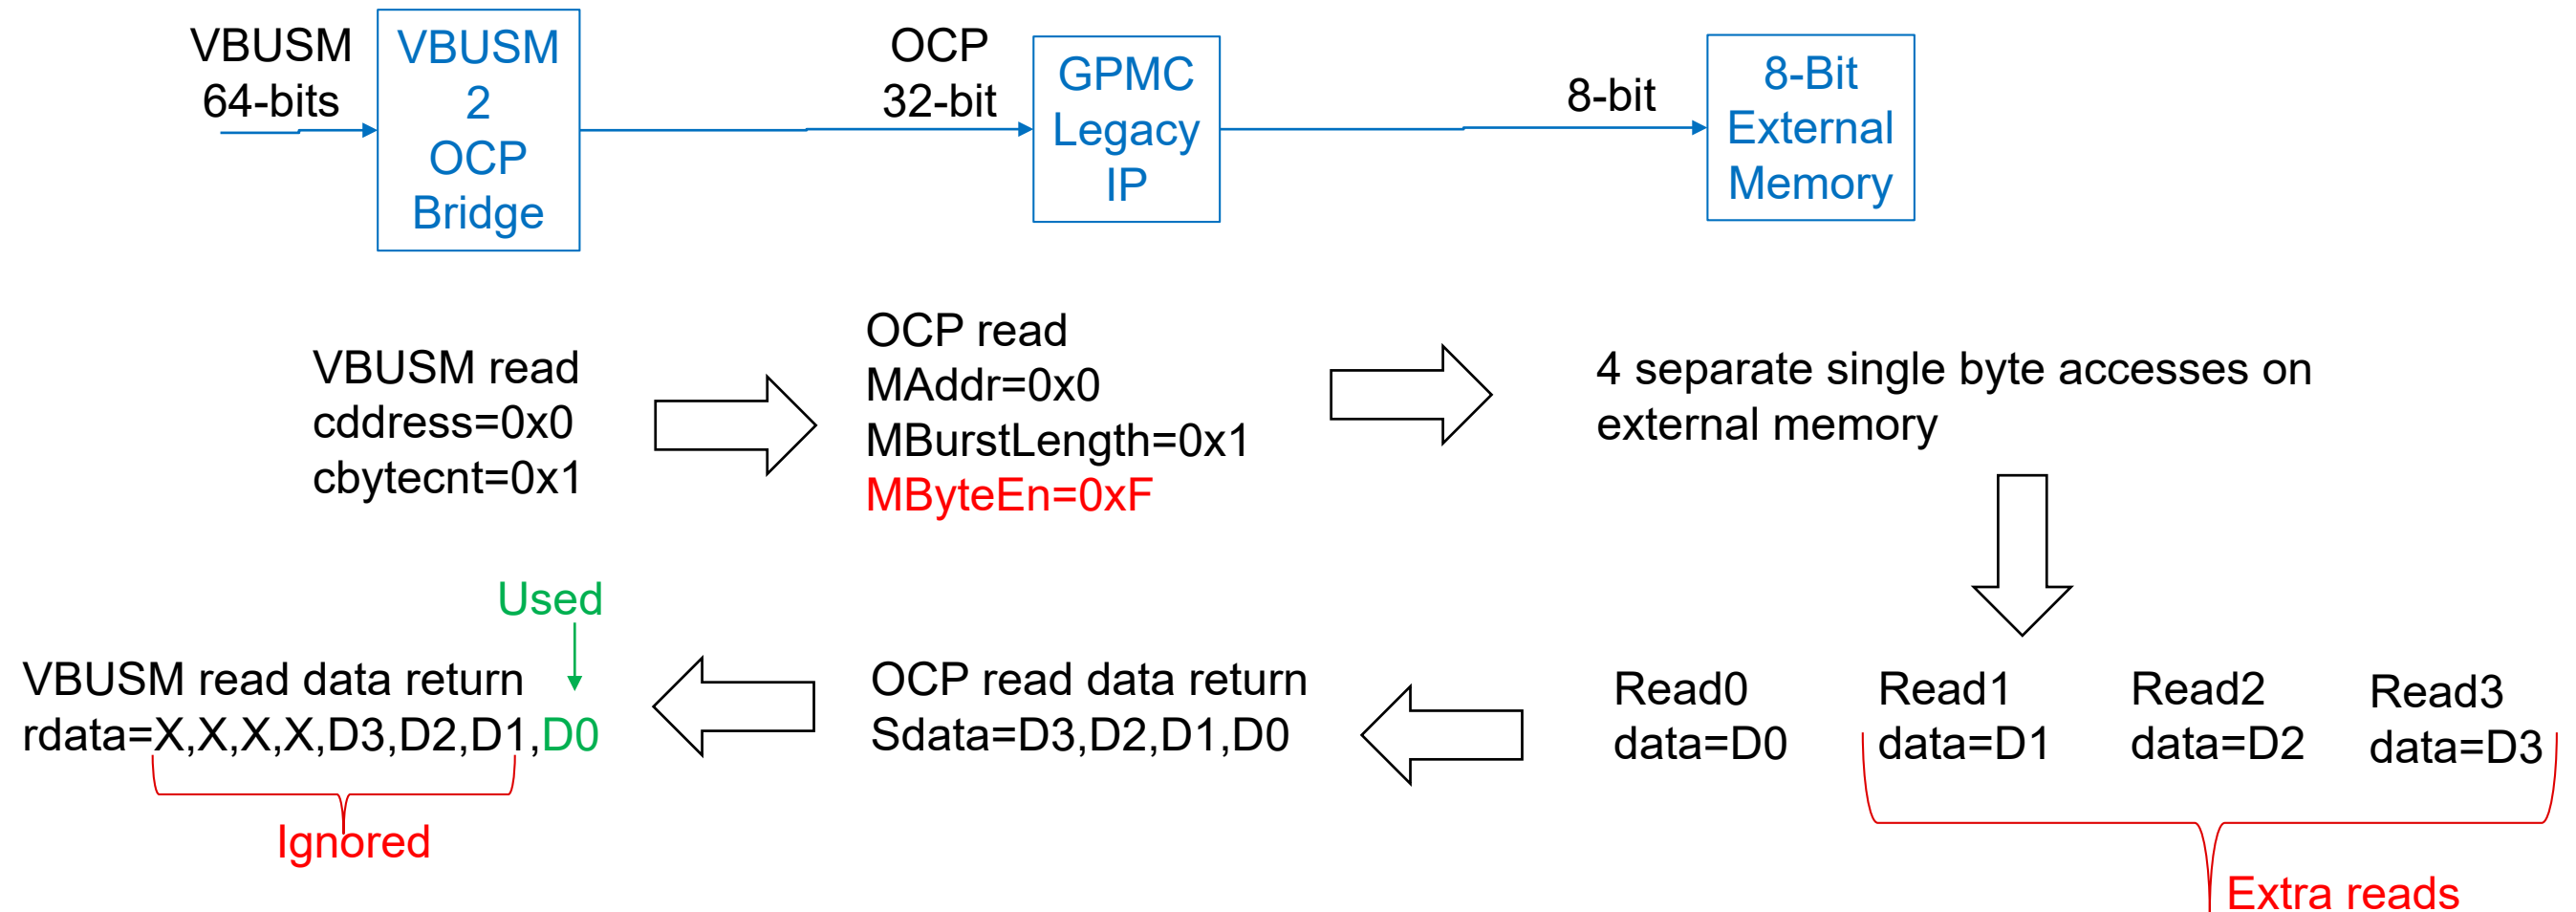
VBUSM2OCP Bridge for GPMC

- Bridge translating sub-32-bit reads on VBUSM to 32-bit reads on OCP

- No equivalent signal on VBUSM command to drive OCP MByteEn – need extra calculation
- Only D0 is used, all other data bytes are ignored₃ at the VBUSM - no functional issue

- Devices impacted
 - AM64x_SR1.0, AM243x_SR1.0, AM263_SR1.x – Errata i2313
 - AM64x_SR2.0, AM243x_SR2.0 - Fixed
- Bridge fix
 - Fix has been identified and implemented
 - Involves addition of combinatorial gates
 - No addition of new flops

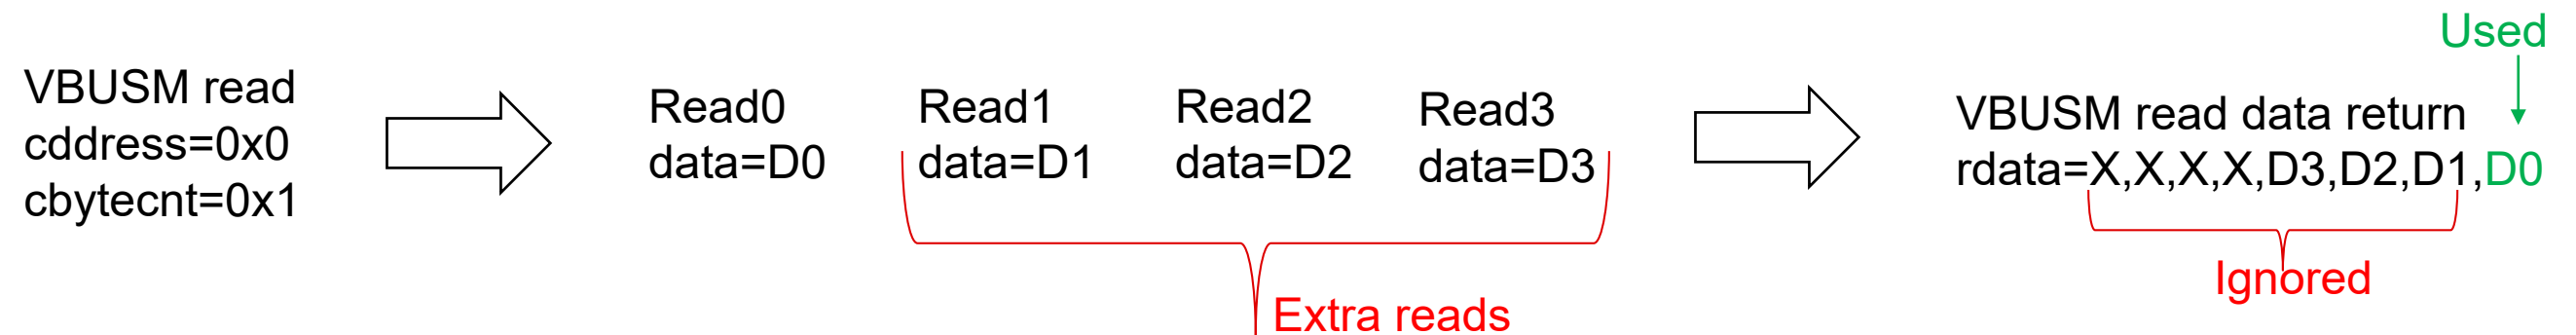
- NAND is accessed in 512 byte pages
- A single byte read will cause 4 reads on an 8-bit NAND device

- GPMC Legacy IP Behavior
 - OCP interface on the legacy GPMC IP only supports accesses with byte count equal to power-of-2 and starting address aligned to the requested byte count
- Potential SW workaround
 - Always use 32-bit or multiple of 32-bit reads to GPMC memory space when using NAND and/or FPGA FIFO implementation
 - Sub-32-bit reads (1 byte or 2 bytes) can be used for other async memories, but will have performance impact

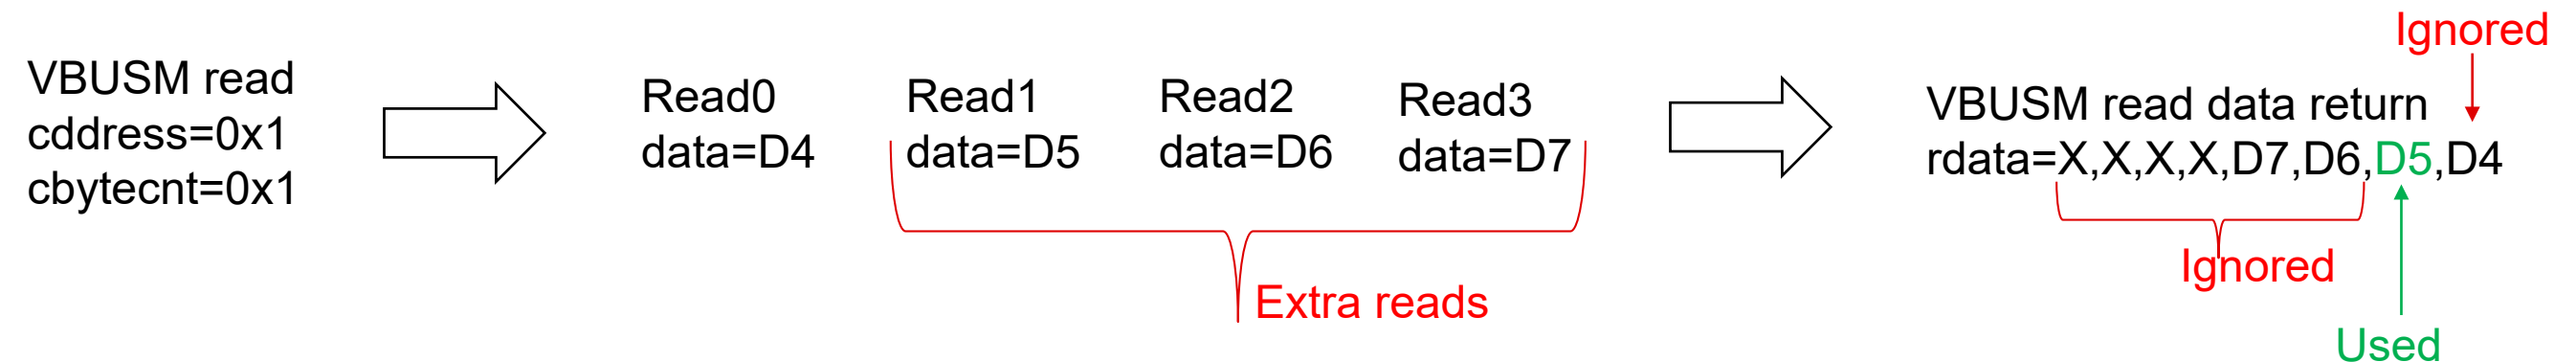
- Internal NAND page counter increments by 4, any sequential byte read will read next data
