# Q 20240502

As shown on the right  
In front of the imaging lens after DMD reflection  
There is some unevenness as shown in the photo.  
The strength of the unevenness is 50% compared to the center.

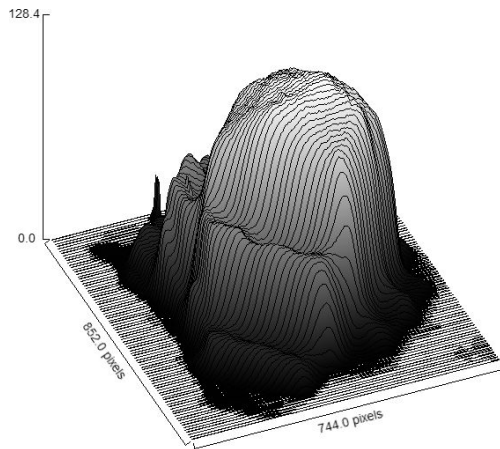
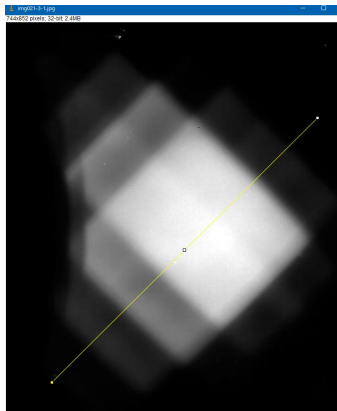
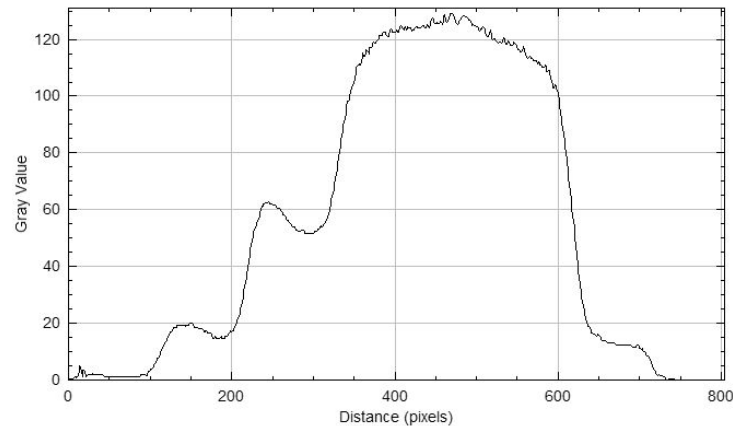
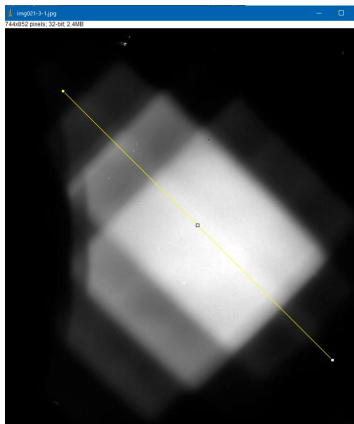
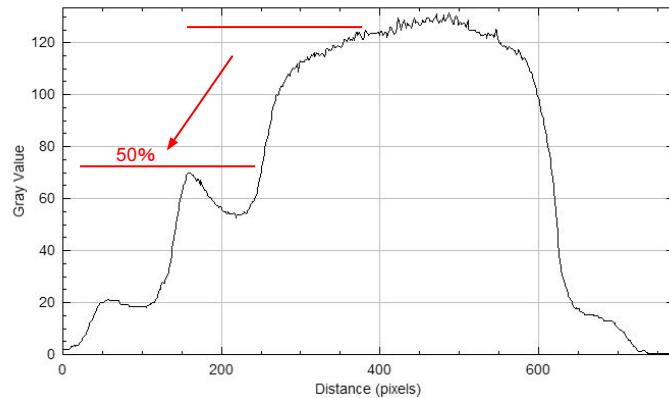
## 2.Imaging lens incidence plane

Unevenness occurs in front of the imaging lens.  
The intensity of the unevenness is 50% of the median.  
Is it diffracted light?
