TI DLPC900 Two Controller - Port Configuration Issue

October 9, 2020

Hardware: BLI designed DLPC900 Two Controller PCA. Display Port and HDMI removed and USB3 is used as the imaging interface to the DLPC900s.

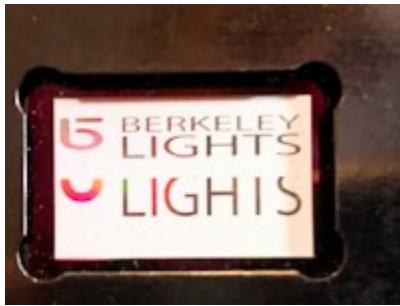
We can project images but occasionally (about once every three days) the image gets squeezed into the top or bottom half of the DMD as shown:

Once every three days:

We have stumbled onto a way to re-create the problem:

- 1) While imaging, send the following two commands:
2) Send a CLK_SEL : 0xD0 (We know this is an invalid command)
3) Send a CLK_SEL : 0x02

<- DMD goes blank
<- DMD goes into weird state

We have been able to recover by sending the following:

- 1) Sending one additional CLK_SEL : 0x02

<- DMD returns to normal
