# Customer's Verification Environment

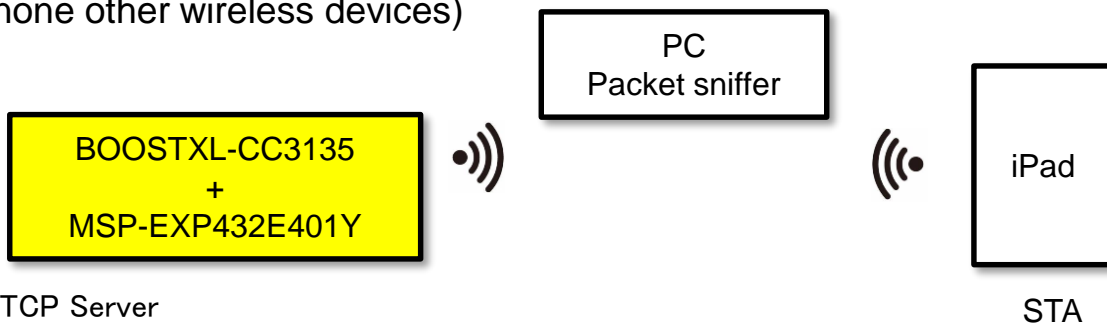
Shield-room (none other wireless devices)

AP mode / TCP Server

Customer is using the default setting except IP configuration.

After connecting to the client, 1000 bytes of data are transmitted to the client at a certain cycle.

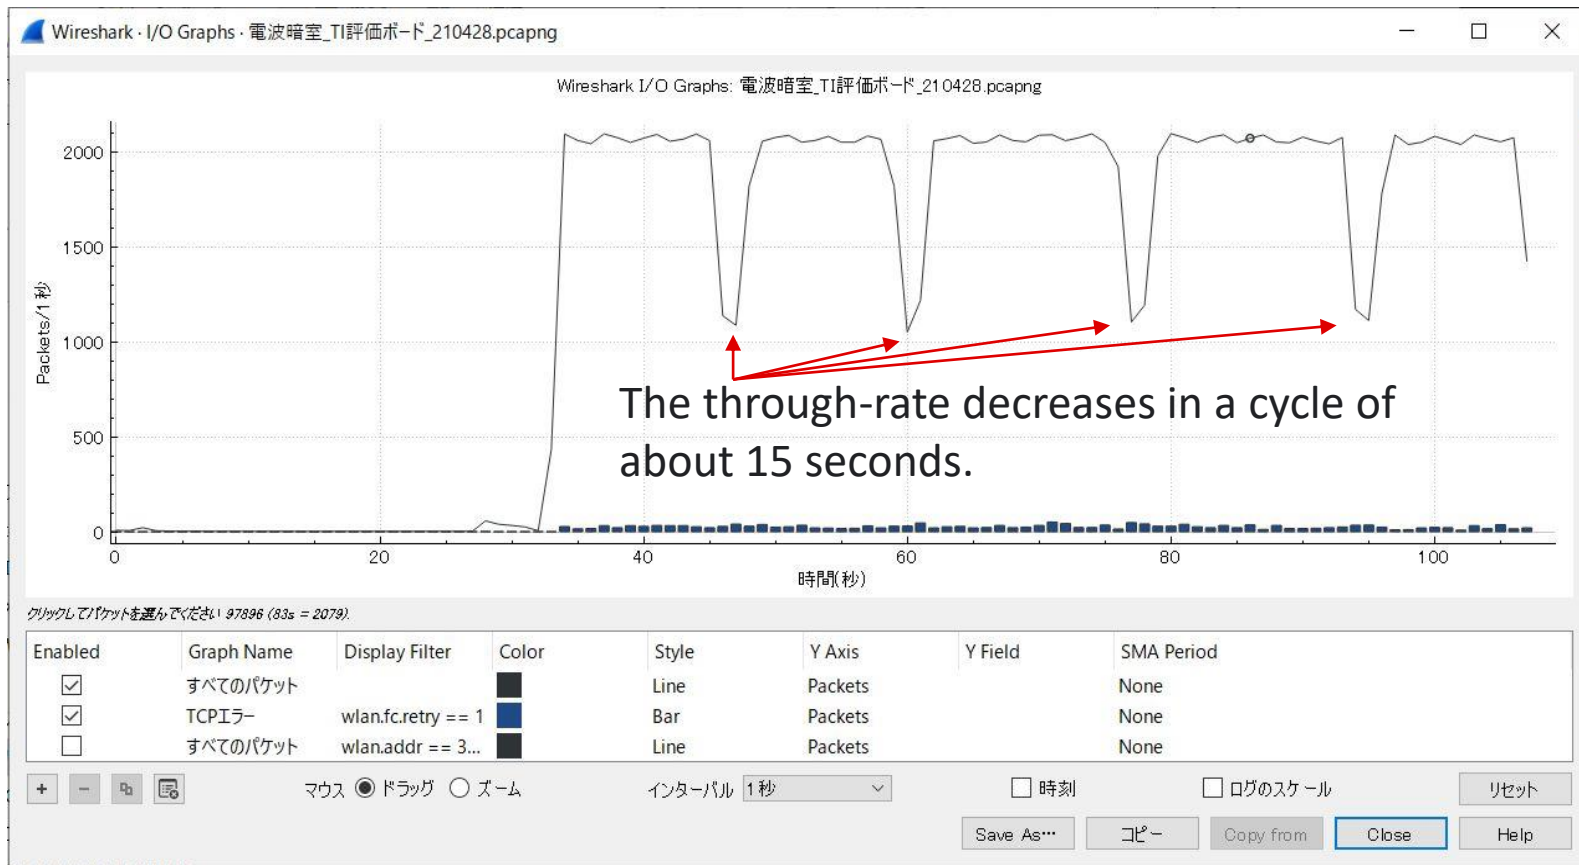
Customer noticed the through-rate decreases in a cycle of about 15 seconds, like next page.

Customer tried to verify it with other Wi-Fi module(AP), however, this behavior was not observed.
