**Overview:** Customer is using Murata Type WT (WL 1831) + i.MX 6UL processor.

**Problem Statement:** Wi-Fi connection issue with 2 devices out of 2500 devices deployed on field. Skyline 410 is configured as soft access point to allow clients to connect to its network. Clients could not connect to the Wi-Fi network in 2 devices out of 2500. Wi-Fi access point is discoverable from other clients but unable to join the network.

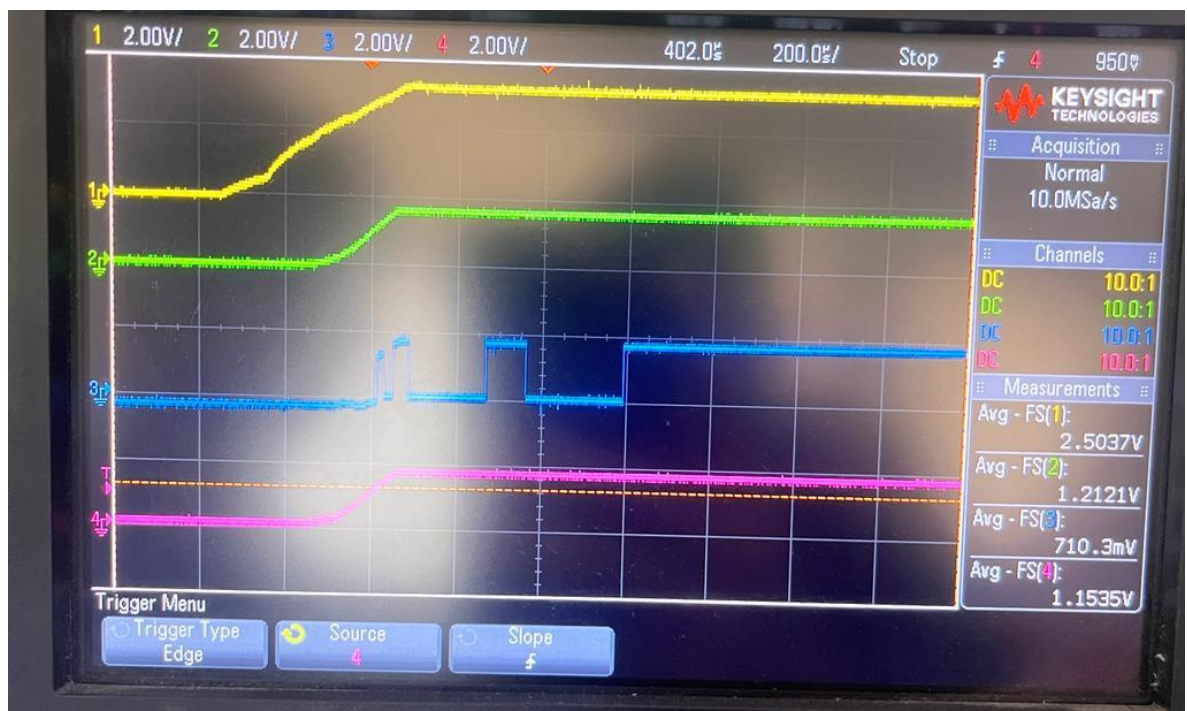
**Non-Working Board:**

- WL\_EN is up before slow clock stabilization
- Measured slow\_clock frequency ~ 32.77 kHz

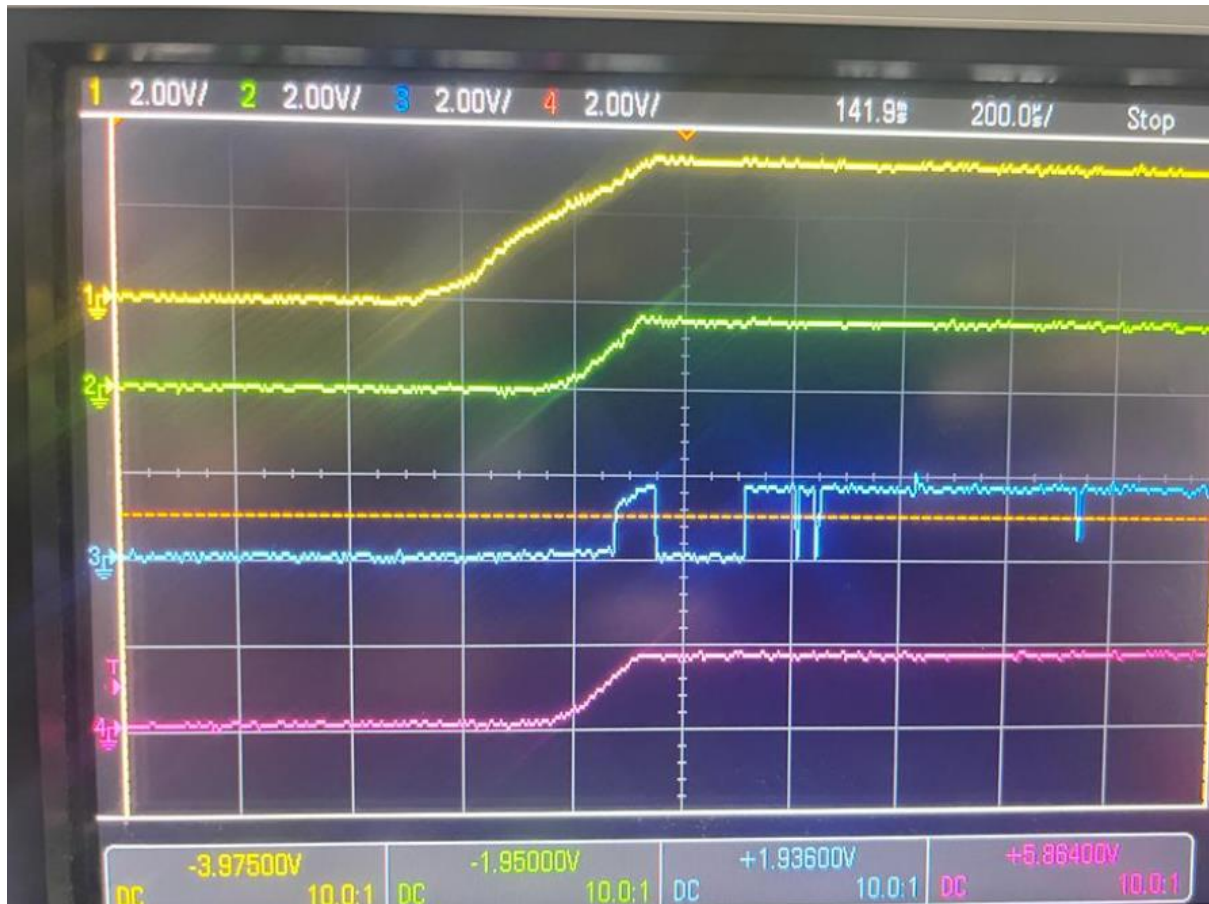
### Working Board:

- WL\_EN is up before slow-clock stabilization
- Measured slow clock frequency ~ 32.8 kHz

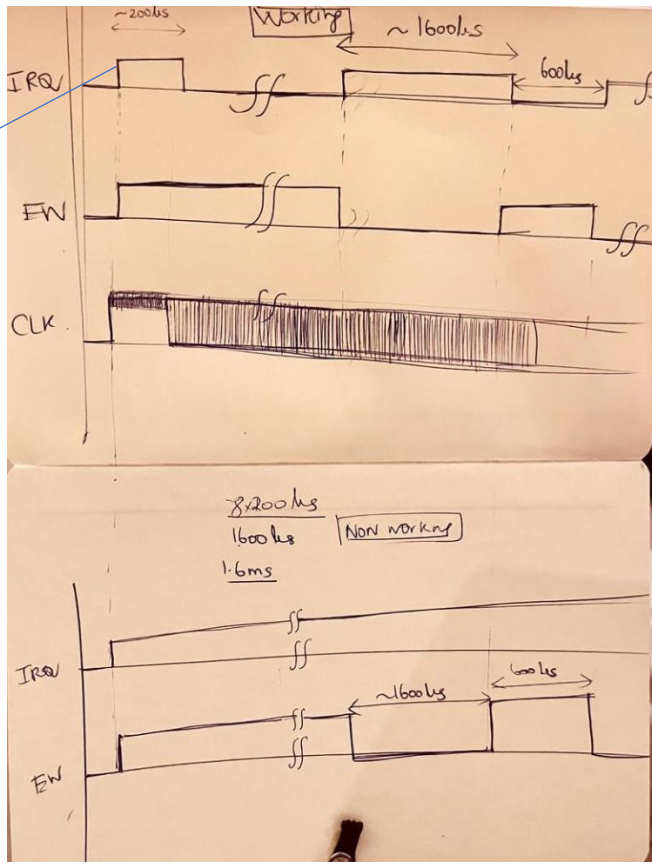
## WLAN IRQ Waveform Comparison

- In the non-working board WLAN\_IRQ line is always held high and never comes down. Which indicates the module initialization and fw download is not complete.
- In both working and non-working board WL\_EN is made high before clock stabilization
