1) WLAN module initialization

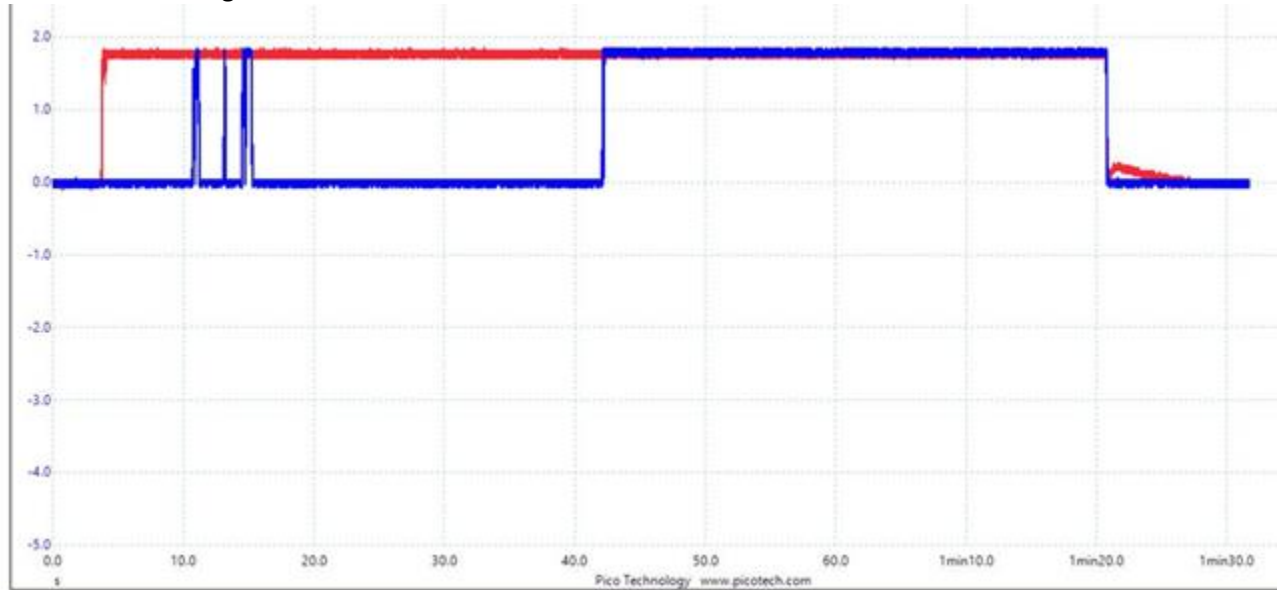
We suspect that the WLAN module start-up might could cause the problem. Module start up looks like this:

red: operating voltage

blue: wlan enable signal

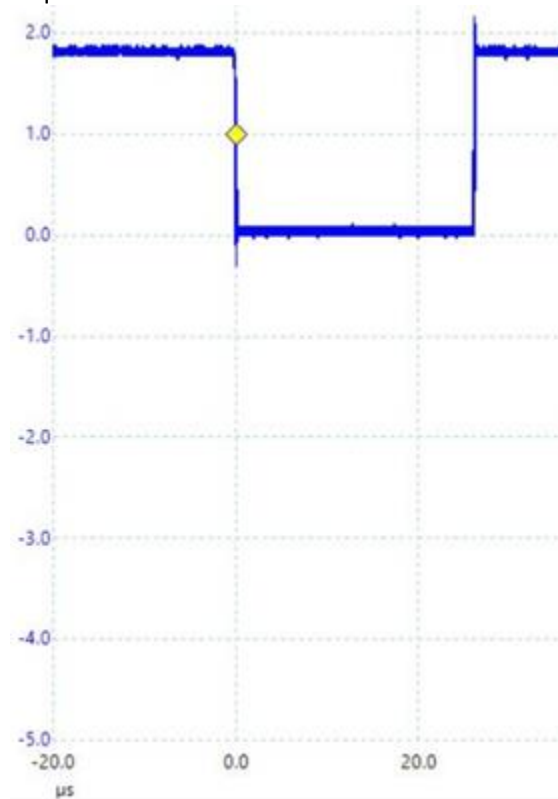
Looks like for some reason during boot linux pincontrol driver enables/disables WLAN enable signal multiple times. Timing of consecutive enable/disable timing does not fulfill minimum 60us requirement
