Removing “Pop” Noise in TAS570X Power-Up

INTRODUCTION

This Application Report describes the causes of the “pop” noise during the power-up sequence of TAS570X devices, and a circuit that can be applied to eliminate the noise. The TAS570X devices covered in this report are the TAS5704, TAS5705, TAS5706, TAS5707, TAS5708, TAS5709, TAS5710, and TAS5716. Devices after the TAS5710, except for the TAS5716, do not experience the “pop” noise during power-up.

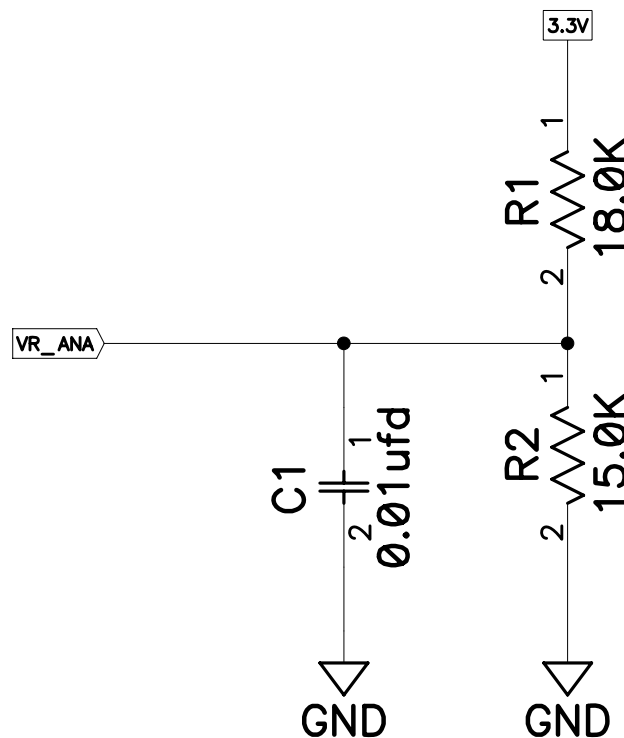
Figure 1: De-"pop" Circuit

The “pop” noise in a TAS570X device can occur when PVDD is applied to the device before the 3.3V line has reached its specified value. The root cause is a leakage current problem with the 3.3V output drivers. The output drivers require a 1.8V and a 3.3V supply to operate. The 1.8V supply comes from the pin VR_ANA, and the 3.3V supply comes from AVDD. If the VR_ANA supply is not present, but the AVDD supply is present and ramping up to 3.3V, leakage currents charge up the internal nodes of the driver, starting the driver and driving AVDD to the output pad. During this time the state of VALID signal is unstable and can turn on the power stage briefly causing the “pop”.

The first cause for the “pop” noise is current leakage while the VR_ANA supply is absent. The circuit described in this section offers a way to keep the VR_ANA supply present while AVDD ramps to its operating value.

The de-“pop” circuit shown in Figure 1 is a voltage divider for AVDD. The resistor R1 is placed between AVDD and VR_ANA, and the resistor R2 is placed between VR_ANA and AVSS. The voltage between VR_ANA and AVSS across R2 should be 1.5V when AVDD reaches 3.3V. This is found by voltage division. When AVDD is at 3.3V, the voltage at the VR_ANA node needs to be

$$\frac{R_2}{R_1 + R_2} \cdot 3.3V = \frac{1.5k\Omega}{1.8k\Omega + 1.5k\Omega} \cdot 3.3V = 1.5V .$$

This voltage across R2 acts as a bias voltage for the pin VR_ANA as AVDD ramps up to 3.3V. The capacitor in the circuit from VR_ANA to AVSS filters out 3.3V supply noise.

Application of the De-"pop" circuit to a TAS570X system eliminates the power-on "pop" noise. The VR_ANA supply will ramp at approximately the same rate as the AVDD supply, because the two supplies come from the same source. A voltage on VR_ANA will be present while AVDD is ramping, but still below 3V. This means that even though the voltage regulator for VR_ANA is off for AVDD less than 3V, the biased voltage on VR_ANA will prevent current leakage to the output drivers. Since the circuit prevents the current leakage to the output drivers, the circuit prevents the "pop" noise.
