# MSP430F5529 Device Erratasheet

## 1 Revision History

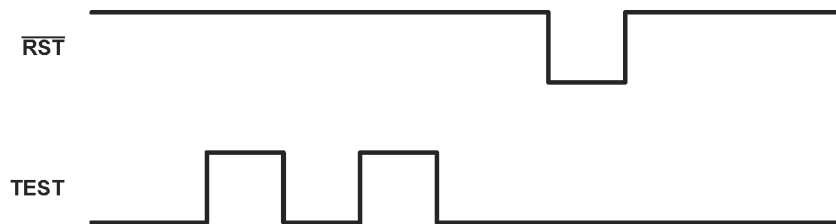
To exit the BSL one of the following methods must be used.

- A Power cycle
- or
- Toggle the TEST pin twice when nRST is high and then pull nRST low.

Note: This sequence is not subject to timing constraints and the appropriate level transitions are sufficient to trigger an exit from BSL mode.

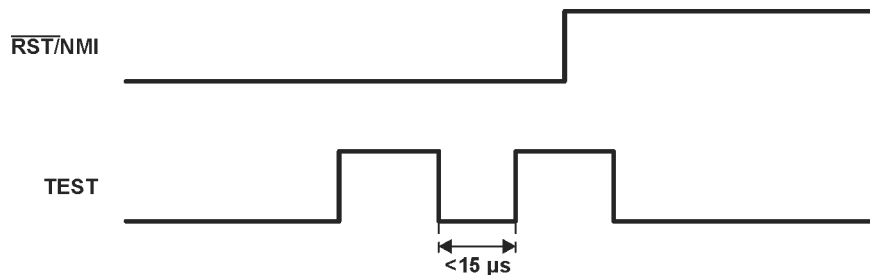
**Function** BSL entry sequence is subject to specific timing requirements

**Description** The BSL entry sequence requires that the low phase of the TEST/SBWTCK pin does not exceed 15us. This timing requirement is faster than most PC serial ports can provide, as shown in the following picture. If this requirement is not met, the entry sequence fails and the SYSBSLIND is not set.

**Workaround** An external hardware solution is recommended to provide the appropriate BSL entry sequence. See [http://processors.wiki.ti.com/index.php/BSL\\_\(MSP430\)](http://processors.wiki.ti.com/index.php/BSL_(MSP430)) for recommendations on available BSL hardware.

Note: The erroneous behavior is only applicable if the default TI USB BSL is replaced by the TI UART BSL.
