**Final Report**

<b>Customer:</b>	ARROW ELECTRONICS TAIWAN LTD	<b>Date Received:</b>	07/17/2014
<b>Customer Location:</b>	TAIPEI (TAIWAN)	<b>TI Device Type:</b>	DCP021212DU/1K
<b>Customer Part #:</b>		<b>TI Tracking #:</b>	QTS # 404768
<b>Customer Ref #:</b>	Mapletek - RTW	<b>CR</b>	CR1878
<b>Quantity Returned:</b>	2 devices	<b>RMA</b>	3881TG
<b>Origin of Detection:</b>	Field and final assembly

# FAILURE ANALYSIS REPORT

FA404768-1

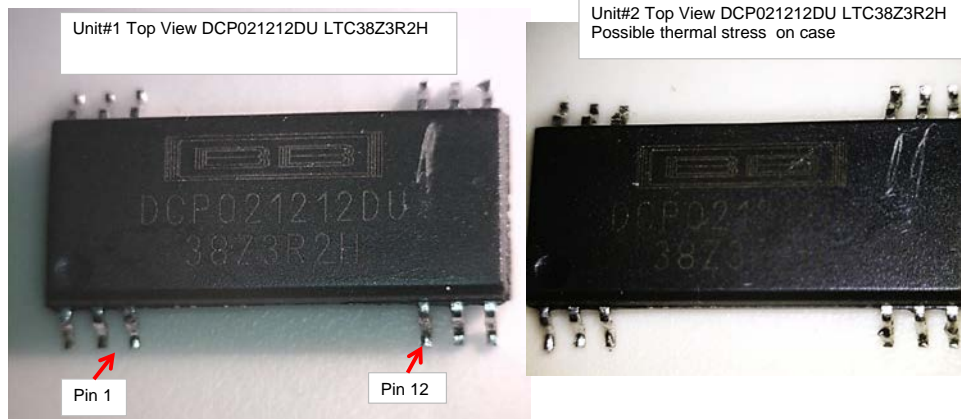
Pictures Unit#1 and Unit #2

(a) Case 1: The customer returns 1pcs 8-channels A/D conversion board, and DCP021212 failed. After turn on power, the temperature over 150°C within 3 second, then thermal protection was enabled and the output voltage drop below 5V.

(b) Case 2: In our QC procedure, we also found 1-pcs DCP021212 failed in the system test (Step3). After turn on power the temperature of over 150°C spontaneously, then thermal protection was enabled and the output voltage drop below 5V.

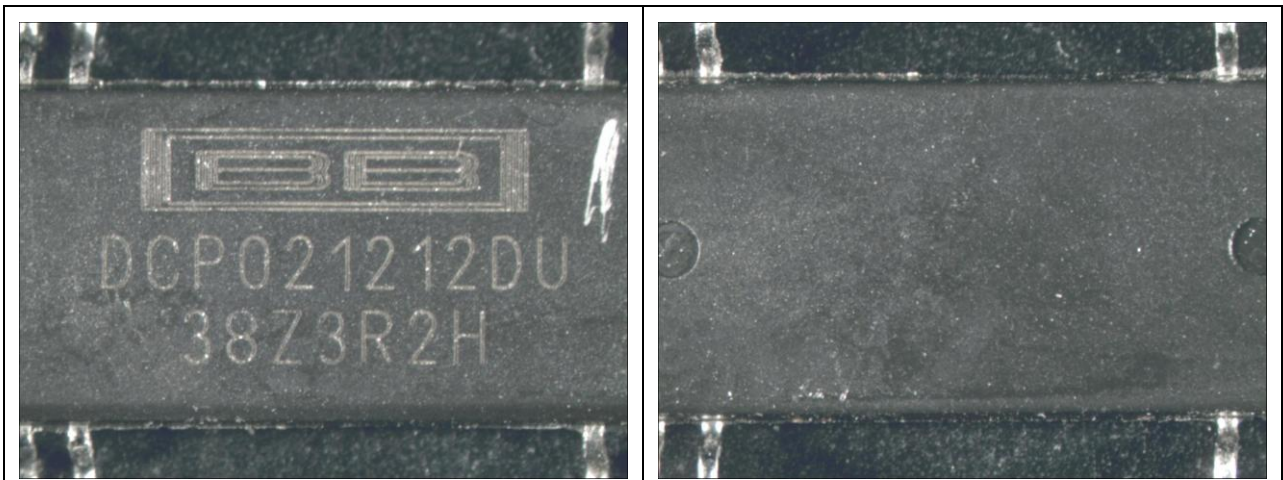
The external package surfaces were inspected with a stereo microscope. The packages were in normal condition with no evidence of damage to the plastic encapsulant. Residual solder was seen on the external pins (Figures 1 and 2).

**Figure 1. Unit 1.** Truncated images show package condition and marking.

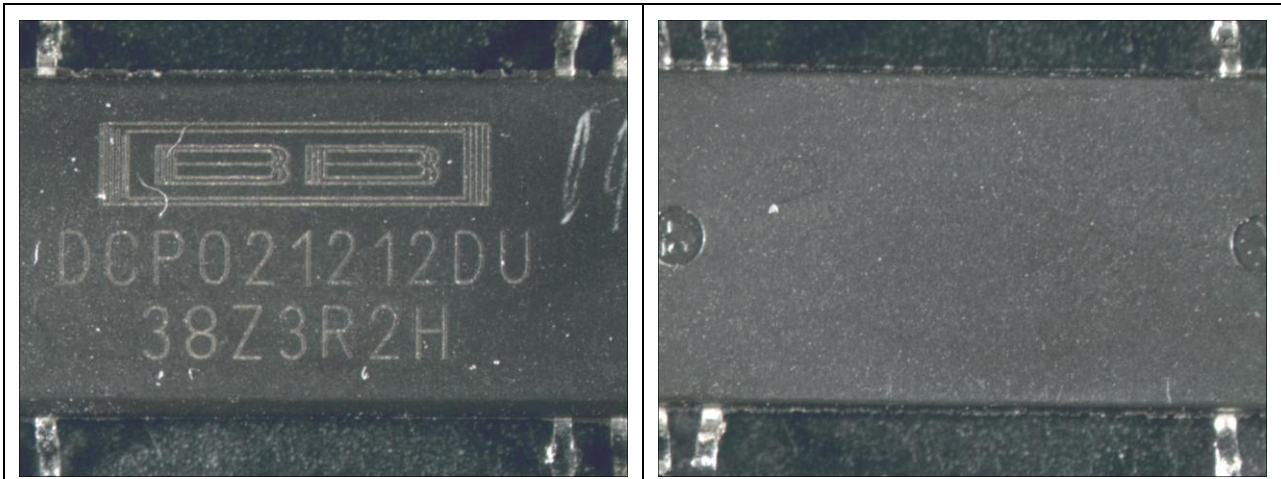
**Figure 2. Unit 2.** Truncated images show package condition and marking.

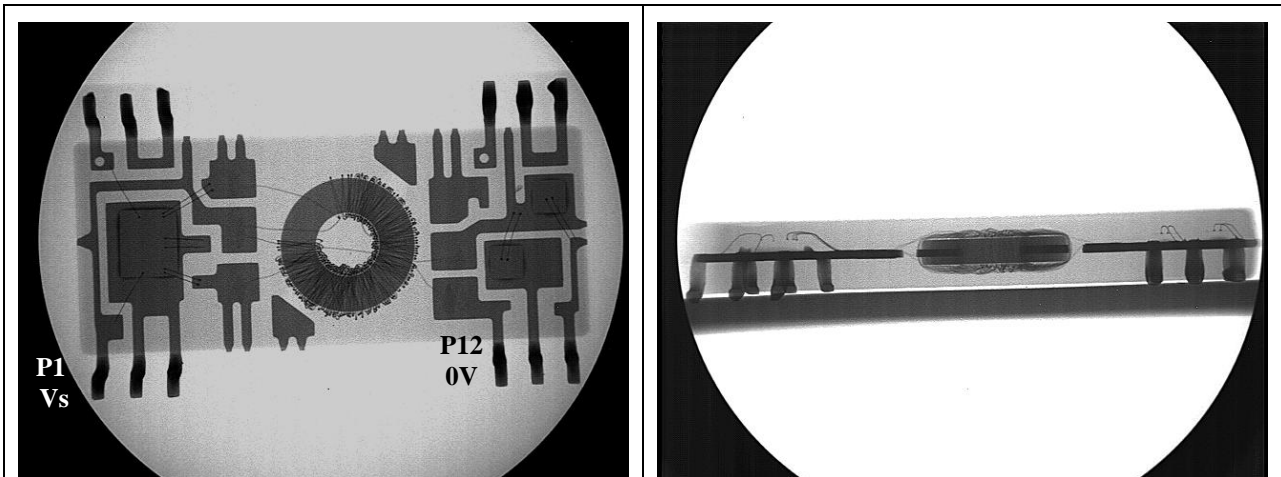
The internal package construction was evaluated by x-ray imaging (Figures 3 and 4). Assembly workmanship was normal and there was no evidence of damage to the die or the package. Bond wire workmanship appeared normal.

**Figure 3. Unit 1.** X-ray package top-down and package side views are shown.

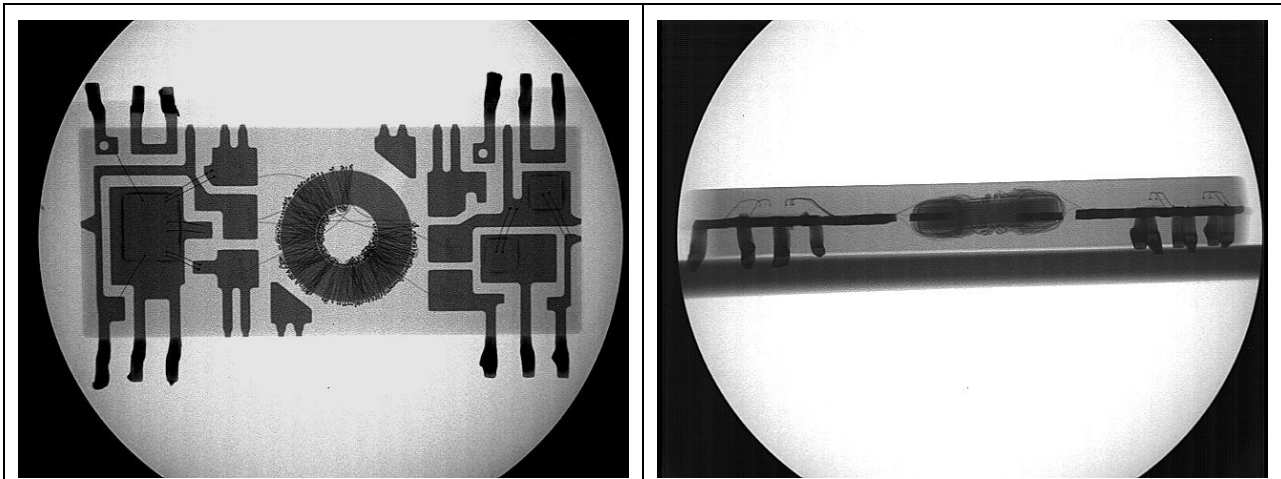
Figure 4. Unit 2. X-ray package top-down and package side views are shown.

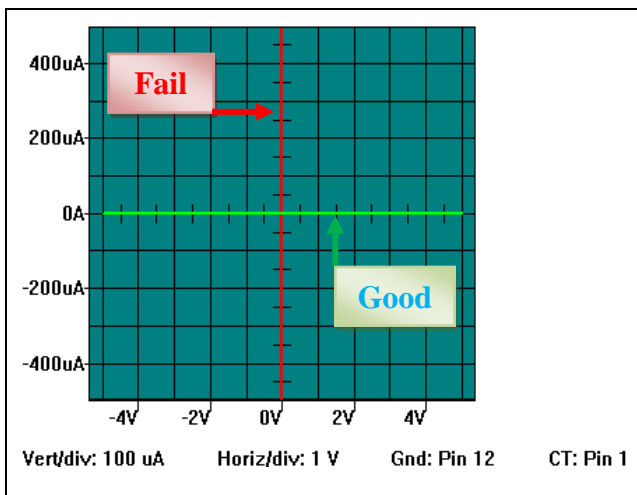
The unit was subjected to an unpowered curve trace evaluation. The I-V characteristics of each pin were observed and compared to a known good unit. Pin-to-pin analysis showed a shorting condition from pin 1 (Vs) to pin 12 (V0) in each unit (Figures 5 and 6).

Figure 5. Unit 1. Shorting condition shown.

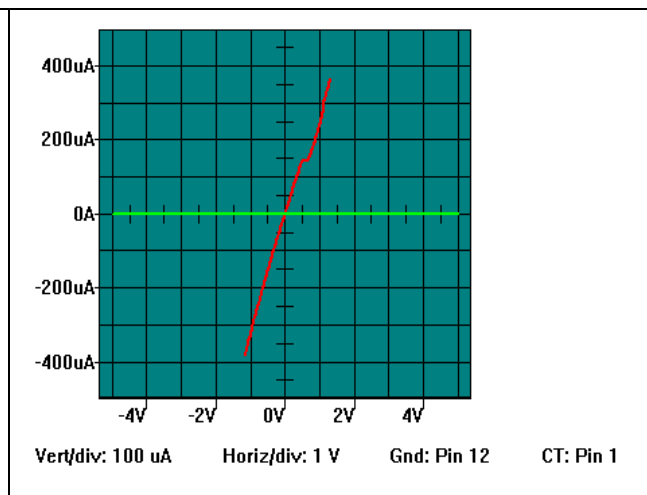
Figure 6. Unit 2. Shorting condition shown with linear resistance.

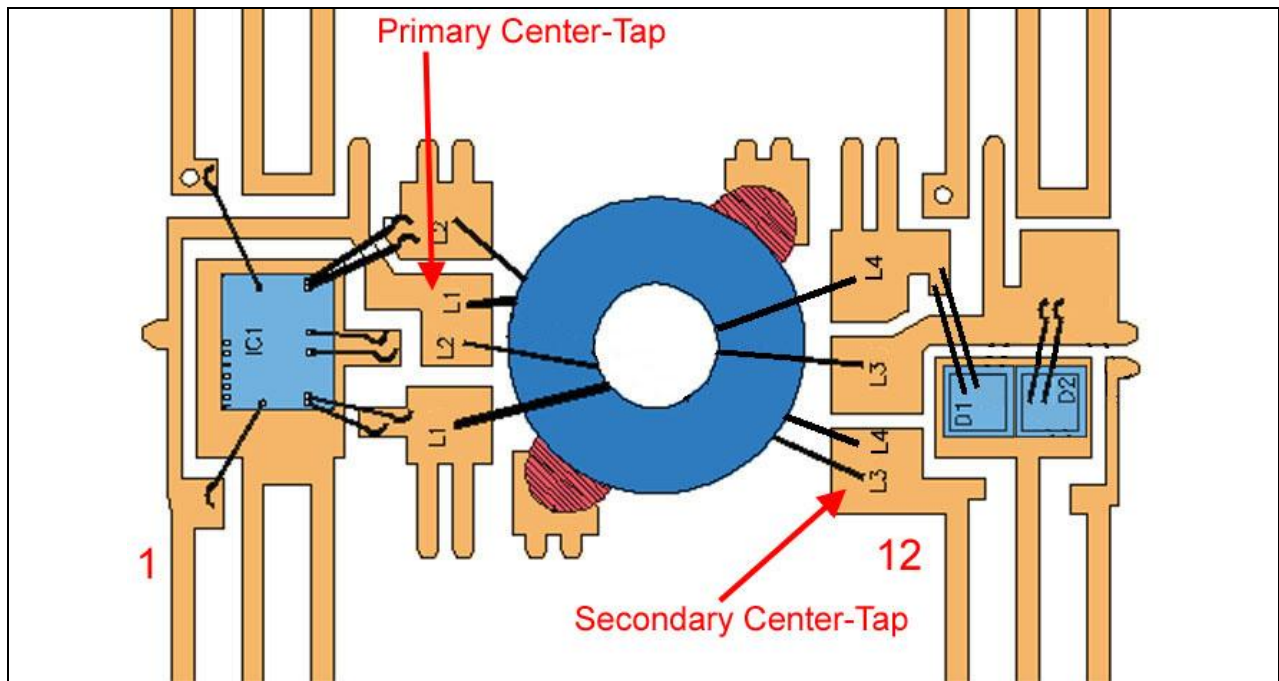
**Figure 7.** In this representative illustration pin 1 of the primary center-tap needs a conductive path to pin 12 of the secondary center-tap through the transformer core coincident windings to have a shorting condition.

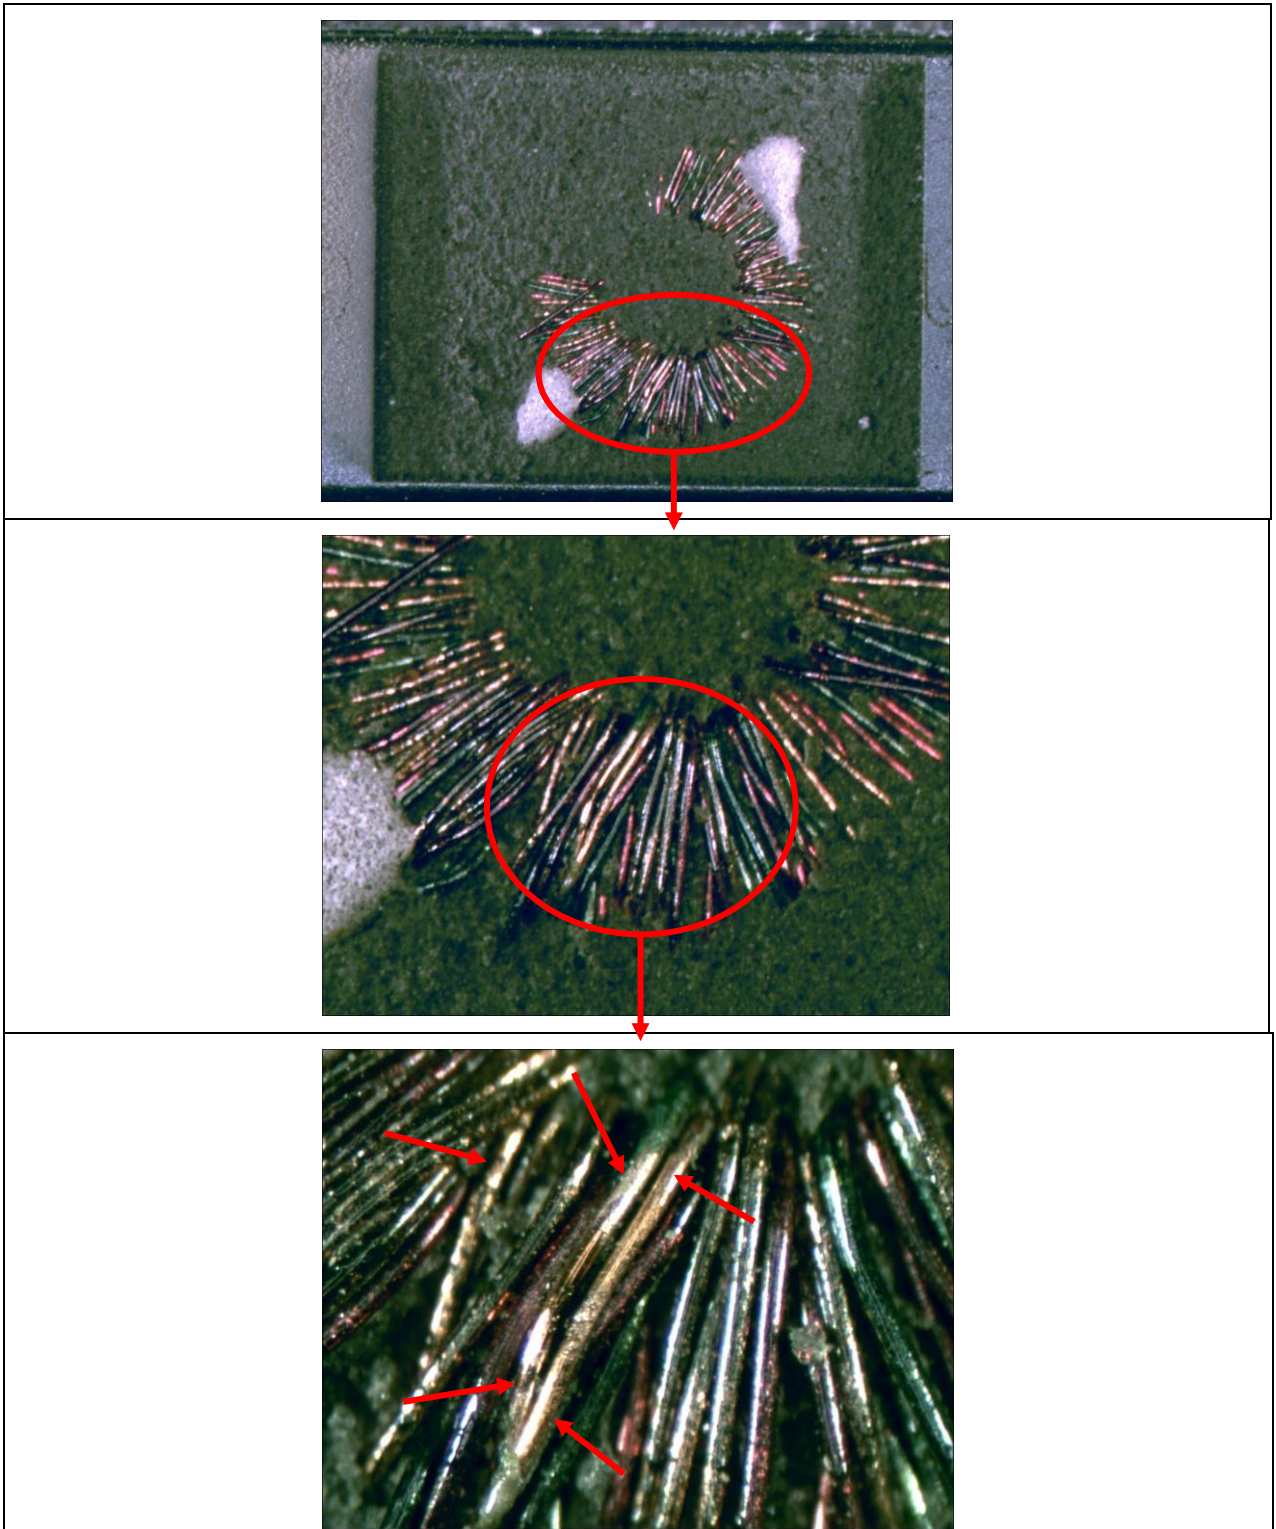
Optical inspections found degraded and missing coating of the copper wire windings (Figures 8 and 9).

**Figure 8. Unit 1.** Transformer core windings showed exposed copper.

Exposed and shorted coincident wound copper windings of the transformer.

These units failed as a result of a short from primary to secondary windings on the transformer. Laser ablation decapsulation of the transformer found exposed copper windings with missing wire coating. The transformer windings on this model are coincident wound, primary and secondary windings overlapping. This means that any damage to the wire's coating can result in a short from the transformer's primary to secondary terminals and catastrophic failure.

Degradation of the magnetic wire varnish can occur if the DCP is exposed to a high humidity environment followed by high temperature exposure, such as solder re-flow. During qualification, results from moisture reliability testing resulted in the MSL3 classification. The magnetic wire insulation, a thin polyesterimide varnish, can degrade in a moist environment. Data from magnetic wire manufactures reports polyesterimide tends to hydrolyze in the presence of water at elevated temperatures.

For the DCP product line, MSL3 needs to be strictly followed. If product from previously opened packages are going to be exposed to solder re-flow, then bake prior to re-flow needs to be performed.

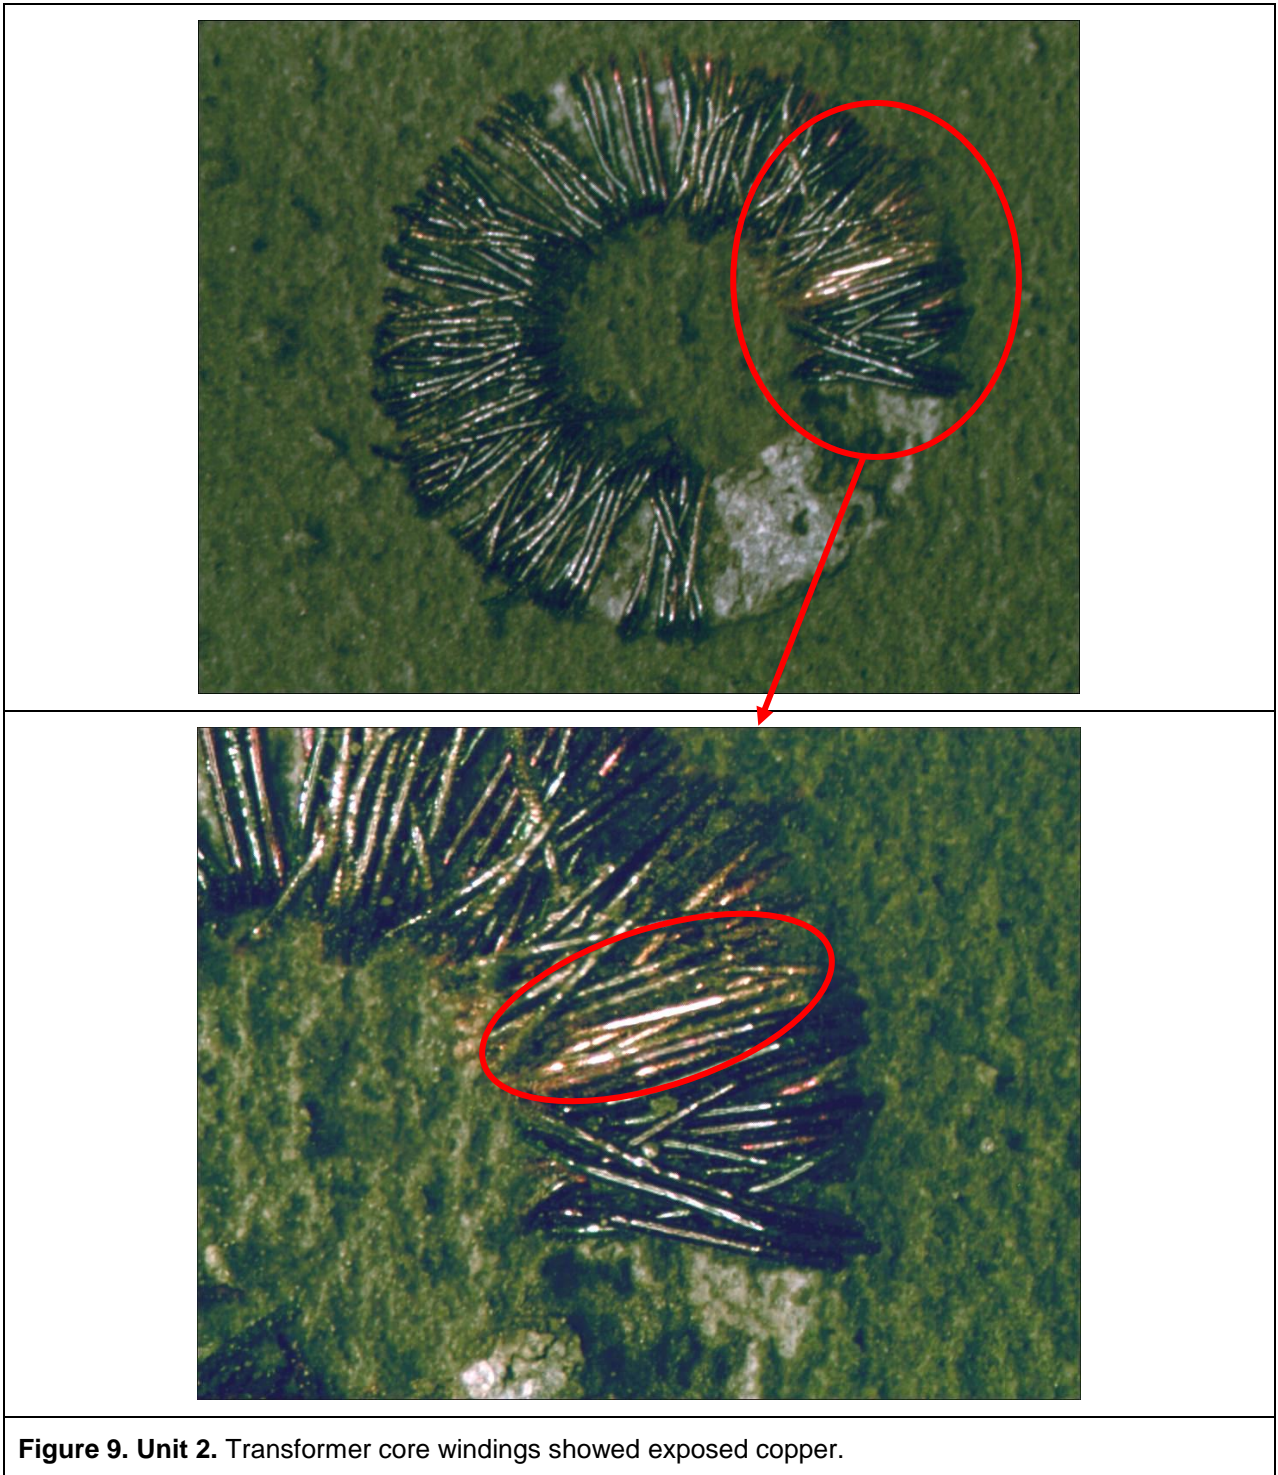
**Figure 9. Unit 2.** Transformer core windings showed exposed copper.

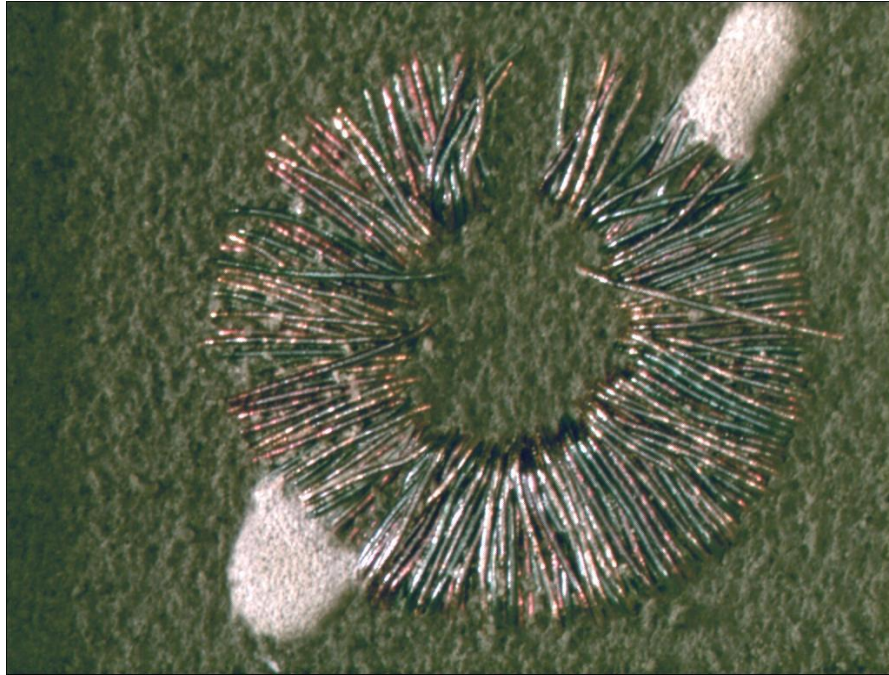
**Figure 10. Control Unit.** No degraded coating over copper windings is shown.
