TPS54295 Result

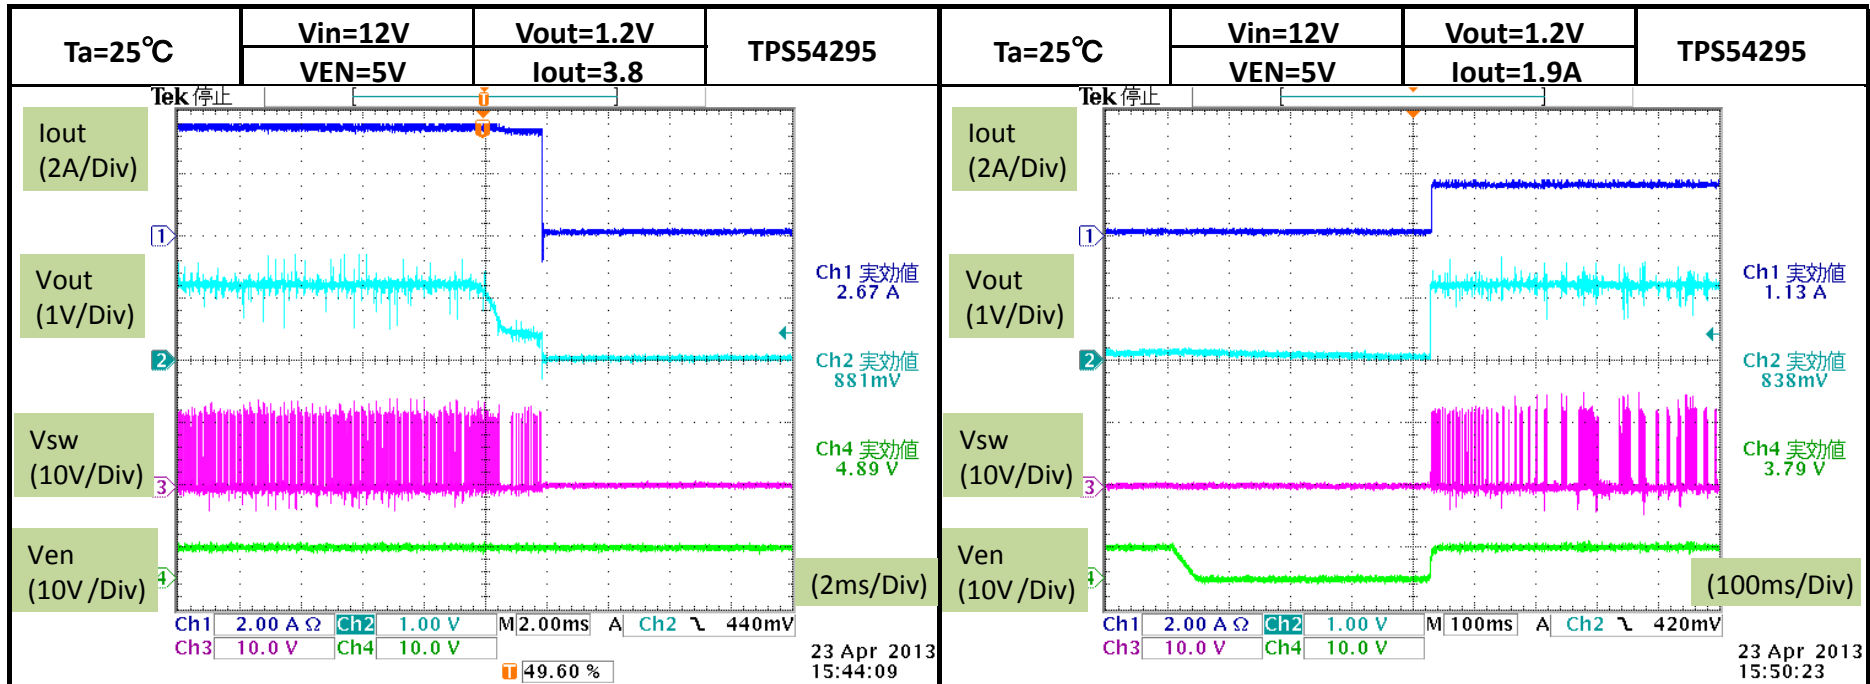
Since too much load current, OCP situation happen, then output voltage was decreased. This triggers UVP protection and SW stopped.

Even though load current was decreased, TPS54295 did not recover, since it's latch-off. Once EN pin is toggled, then restarted.

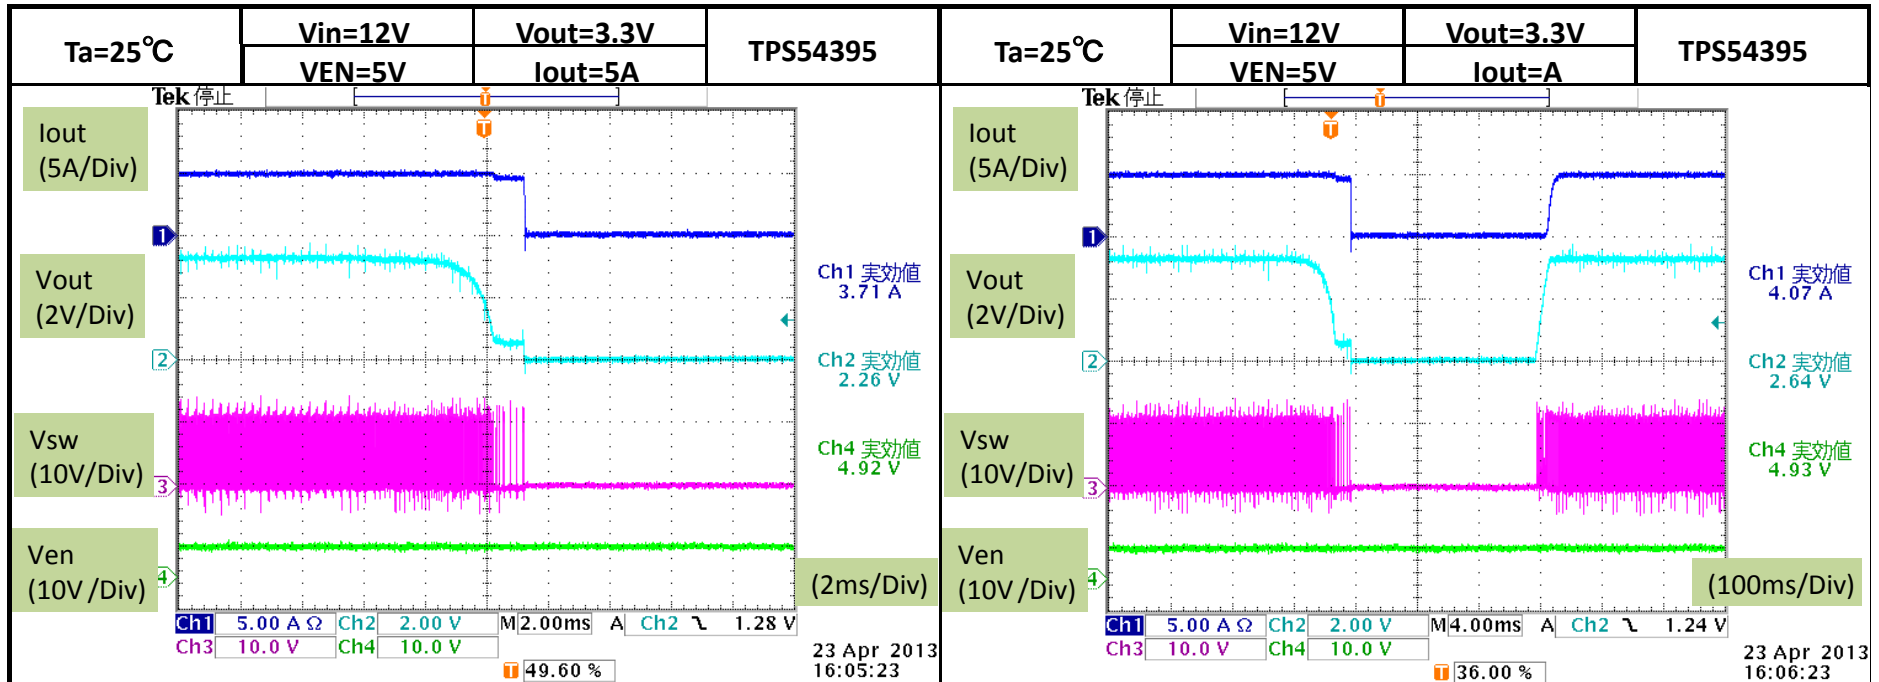
TPS54395 Result

Same as previous waveform, too much load make OCP and UVP situation, then SW is stopped.

Since TPS54395 has Hiccup topology, after the delay time (see datasheet page8), device try to restart by itself.
