## Removing “Pop” Noise in TAS570X Power-Up

Audio Products

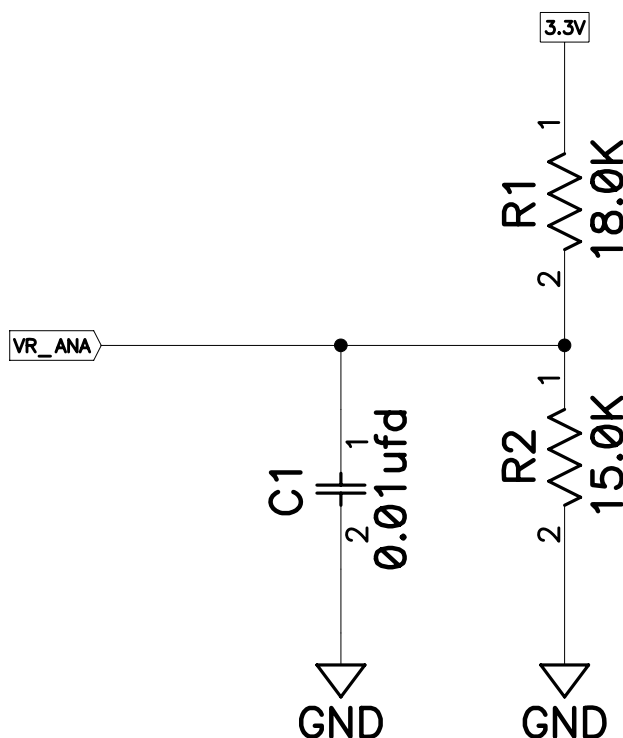
**Figure 1: De-"pop" Circuit**

The “pop” noise in a TAS570X device can occur when PVDD is applied to the device before the 3.3V line has reached its specified value. The root cause is a leakage current problem with the 3.3V output drivers. The output drivers require a 1.8V and a 3.3V supply to operate. The 1.8V supply comes from the pin VR\_ANA, and the 3.3V supply comes from AVDD. If the VR\_ANA supply is not present, but the AVDD supply is present and ramping up to 3.3V, leakage currents charge up the internal nodes of the driver, starting the driver and driving AVDD to the output pad. During this time the state of VALID signal is unstable and can turn on the power stage briefly causing the “pop”.

The first cause for the “pop” noise is current leakage while the VR\_ANA supply is absent. The circuit described in this section offers a way to keep the VR\_ANA supply present while AVDD ramps to its operating value.

The de-“pop” circuit shown in Figure 1 is a voltage divider for AVDD. The resistor R1 is placed between AVDD and VR\_ANA, and the resistor R2 is placed between VR\_ANA and AVSS. The voltage between VR\_ANA and AVSS across R2 should be 1.5V when AVDD reaches 3.3V. This is found by voltage division. When AVDD is at 3.3V, the voltage at the VR\_ANA node needs to be

$$\frac{R_2}{R_1 + R_2} \cdot 3.3V = \frac{1.5k\Omega}{1.8k\Omega + 1.5k\Omega} \cdot 3.3V = 1.5V.$$

This voltage across R2 acts as a bias voltage for the pin VR\_ANA as AVDD ramps up to 3.3V. The capacitor in the circuit from VR\_ANA to AVSS filters out 3.3V supply noise.

Application of the De-"pop" circuit to a TAS570X system eliminates the power-on "pop" noise. The VR\_ANA supply will ramp at approximately the same rate as the AVDD supply, because the two supplies come from the same source. A voltage on VR\_ANA will be present while AVDD is ramping, but still below 3V. This means that even though the voltage regulator for VR\_ANA is off for AVDD less than 3V, the biased voltage on VR\_ANA will prevent current leakage to the output drivers. Since the circuit prevents the current leakage to the output drivers, the circuit prevents the "pop" noise.
