# AWR1243+DCA1000EVM problem

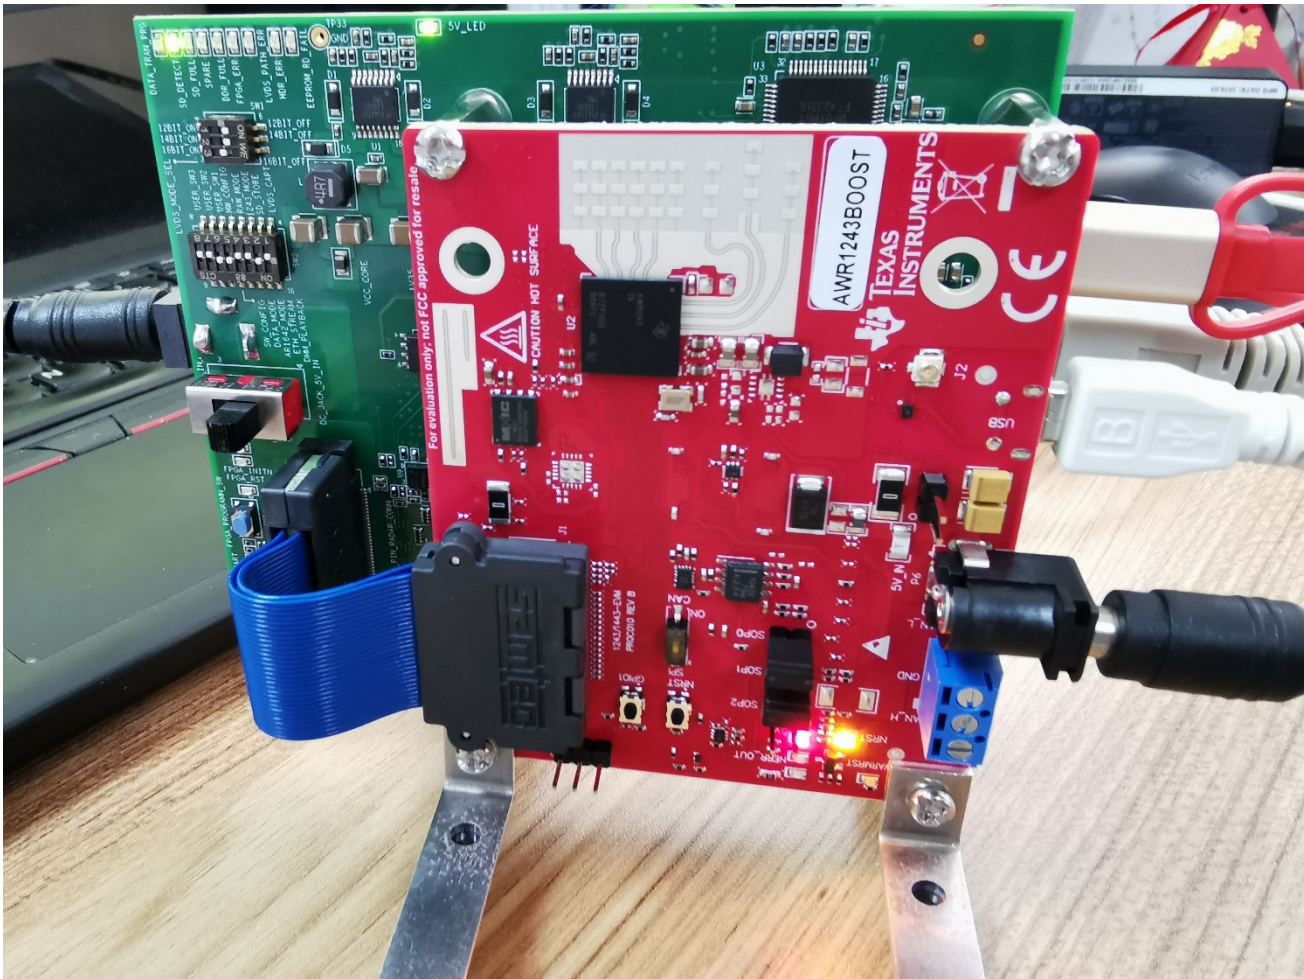
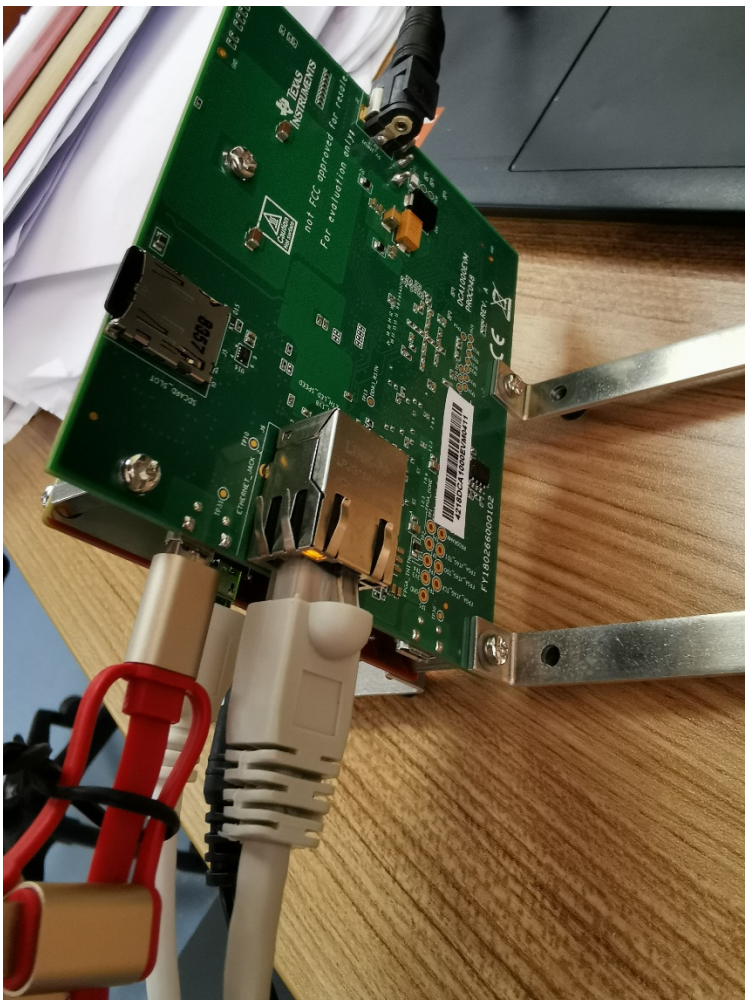
1. Connect the hardware to the PC (see the picture), and the software and corresponding drivers are installed correctly. See below

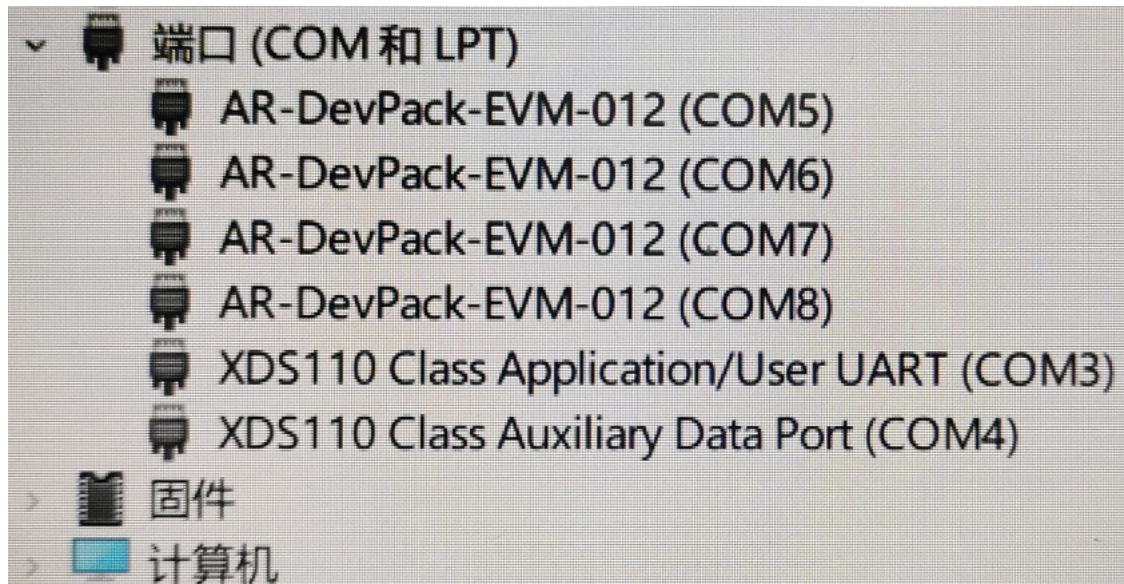
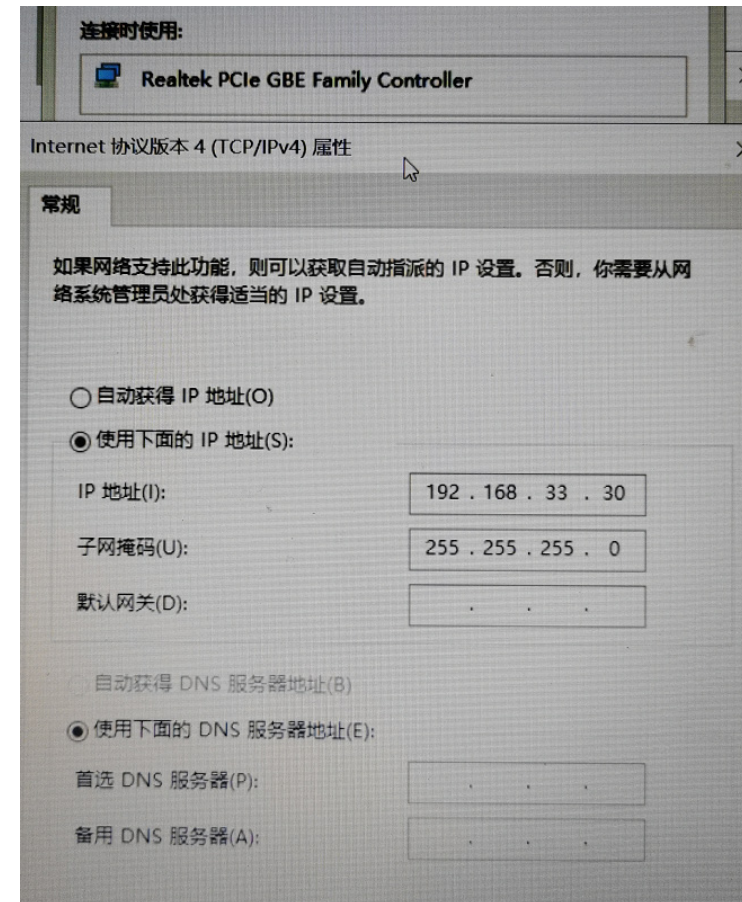
Third step: **RS232 Operations and push the connect button (Connect (2)) (The output shows Error: Connection failed: calling \_connect Target returned 3)**

3. I have changed three host PCs, but the connection problems are always existed. What is more, the light of ethernet is yellow.

RS232 Connectivity Status: **Disconnected**

[17:01:42] [RadarAPI]: Status: Passed
[17:01:42] [RadarAPI]: arl.SOPControl(2)
[17:01:42] [RadarAPI]: Status: Passed
[17:01:49] [RadarAPI]: arl.Connect(3,921600,1000)
[17:01:52] [RadarAPI]: Error: Connection failed: Calling_ConnectTarget returned 3
[17:01:52] [RadarAPI]: arl.Calling_IsConnected()
[17:01:52] [RadarAPI]: arl.SaveSettings('C:\Users\ASUS\AppData\Roaming\RSTD\arlgui.ini')
```
