We are trying to extract raw ADC data from the AWR1843BOOST and DCM1000EVM board through mmWave Studio. But we are facing multiple errors while doing the same.

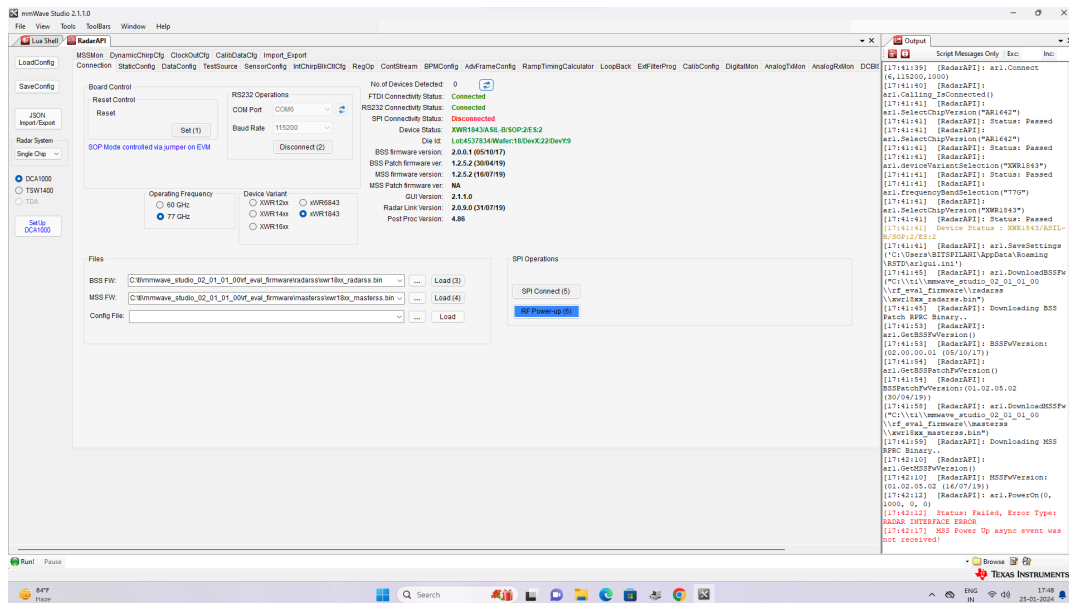
### The error faced is

[17:42:12] Status: Failed, Error Type: RADAR INTERFACE ERROR

[17:42:17] MSS Power Up async event was not received!

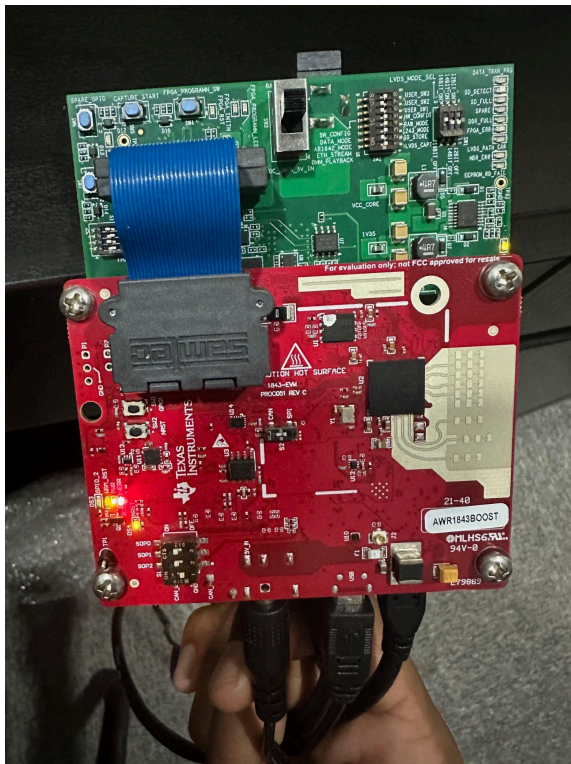
On startup of the device, the DS1 NERR LED is switched on RED. On searching up this we found out that this means a HW error. But this red light would go away once the MSS file was loaded. Attaching the hardware setup picture for your reference.
