TOF Detection Problem

Problem:

We cannot get consistent TOF indications from theTDC1011, STOP signal detected varies as much as 30uS, reading to reading, with a 300uS delay between readings.

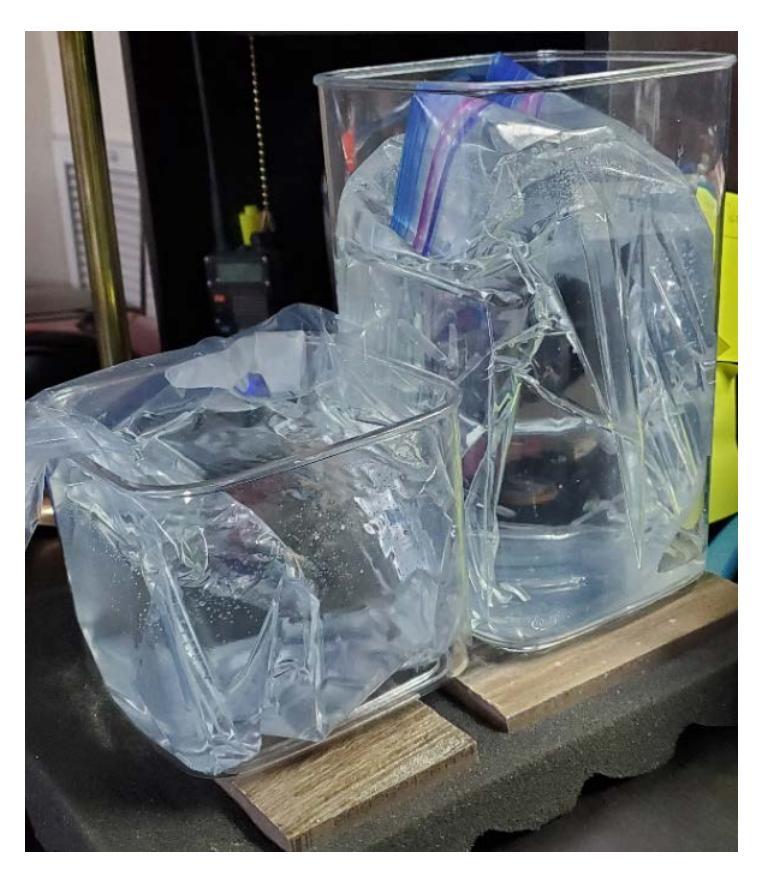
We are using plastic bags with different levels of water (one 3.5" and one 7.5") housed in acrylic containers with ceramic plates below and the transducer is mounted at the top of a bag of water, we get spurious readings for Time-of-Flight from TDC1011.

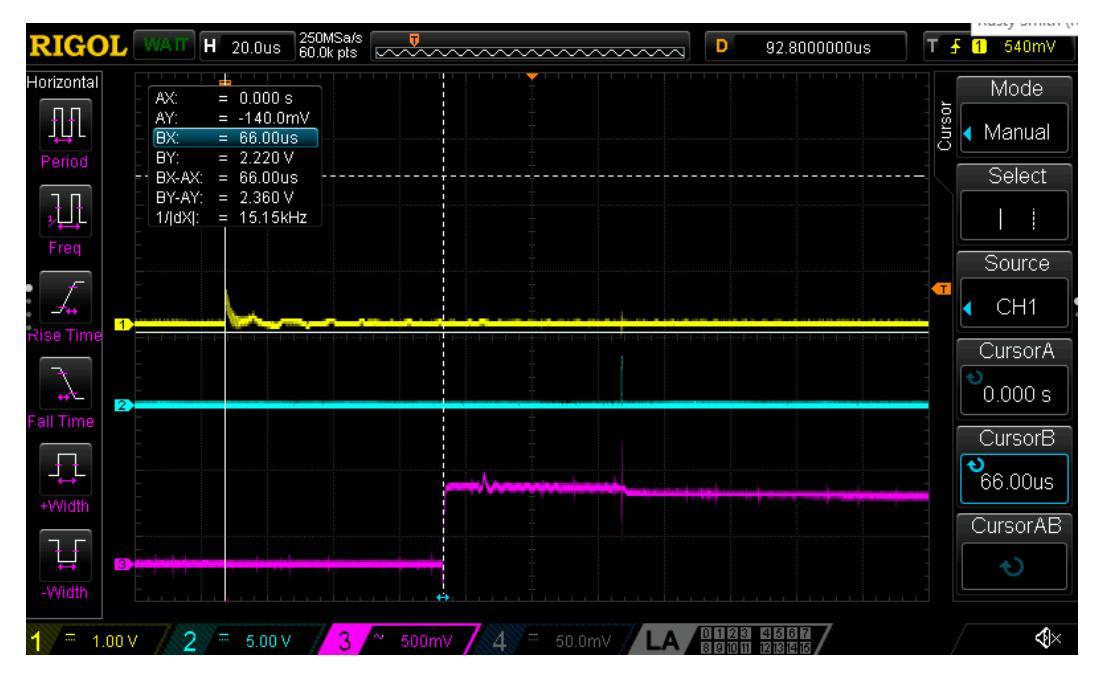
3.5" container and 28mm piezo: CH1 = TRIG, CH2 = STOP, CH3 = COMPIN TRIG to COMPIN = 66uS

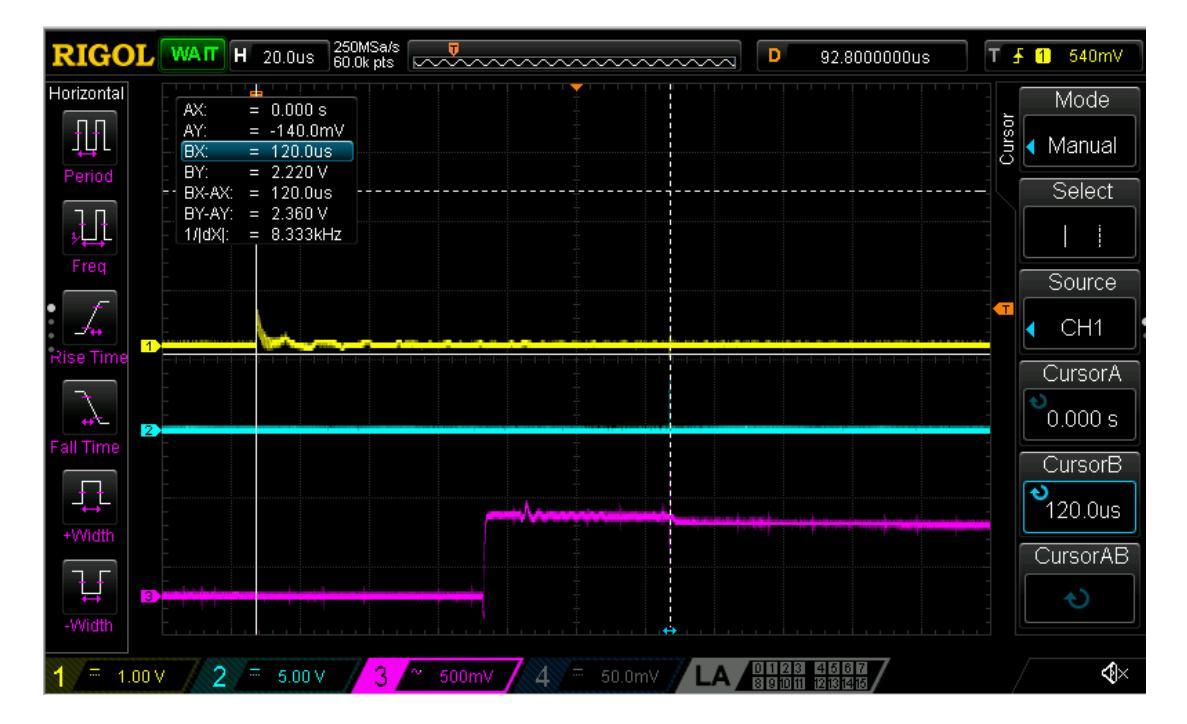
3.5" container and 28mm piezo: TRIG to STOP = 120uS
