During some initial testing with the TPS65987D we found what appears to be an error in the datasheet.

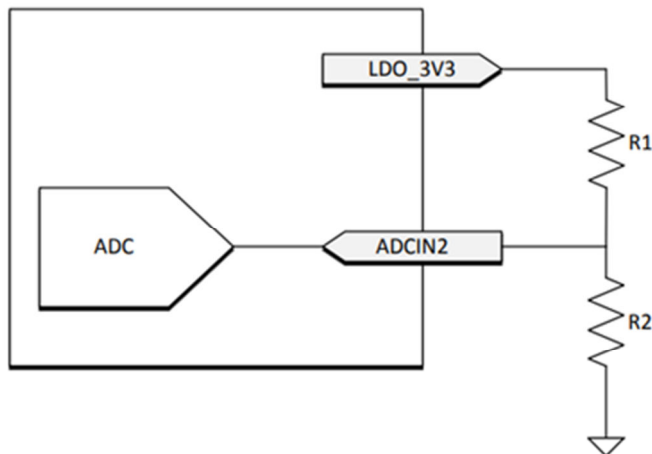
Figure 32. I²C Address Divider

Based on our testing though, I2C2 is behaving as I2C1 from an address perspective.

If "ADCIN2" is 3.3V I2C2 ACK's at 0x23,
If "ADCIN2" is 0.0V I2C2 ACK's at 0x20.

But since we are connected to I2C2, ADCIN2 should have no effect on I2C2 address, which based on the table should be fixed at 0x38.
