The problem I am experiencing is that there is ripple on my +VBUS rail when those 3 IC are switched on.

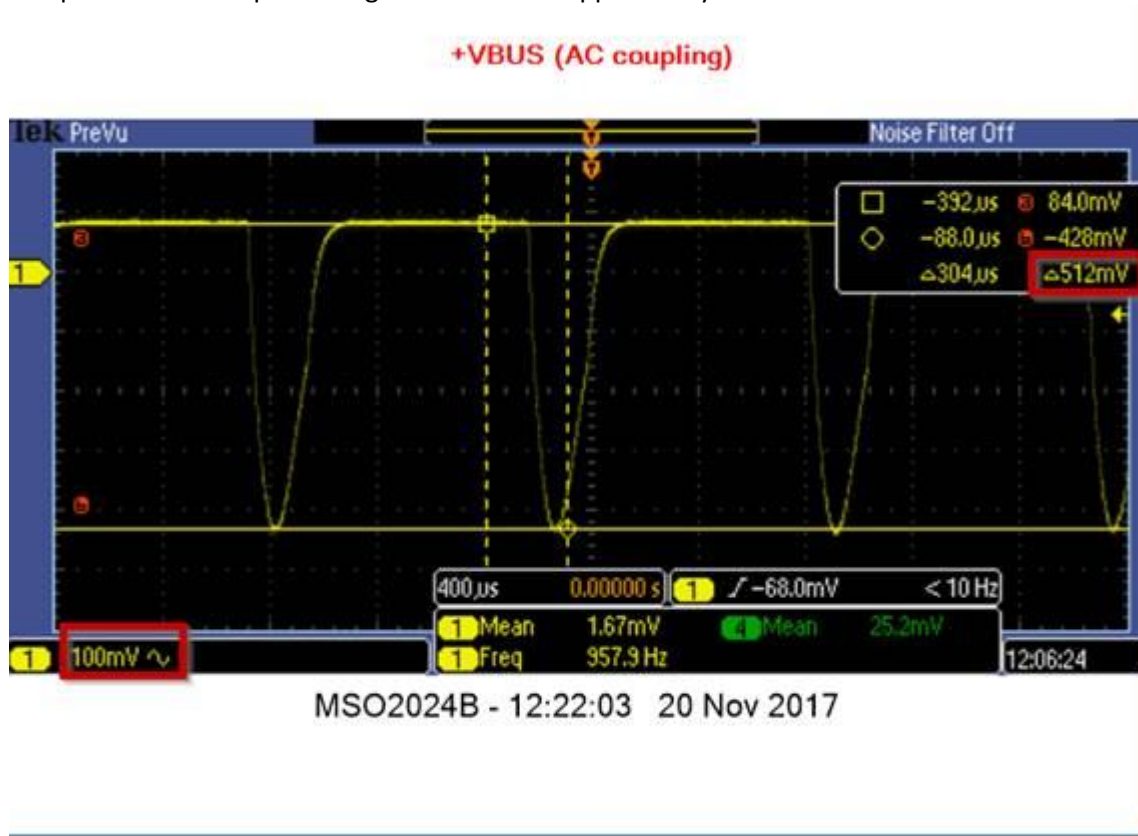
I am testing on 2 boards at the moment and the behaviour is not the same. (frequency of the ripple and amplitude are different)

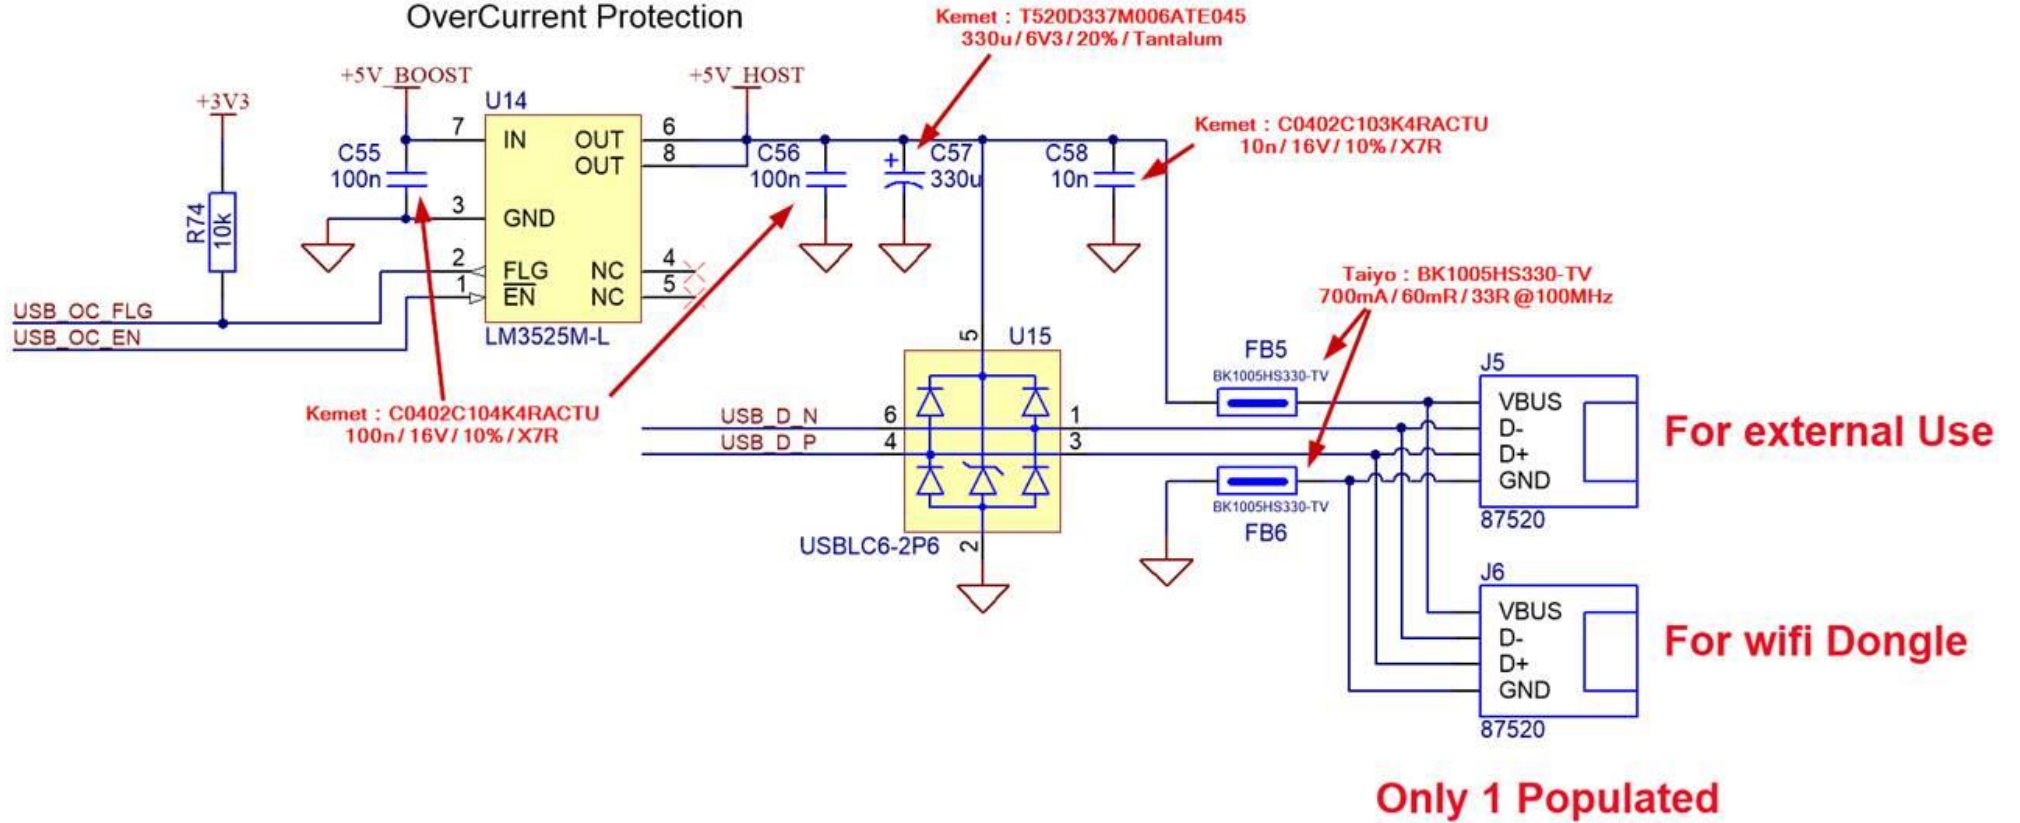
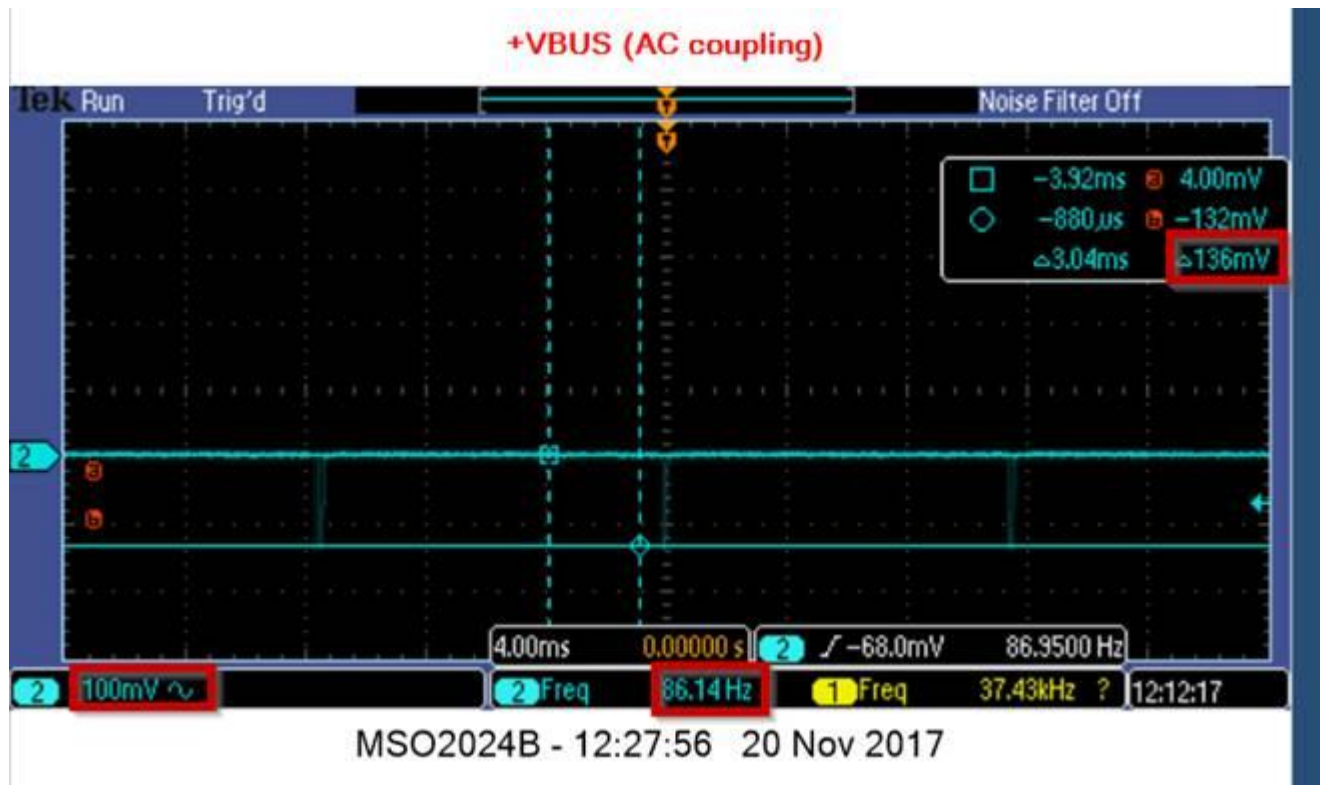
OverCurrent Protection

By process of elimination we found out that the ripple was induced by the 5V power rail.

That power rail feeds 2 RGB LEDs and a USB A connector for a host. We are currently using the USB connector for a Wi-Fi dongle. We are using an Over current protection IC for the USB Host connector (LM3525M-L).

We narrowed the problem down to that IC (LM3525). So when we disable the IC (EN pull HIGH), the ripple disappears but the VBUS line is still noisy.

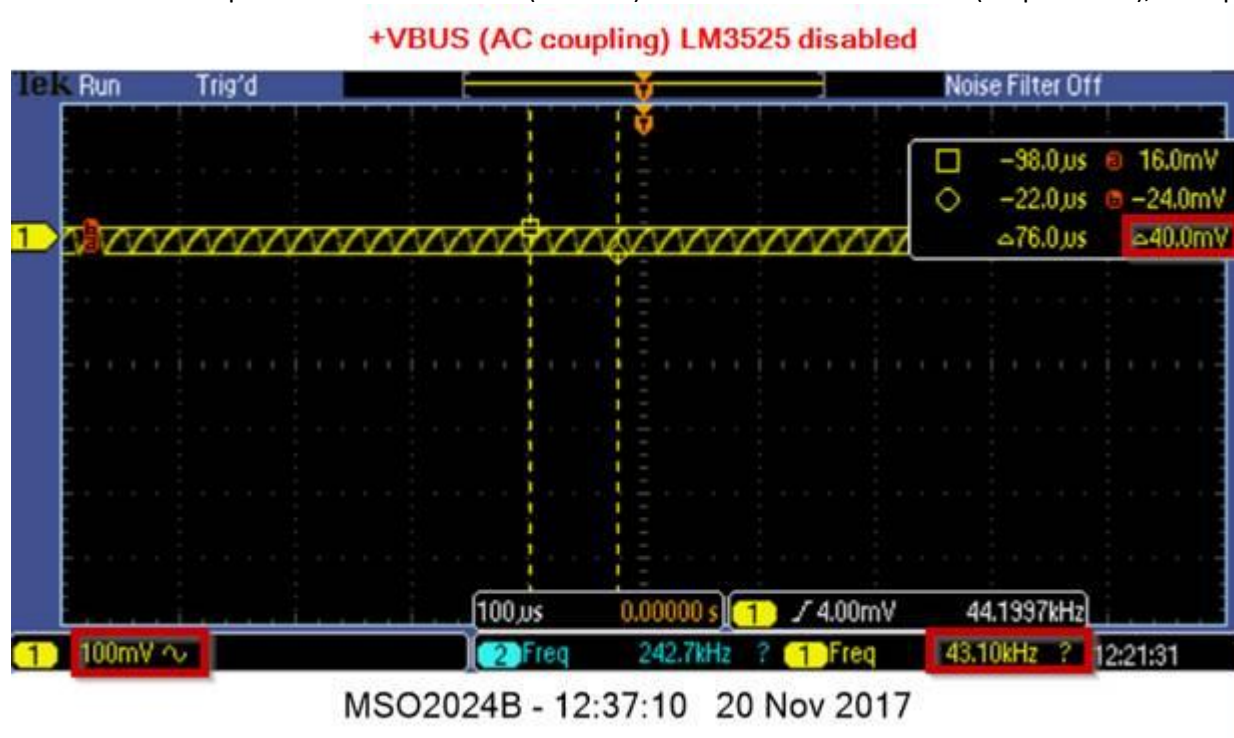
We can observe the same phenomenon when the Bulk capacitor (C57) is removed and LM3525 is enabled.

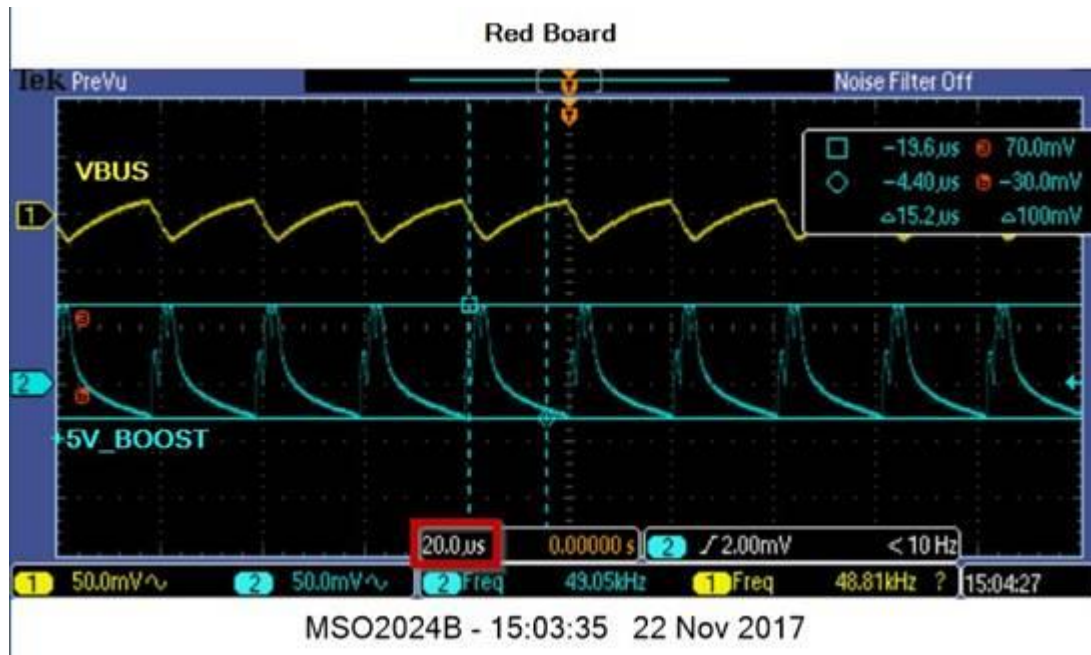
If nothing is connected to the 5V_BOOST (output of TPS61027) then the VBAT and VBUS are noisy.

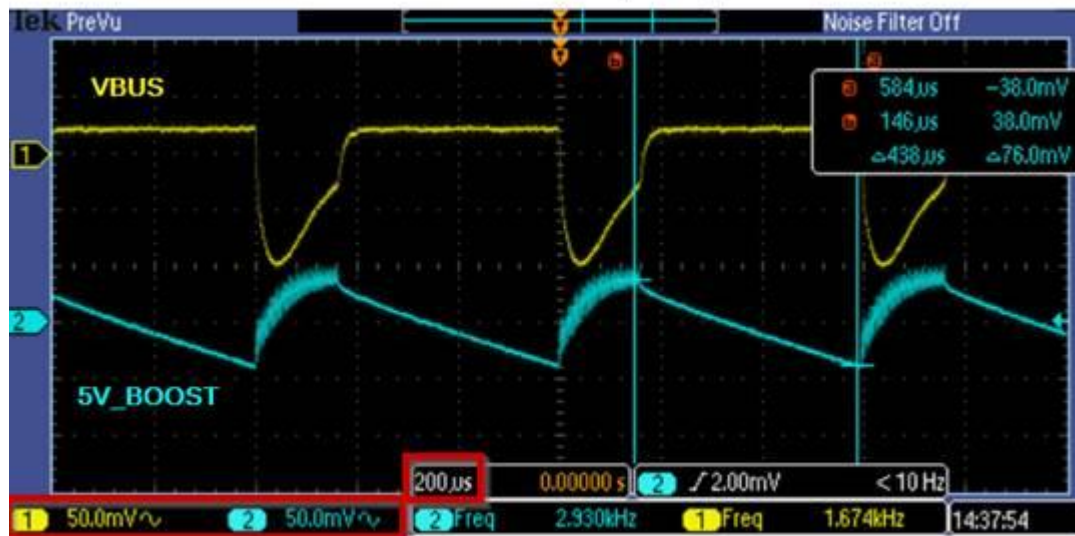
Red Board 220uF cap on 5V_BOOST

As soon as I connect something to the 5V_BOOST, I get those 100+mV ripple on the VBUS. In the following example I only use a 220uF capacitor connected between 5V_BOOST and GND.

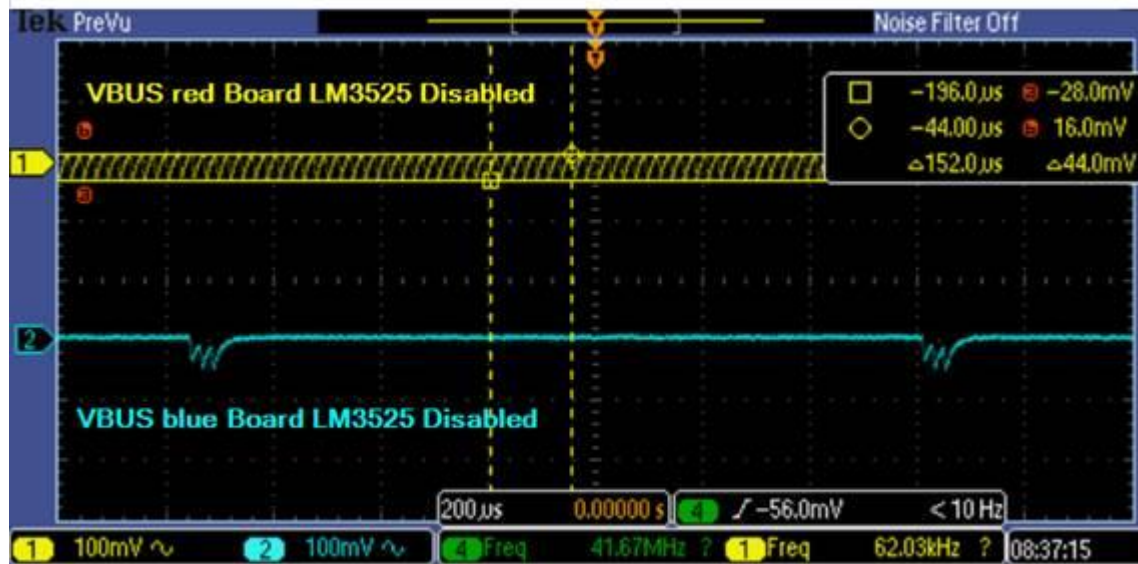
I am currently testing on 2 different boards (I named them Blue and Red board. The Red one being the “faulty” one)
You can see in the following scope screenshot the difference of behaviour on VBUS in the same conditions.

We can see that the amplitude and frequency of the ripple are really different on both boards. The behaviour of Blue board is not ideal but would be acceptable for our application. The behaviour of red board isn't acceptable for our application. The voltage dips influence the power supplies for the all system where I need them to be constant.

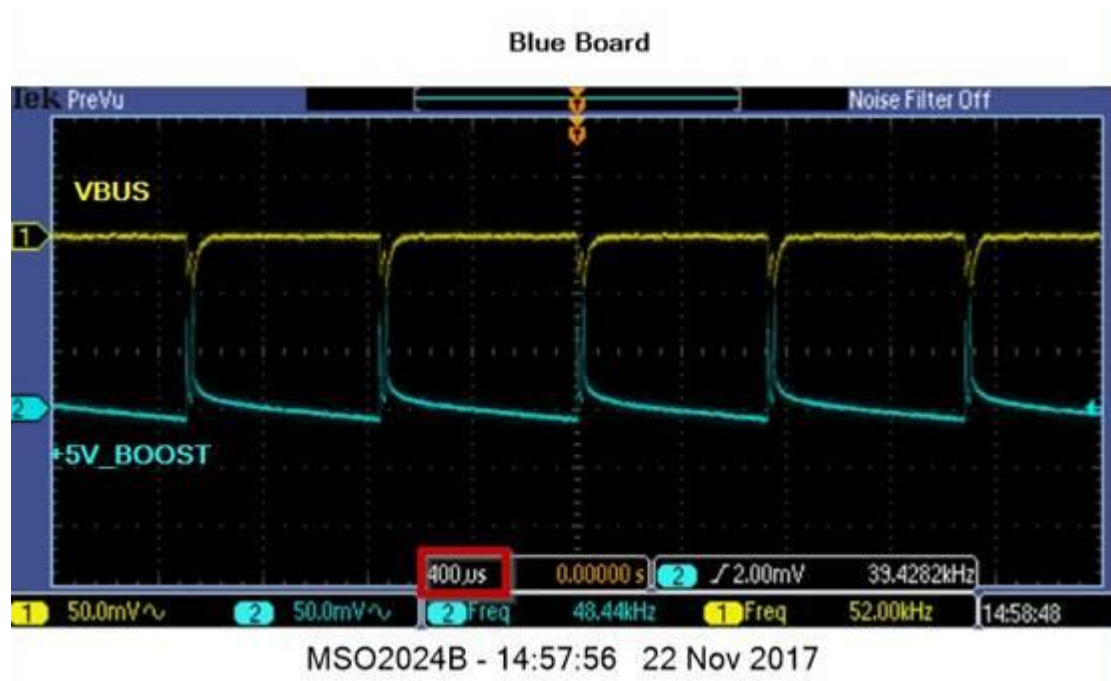
For comparisons here the screenshot for the blue board showing VBUS and 5V_BOOST with no loads
