TUSB320LAI Accessories Support Test

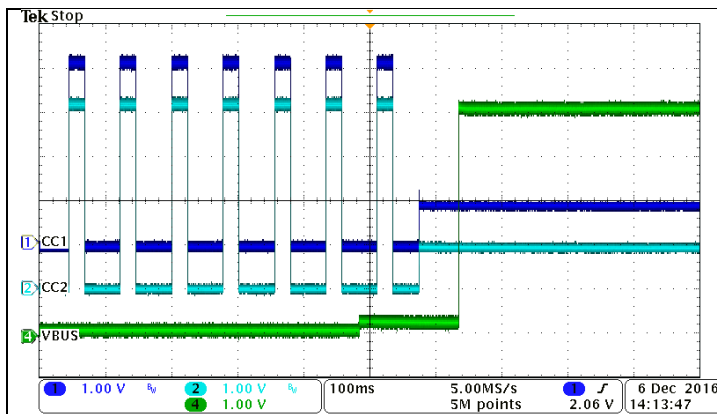
MODE_SELECT= UFP DISABLE_UFP_ACCESSORY=0 CC1 and CC2 connected to Rp + VBUS applied later.

No debug accessory is detected, TUSB320 cannot enter DebugAcc.SNK state. (Conclusion 2)

1. The most strange thing, if the CC1 and CC2 detected Rd at DRP mode, DebugAcc.SRC is detected (Reg 0x08[3:1]=110). While if the CC1 and CC2 detected Rd at UFP mode with accessory support, DebugAcc.SNK is detected (Reg 0x08[3:1]=111).
2. At all the case, if the CC1 and CC2 detected Rp, the device cannot enter DebugAcc.SNK state.

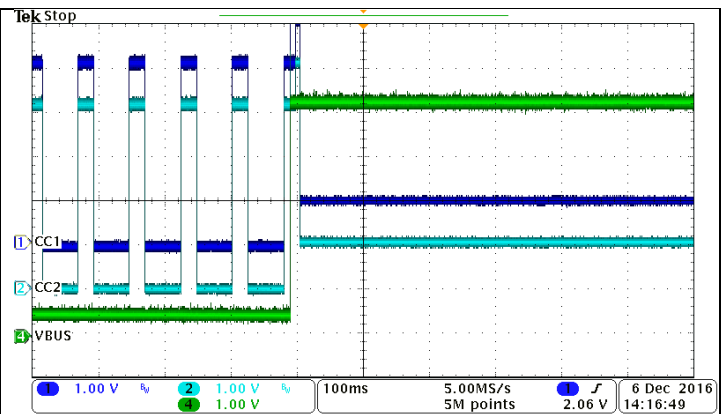
MODE_SELECT= UFP DISABLE_UFP_ACCESSORY=0 CC1& CC2 connected to Rp + VBUS applied. VBUS and Rp applied at the same time.

No debug accessory is detected, TUSB320 cannot enter DebugAcc.SNK state. (Conclusion 2)
