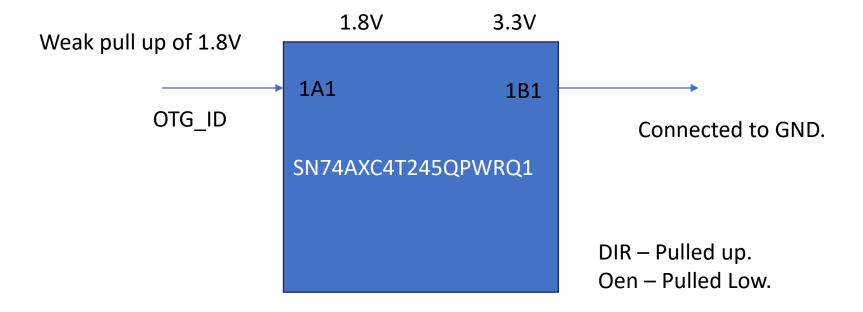
All other signals are from A to B is required and working properly.

Issue: OTG\_ID has to be B to A, by mistake this has been connected as A to B. During operation we are seeing this is working for our use case without any issue. Only concern is whether this usage will have any adverse affect on life of the buffer of particular pin or IC
