TMS430F28377D: **Inquiry about Power up sequence**

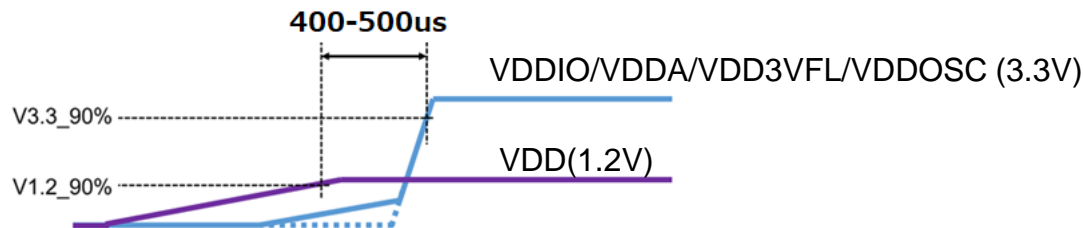
Customer is develop the next generation of their system with TMS320F28377DZWT, they noticed there is the issue on power-up sequence in their system. According to customer's comments, their power-up-sequence is as follows. This means, VDDIO is powered up after VDD(1.2V) is powered up. As the result, customer seems to observed the leakage on VDDIO power rails.

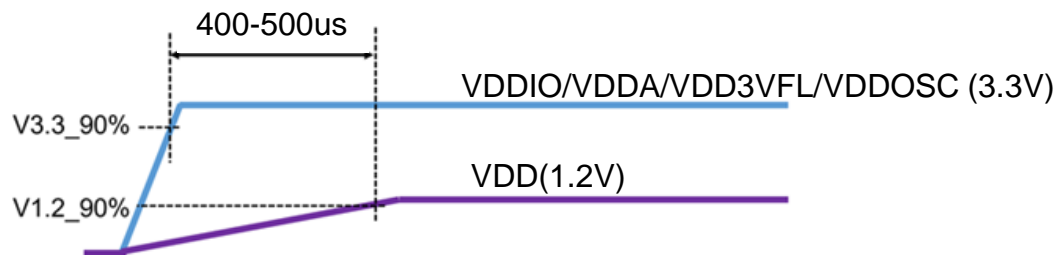
Therefore, customer plans to modify above power sequence as follows. However, customer has some inquiries about this power-up sequence (next page).

1. Regarding the improved power-up sequence, VDDIO(3.3V) and VDD(1.2V) is powered up at the same time, but, there is difference in the time to actually power-up(90% voltage). This period is 400-500us. Would you think any issue for this behavior?
2. Customer is asking if they need to adjust power-up(90% voltage) time as same time? But, it seems difficult to adjust this timing.
3. Regarding above “VDDOSC(3.3V) and VDD(1.2V) must be powered on and off at the same time.”, customer is afraid that it may be spec violation. Would you think any issue for this point?
