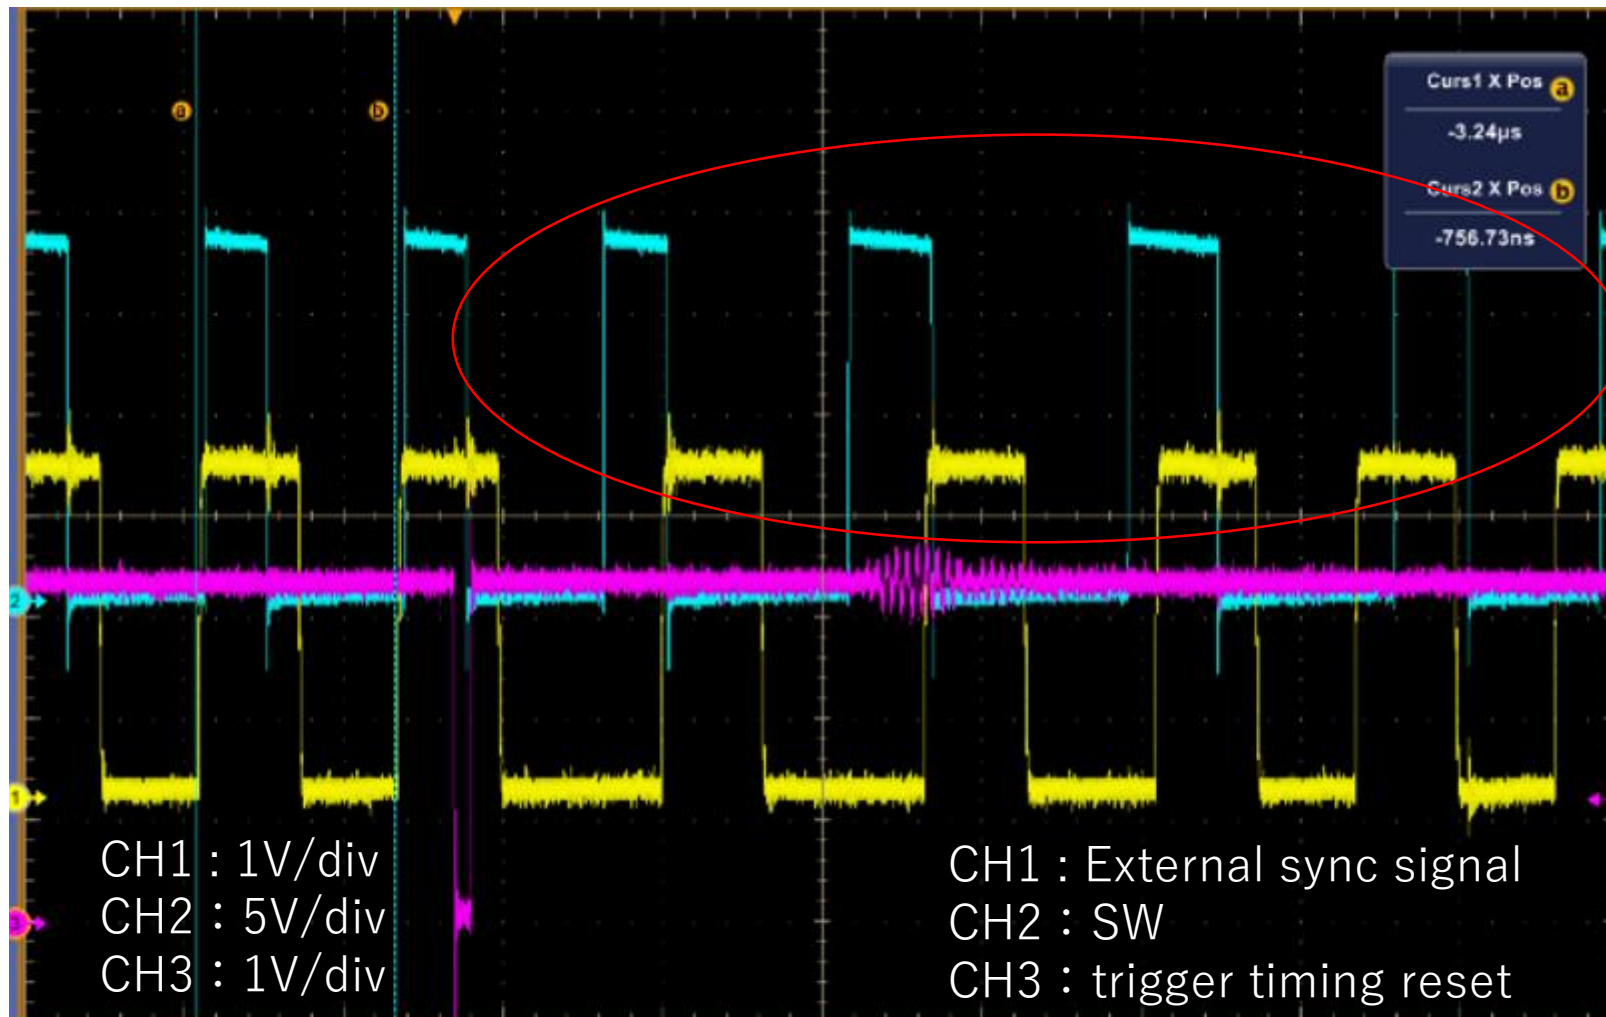
There was a problem that the synchronization frequency and SW shifted.

Vin=24V Vout=5.5V
