Please refer to our customer's circuit,

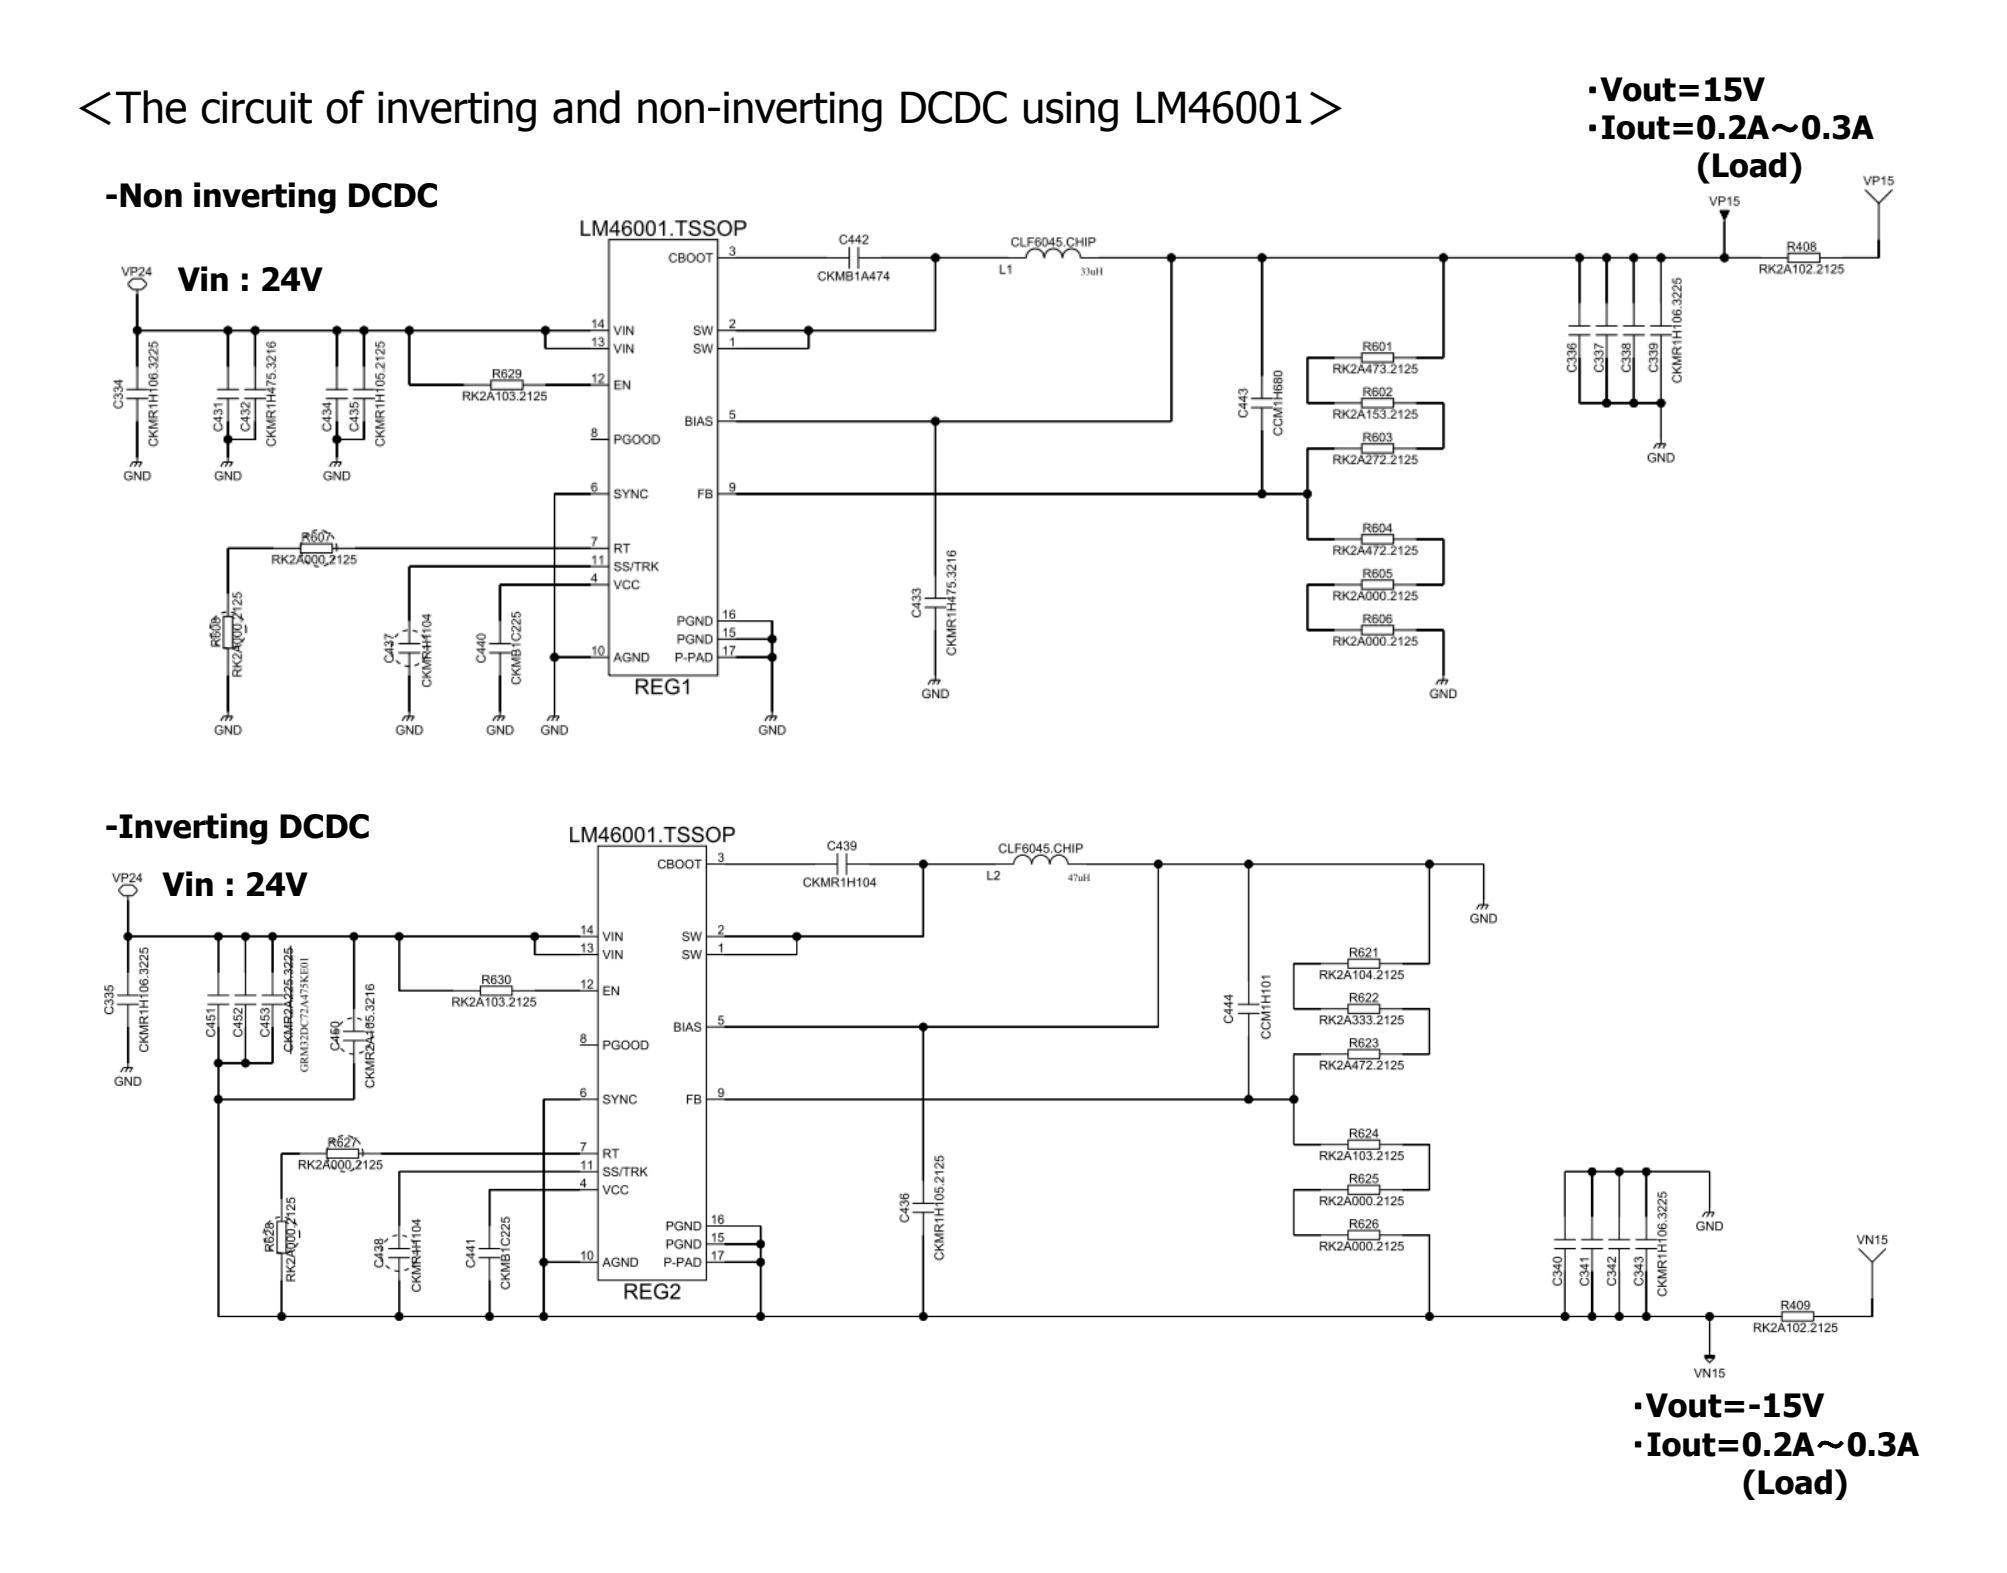
<Some failure?>

-Non inverting's LM46001 operates first, the **+0.6V(SW-GND)** is added to the SW2 of Inverting's LM46001. After that, LM46001's can't operate.

-Inverting's LM46001 operates first, the **-0.6V(SW-GND)** is added to the SW2 of Non inverting's LM46001. After that, LM46001's can't operate.

So, if the $\pm 0.6V$ is added to LM46001's SW pin, might the LM46001 not be able to operate? In the first place, we guess that it is caused by Ground layout.

According to inverting DCDC, is there possibility which GND indefinite?
