RMA Number: 203710 Model Number: U80314 Date: 12/17/2020 Check By: Thanh Nguyen

I. Return Reason

Batteries are only lasting 10 - 12 months and then unable to recharge. Date code: 2019-01

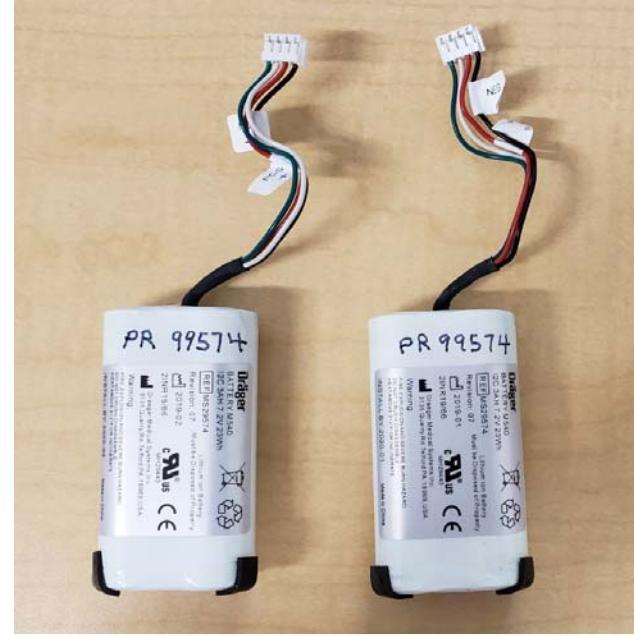
A. Appearance: Normal, no physical damaged.

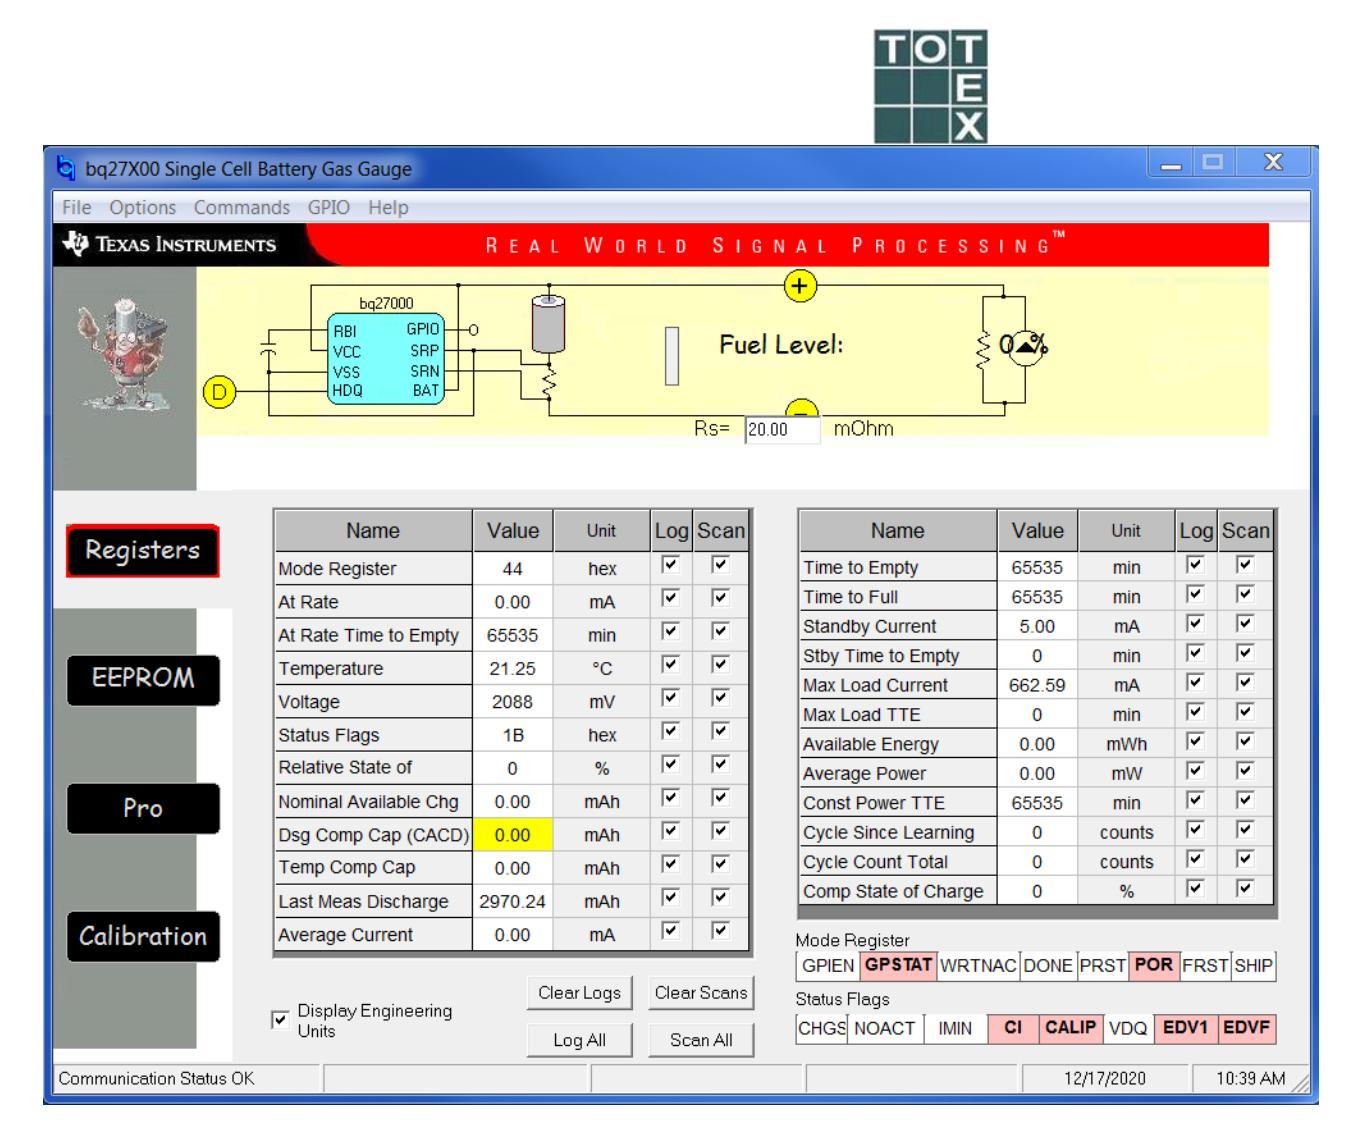
B. Batteries Fuel Gauge Before Fully Charge Test: -Pack #1: Date Code: 2019-01

Note: this battery has no output voltage and only communicates when connecting with a power supply. Also it is not taking charge.

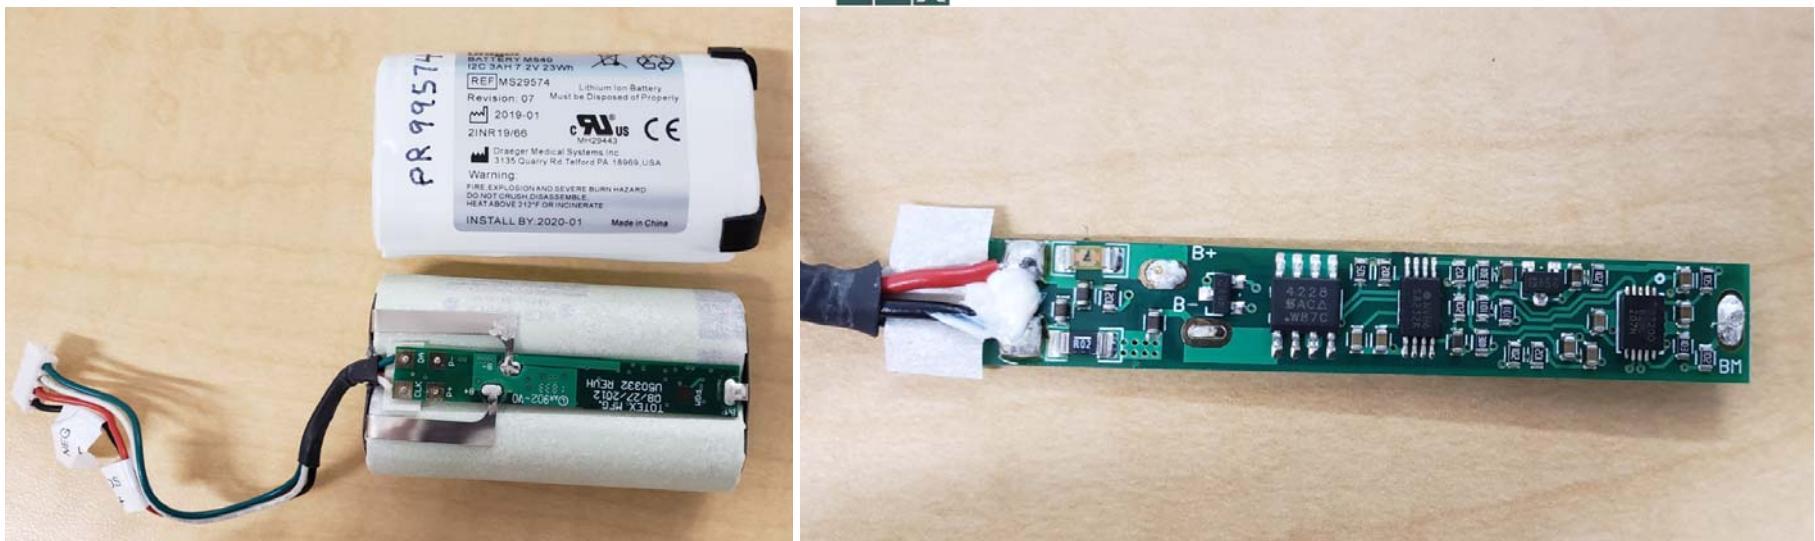
Remove protective shrink wrap

Date Code	Cell Voltage		PCBA Leakage		Domortz
	Cell 1 (V)	Cell 2 (V)	$B+(\mu A)$	BM (µA)	Kelliark
2019-01	4.103	3.786	43.4	<0.1	The cell 2 is not holding energy or taking charge.

Batteries do not show any sign of mechanical or electrical component damage. Both battery PCBAs have normal communication function and quiescent current. Their cell voltages are imbalanced, which will result in premature charge termination due to one of the cell reach cell reach over voltage threshold and trigger over charge protection.

- 1. One of the two cells in the pack is weaker than the other one. Their performance degradation rates are different. This results in Cell voltage difference increases over cycles or long storage.
- 2. Battery is operated or stored at elevated ambient temperature.
- 3. Battery is charged by voltage higher than spec limit or a broken charger.

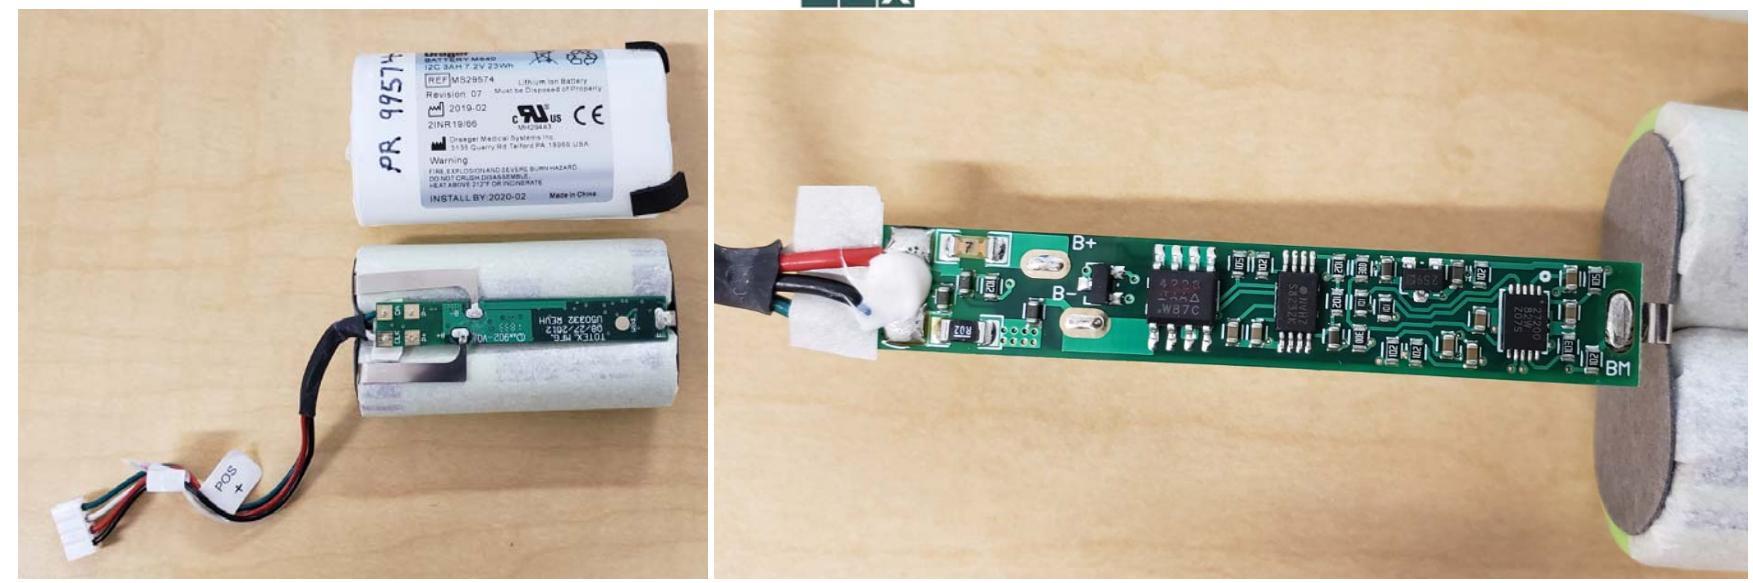
Remove the protective shrink wrap.

Date Code	Cell Voltage		PCBA Leakage		Domostr
	Cell 1 (V)	Cell 2 (V)	$B+(\mu A)$	BM (µA)	Kemark
2019-02	0	4.134	43.7	< 0.1	The cell 1 has zero voltage, and not takes charge.
