Marutakatechno Co., Ltd.  
550-1 Yahata  
Fujieda Shizuoka Japan, 426-0009

August 17, 2018

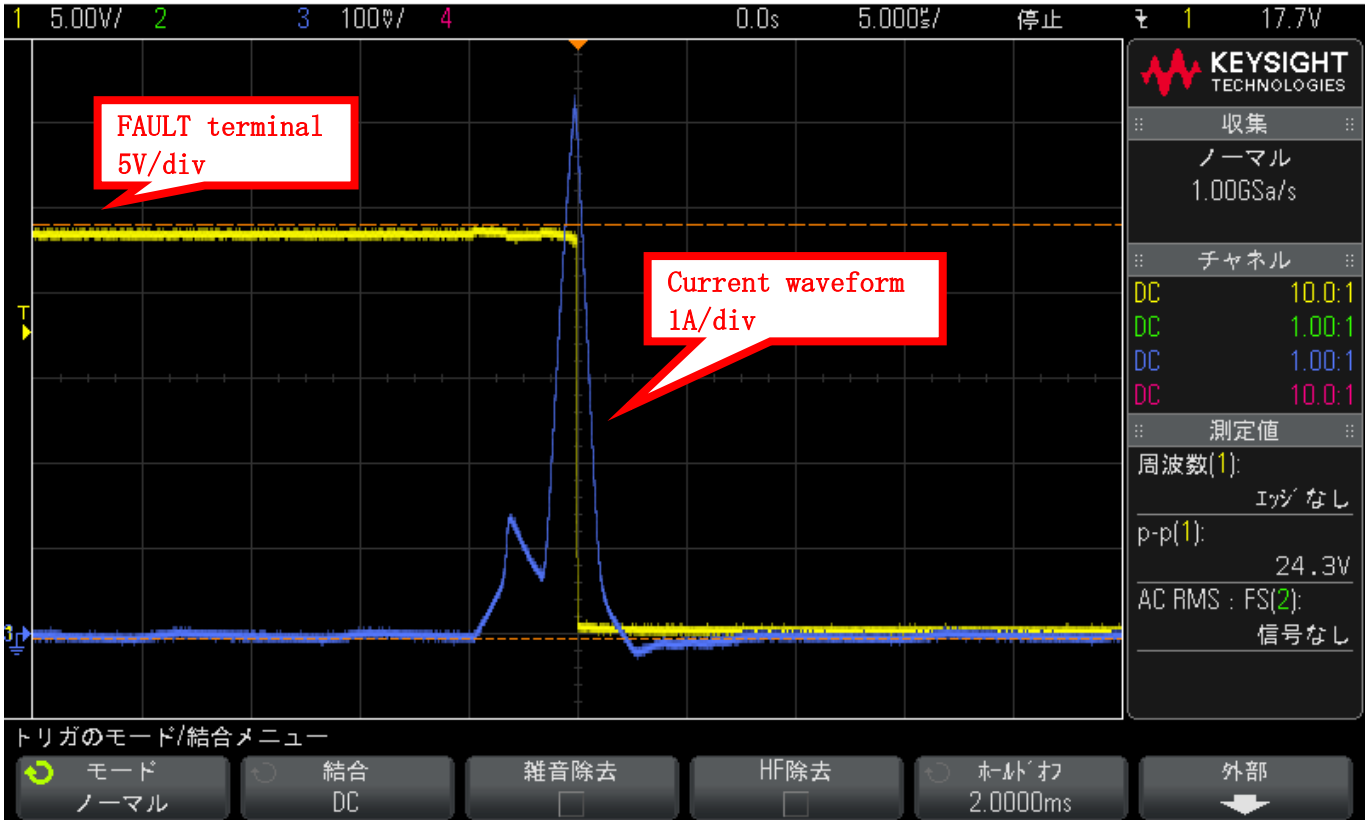
○Waveform of FAULT terminal output when switched from high to low (5us/div)

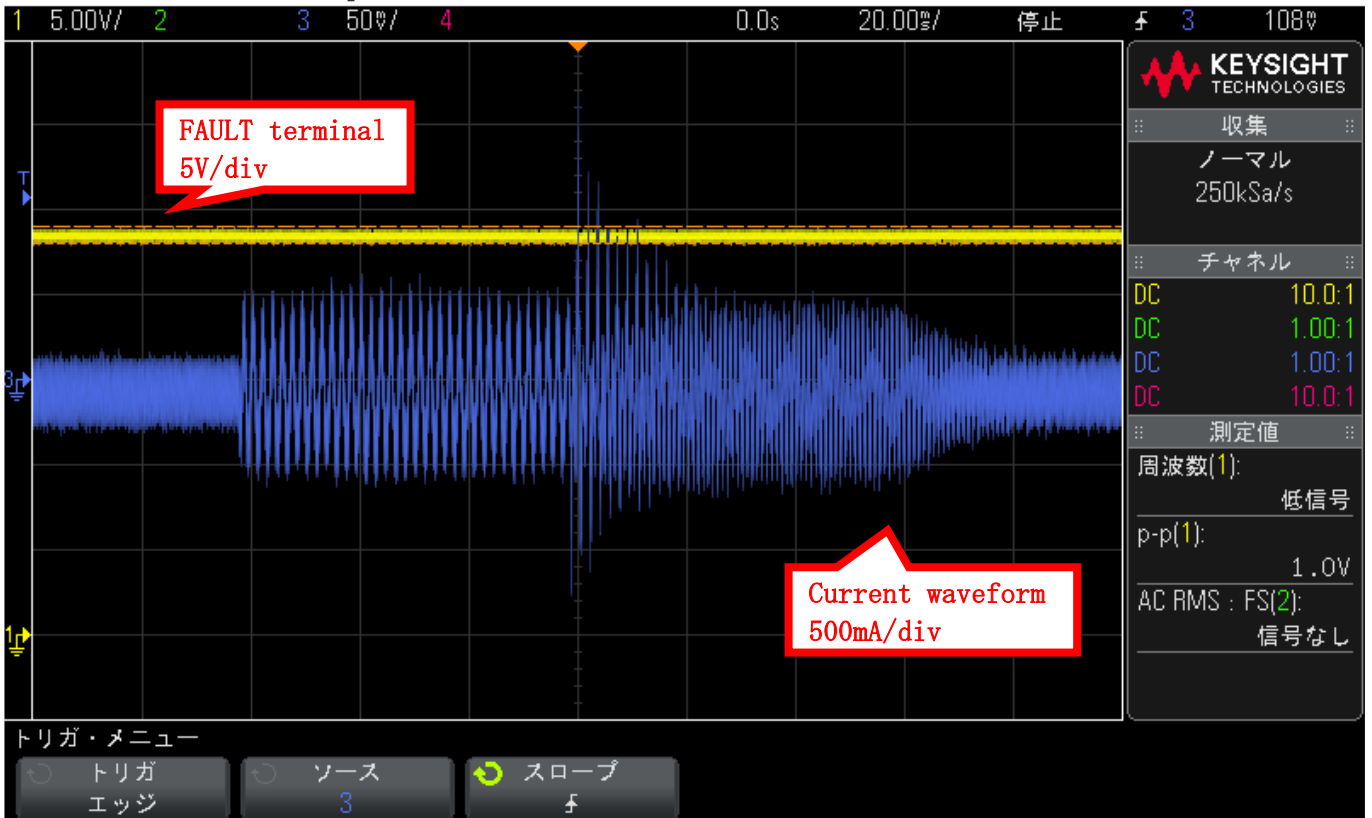
○Current waveform when beep sound is issued (20ms/div)

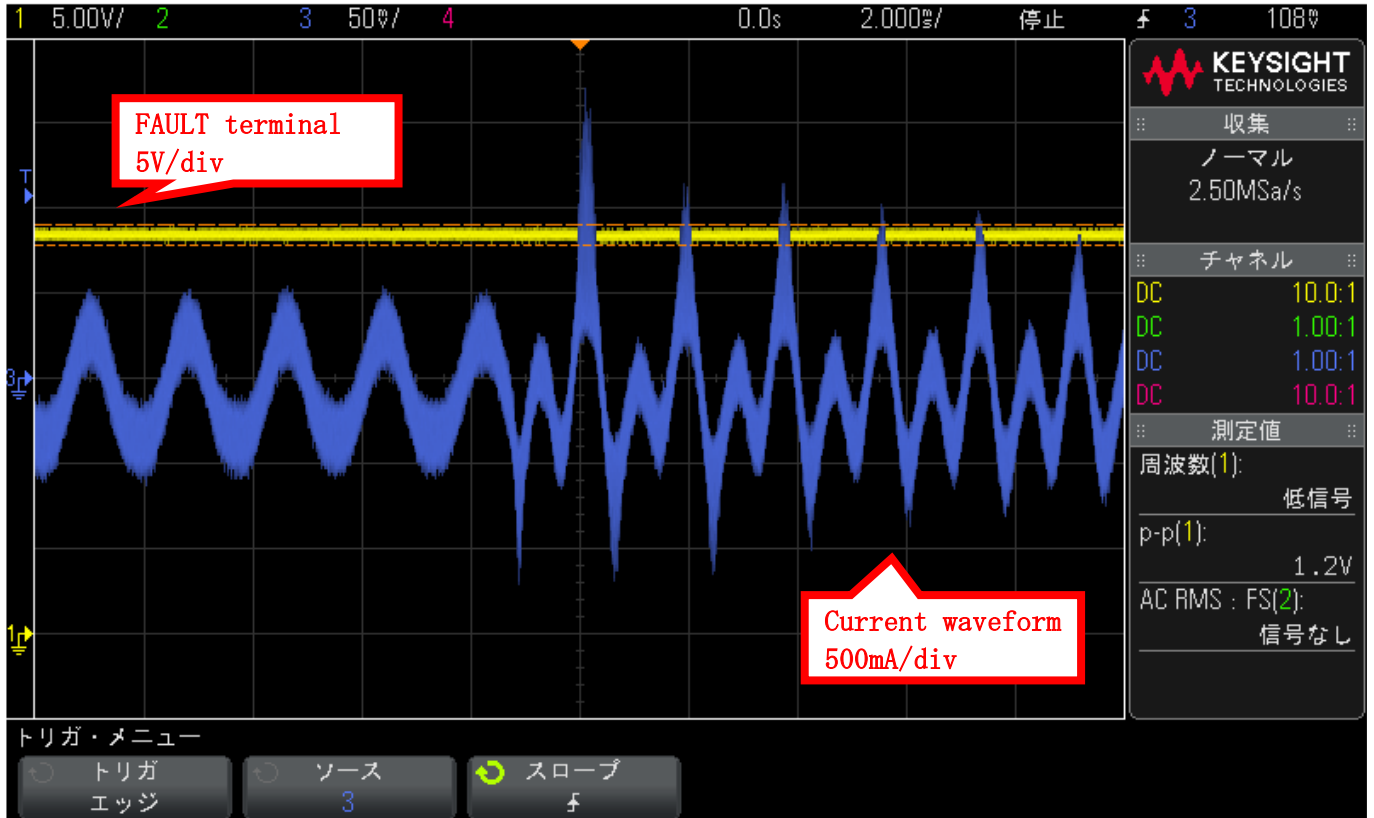
○Current waveform when beep sound is issued (2ms/div)

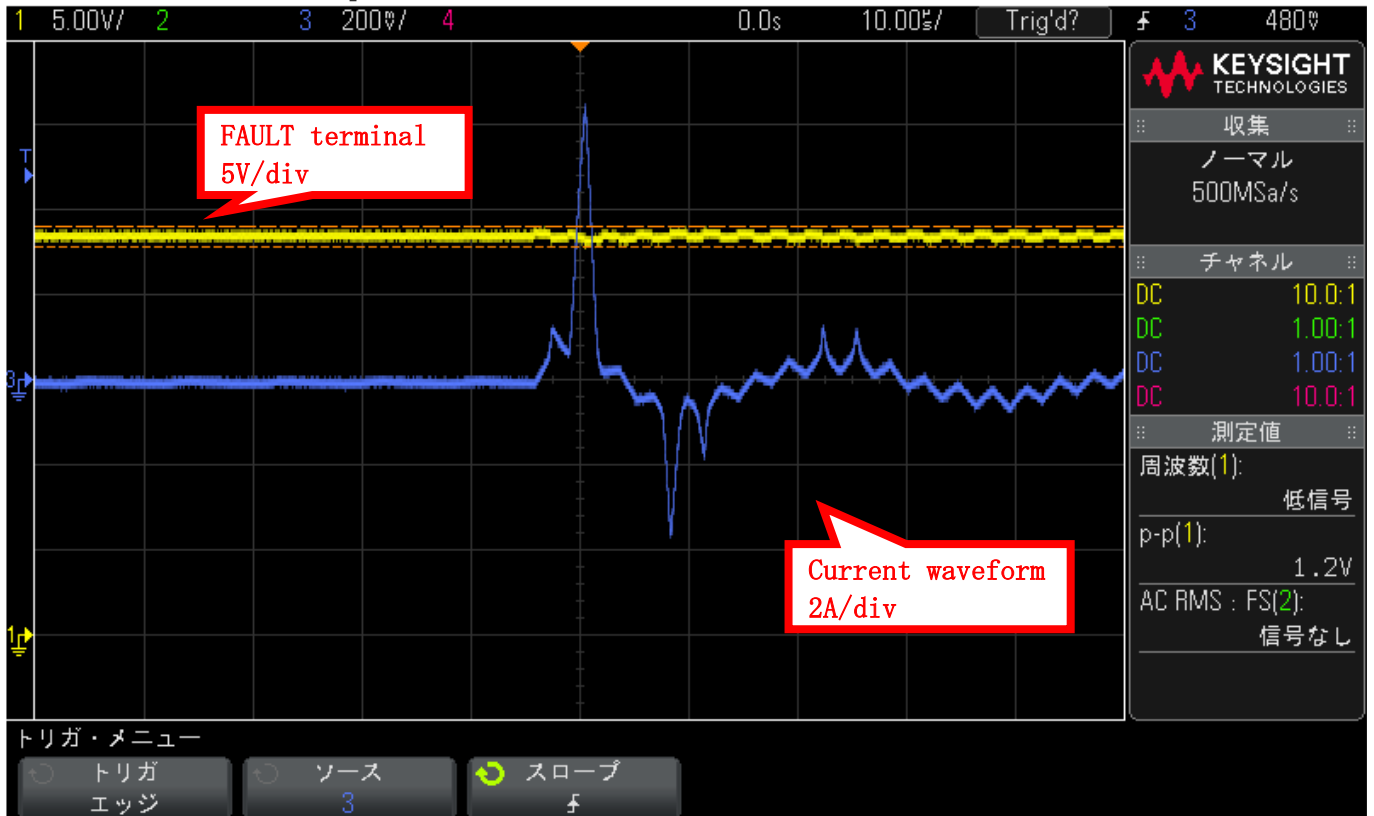
○Current waveform when beep sound is issued (10us/div)

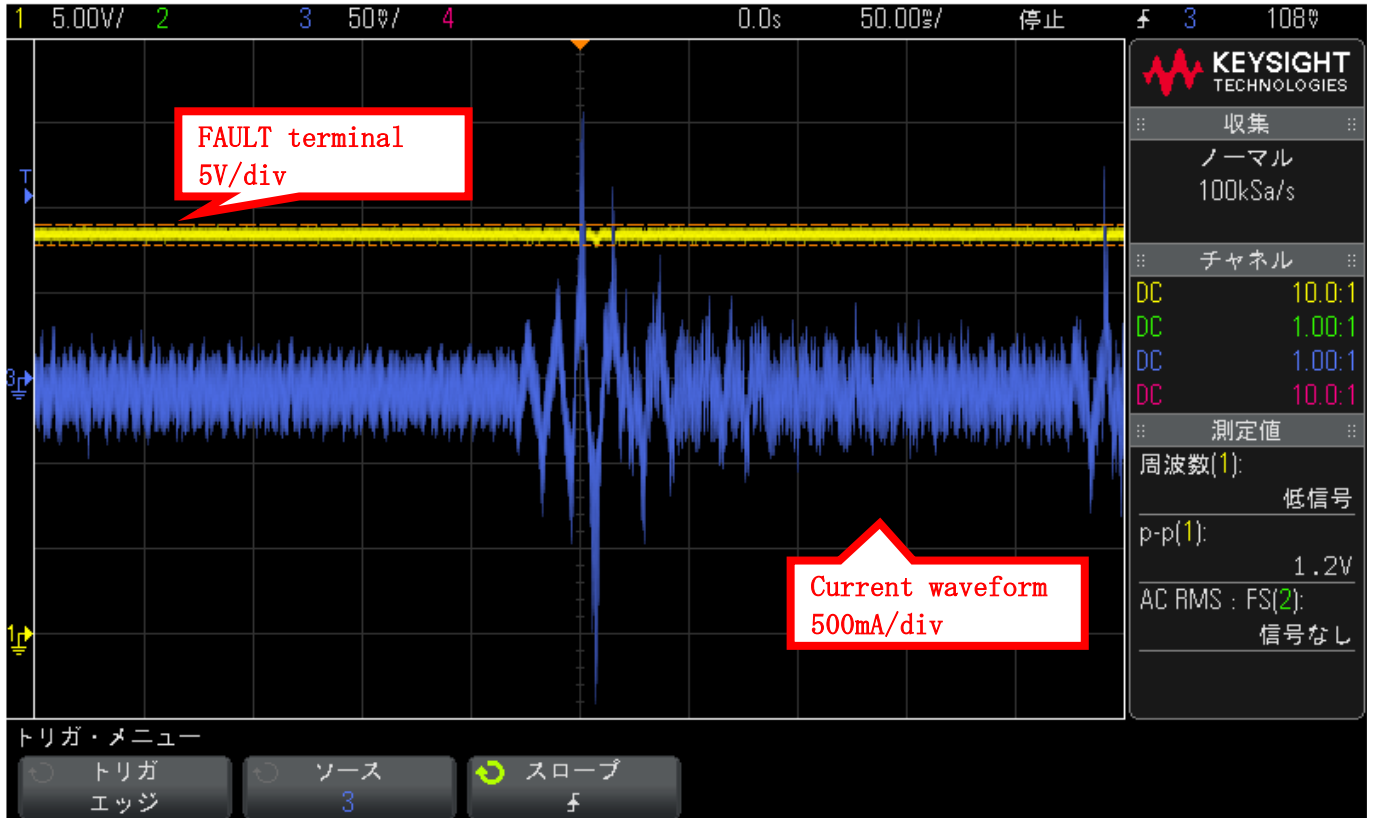
○Current waveform when music is turned on(50ms/div)

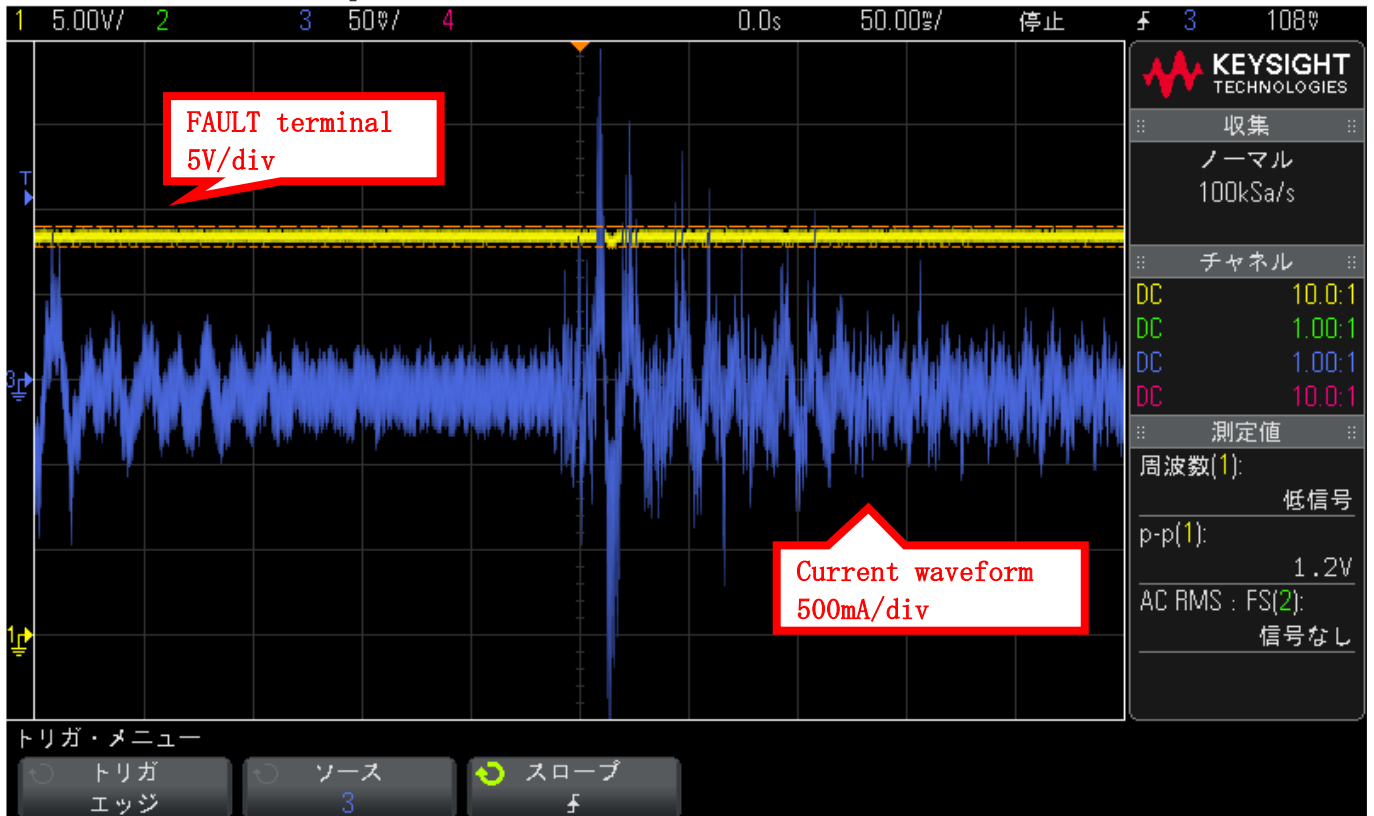
○Current waveform when music is turned on (50ms/div)

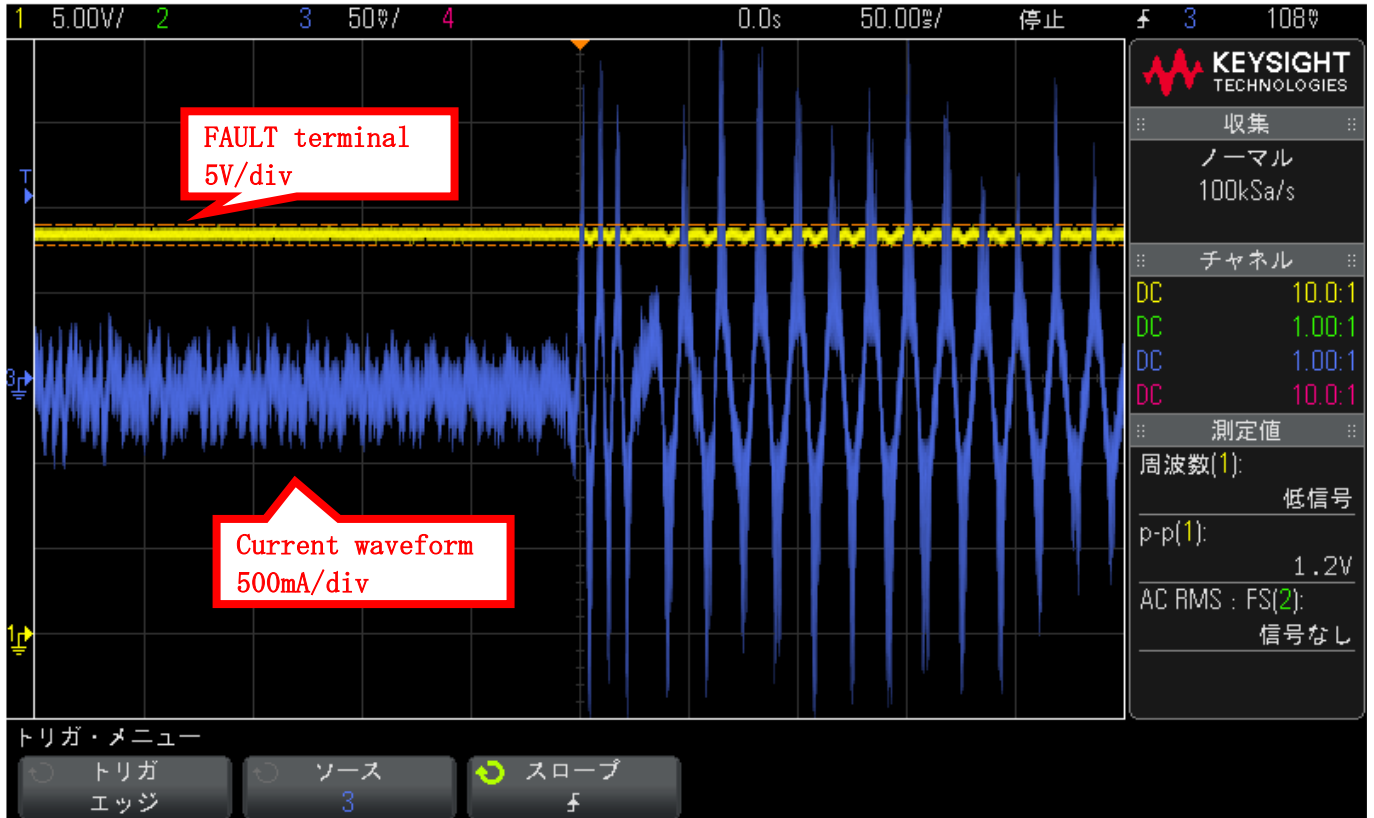
○Current waveform when music is turned on (50ms/div)

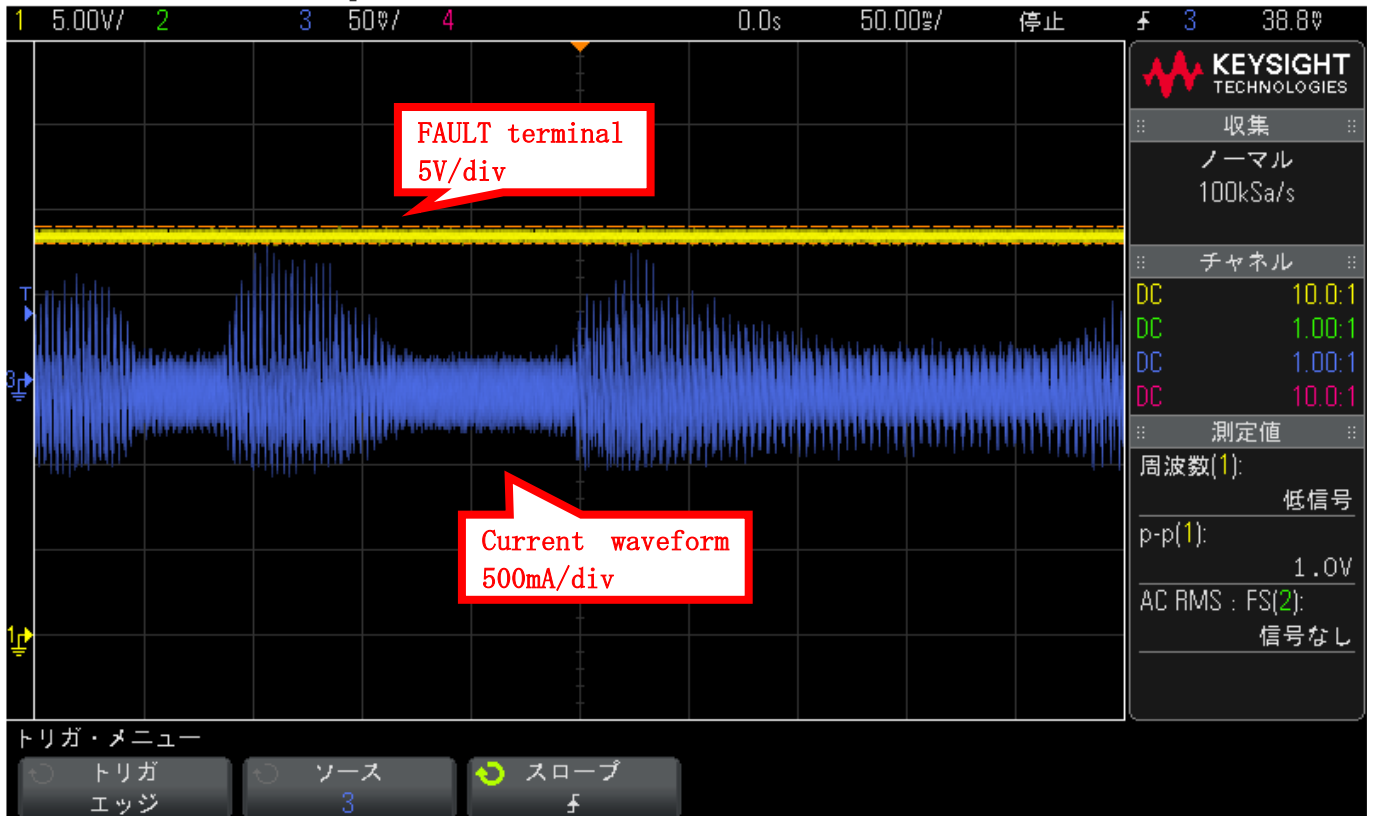
○Current waveform when voice guidance is turned on (50ms/div)

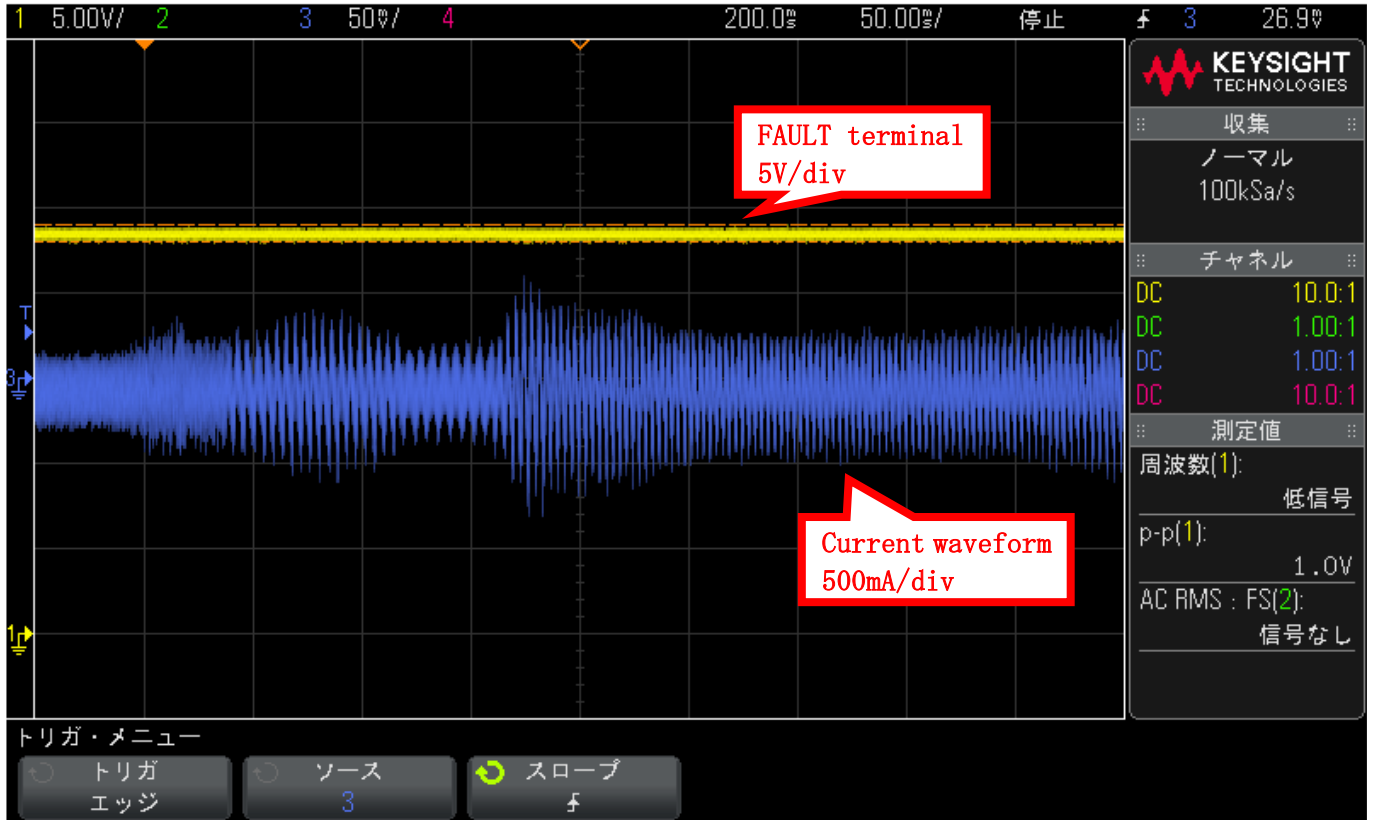
○Current waveform when voice guidance is turned on (50ms/div)
