## RM46L852: Arm-based microcontrollers - INTERNAL forum

**Part Number:** RM46L852

My customer ABB motion just found the following issue in our HErcules Part:

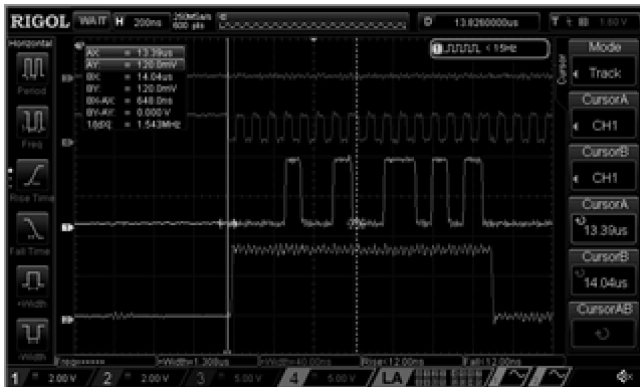
- With Hercules POLARITY=1 and PHASE=0 setting situation looks like this. Hercules does not arm the data to be ready for CLK when CS activates. So master sees 1<sup>st</sup> bit as 0 when it samples it at falling edge.

It technically matches to this one, and we can even see that outputting and latching wont match what master expects (master outputs in rising and this mode in falling)

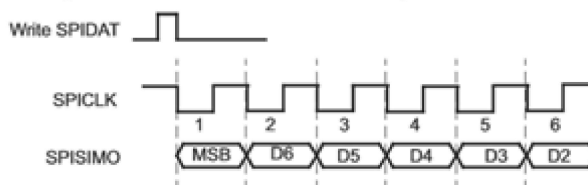
**Figure 27-10. Clock Mode with Polarity = 1 and Phase = 0**

Manual also nicely illustrates that after DAT write it requires CLK to get data into the line

With POLARITY=0, PHASE=0 setting se output of the data is even more delayed

It yet again works like said, but the problem is again that data is not armed at CS, only when CLK edges are seen. Now the output&latch sequence is same

It is also worth to note that data goes to 0 after 16CLK. So even the 1<sup>st</sup> CLK is missed the data ends correctly.

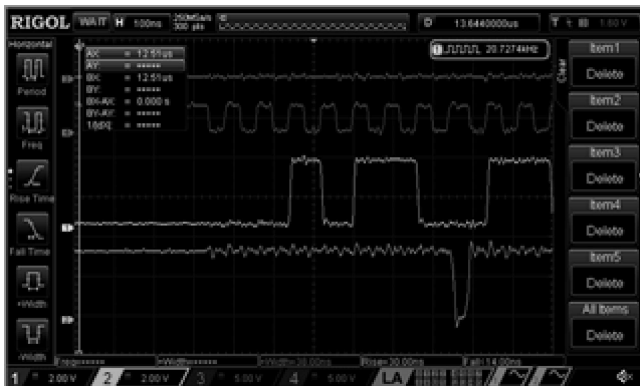
With POLARITY=1, PHASE=1 it looks like this. Data is “armed” to the line before the clock starts running but then something weird happens in byte boundary.

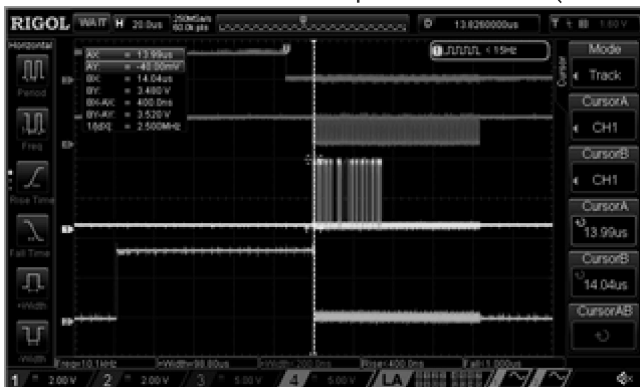
It is also worth to note that in PHASE=1 mode this does not honor/listen CS at all, data looks to be outputted whenever DAT is written despite of CS state (how this would work in multi slave chain??).

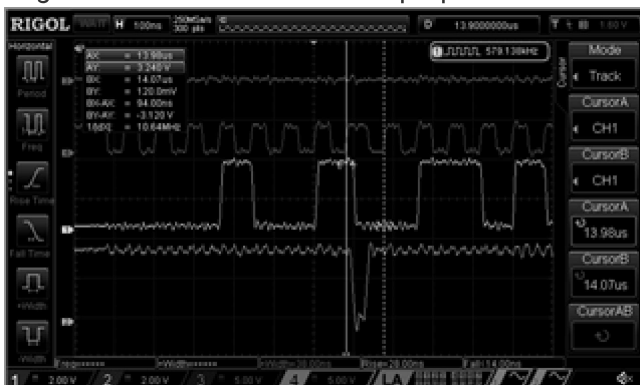
Closeup of the byte boundary. Master sent data 09 35 in this case. 1<sup>st</sup> cursor marks the data update point for the MSB of the 2<sup>nd</sup> byte. Hercules starts to output 0 (why, if I had written 0xFF 0xFF) and then surprisingly near falling edge starts correct the line into proper state

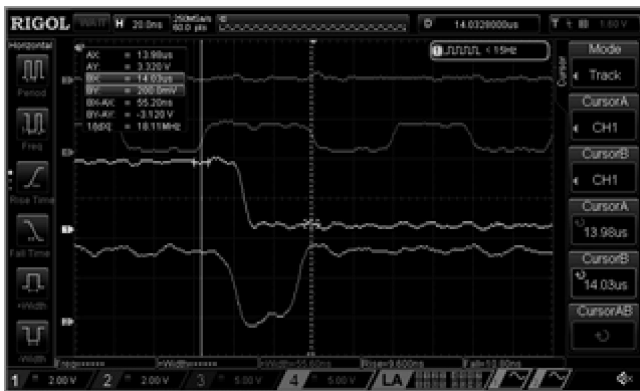
Basically it looks the that “correction” starts even before the falling edge since on edge it is already in 1 state

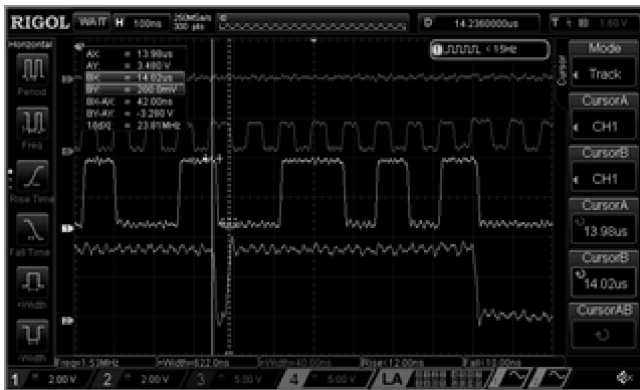
We can also see the data ends correctly and Hercules starts to output 0 exactly as 3<sup>rd</sup> byte MSB bit point in rising edge.

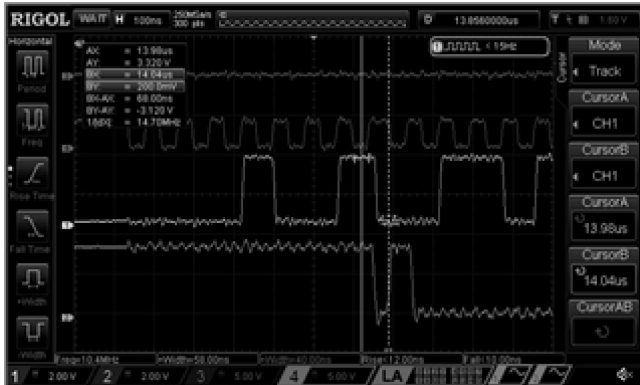
It does not matter do we write 0x80 or what, the behavior is same if then MSB bit is 1. Here is FF 80 write.

So how to say, everything would work OK with POL=1, PHASE=1 setting if we do not send a value over 127dec. All MSB bits after the 1<sup>st</sup> byte will get eaten away by that weird state change in between bytes.

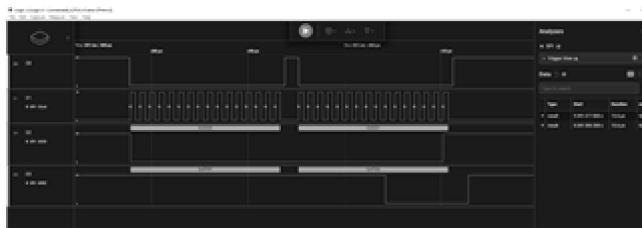
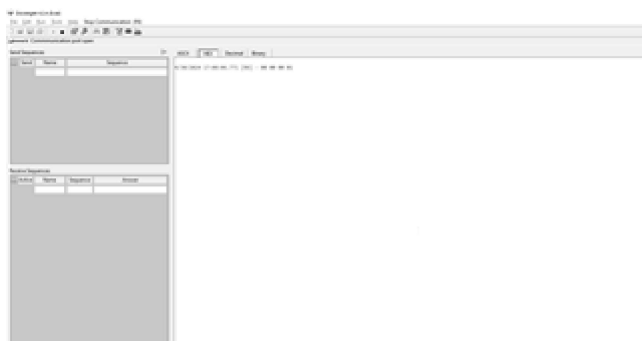
### 1. Output when CPOL=0 and CPHA=0:

Here i didn't get any issues in communication.

Here i am sending two characters of 0x0000 and 0x0001 from master to slave, similarly i am sending two characters of 0xFFFF and 0xFF80 from the slave.

Here i am suggesting customer to first compare my codes and his codes. If there were any difference (HALCoGen settings or code) between them then customer can change his codes according to mine once and can do the test. If customer facing issues, even after making changes also then we will setup a live debugging session and work on the issue again.
